PMFSEL REPORT NO. 06-01

**Investigation of the Vibrations on Overhead
Sign Bridges on US290/SH71**

FINAL REPORT

**Department of Civil Engineering
The University of Texas at Austin**

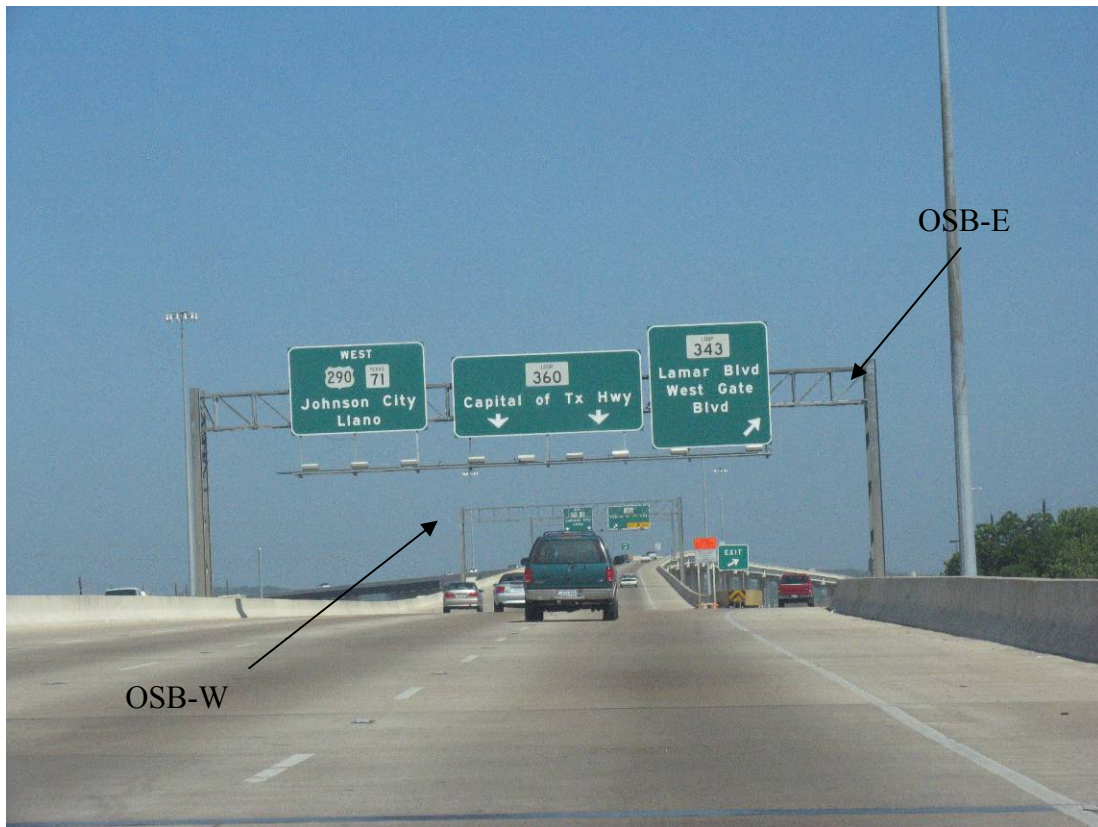
Figure 1.1 Overhead Sign Bridges Investigated

Figure 1.1 is a view, looking west, of both OSBs. The three signs on OSB-E are visible. OSB-W is between OSB-E and another more westerly OSB that has signs mounted. A walkway with a collapsed hand rail is cantilevered in front of the signs with lighting for the signs at the extremity of the cantilever structure. The sign and these ancillary components are attached to a steel wide flange section L frame which is bolted to the OSB.

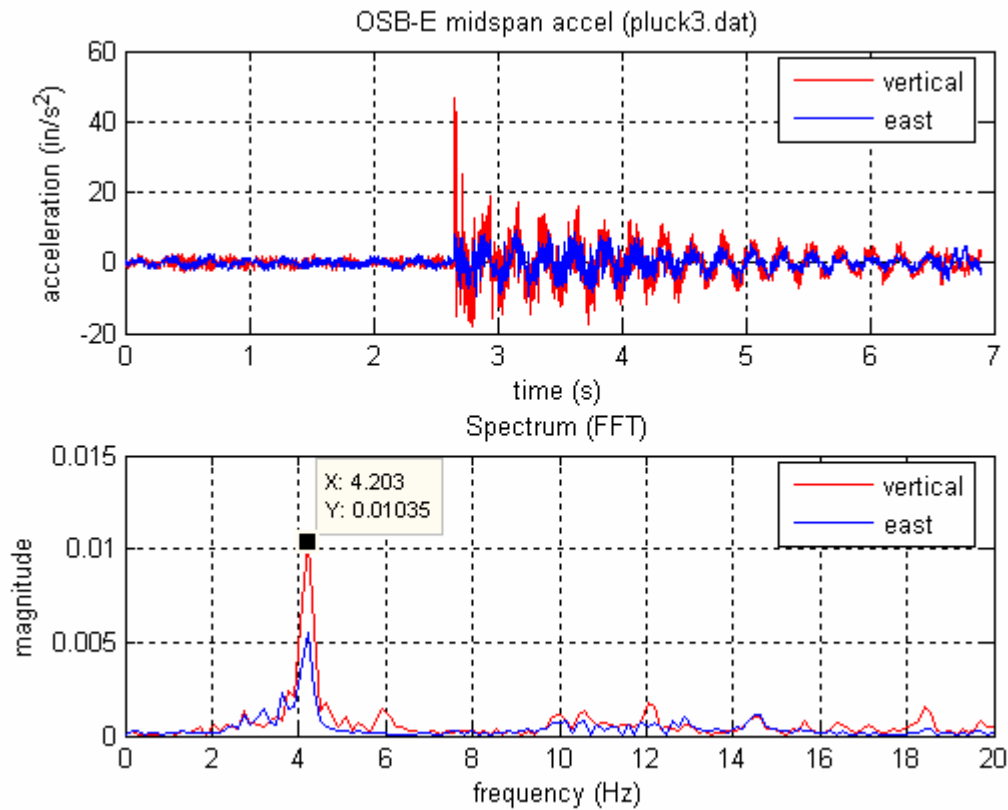
Figure 2.1 Pluck Test Results OSB-E

The spectra show a peak of approximately 4.2 Hz for OSB-E and 6.8 Hz of OSB-W. The difference in the natural frequency is consistent with the differences in geometric configuration and mass of the two structures. OSB-W is shorter in span and lighter due to the absence of signage, L-brackets, walkway, and lights. Since natural frequency of a simply supported beam vibrating in the fundamental flexural mode is a function of the reciprocals of length and mass, it follows that lower mass and less length result in higher natural frequency.

The damping factor of the OSB-E structure was estimated from the pluck test results. The lengthy duration of large motion events indicates low damping in the structure. This is reasonable considering that the only likely energy dissipation mechanisms are aerodynamic damping due to the signs and friction in the bolted connections.

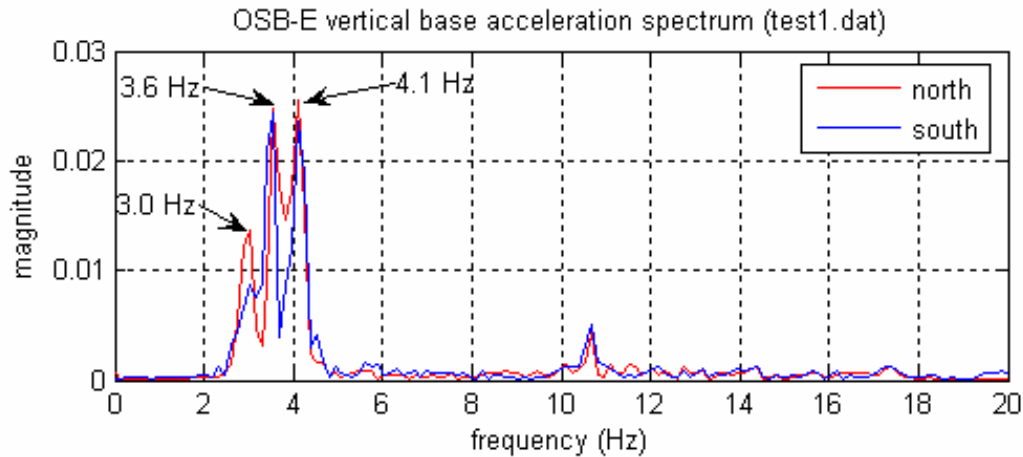
Figure 2.8 Highway Bridge Deck Acceleration Spectrum at OSB-E

For OSB-E, the vertical accelerations of the bridge deck typically exhibit three strong spectral peaks at 3.0, 3.6, and 4.1 Hz as shown in Figure 2.8. Figure 2.9 shows two strong spectral peaks in the vertical accelerations of the deck of the OSB-W highway bridge in the same frequency range. Although there are differences between the two bridge spans, the similarity of geometries and the similarity of the 3 to 4 Hz range of the spectra suggest that these frequencies are the resonances of the highway bridge.

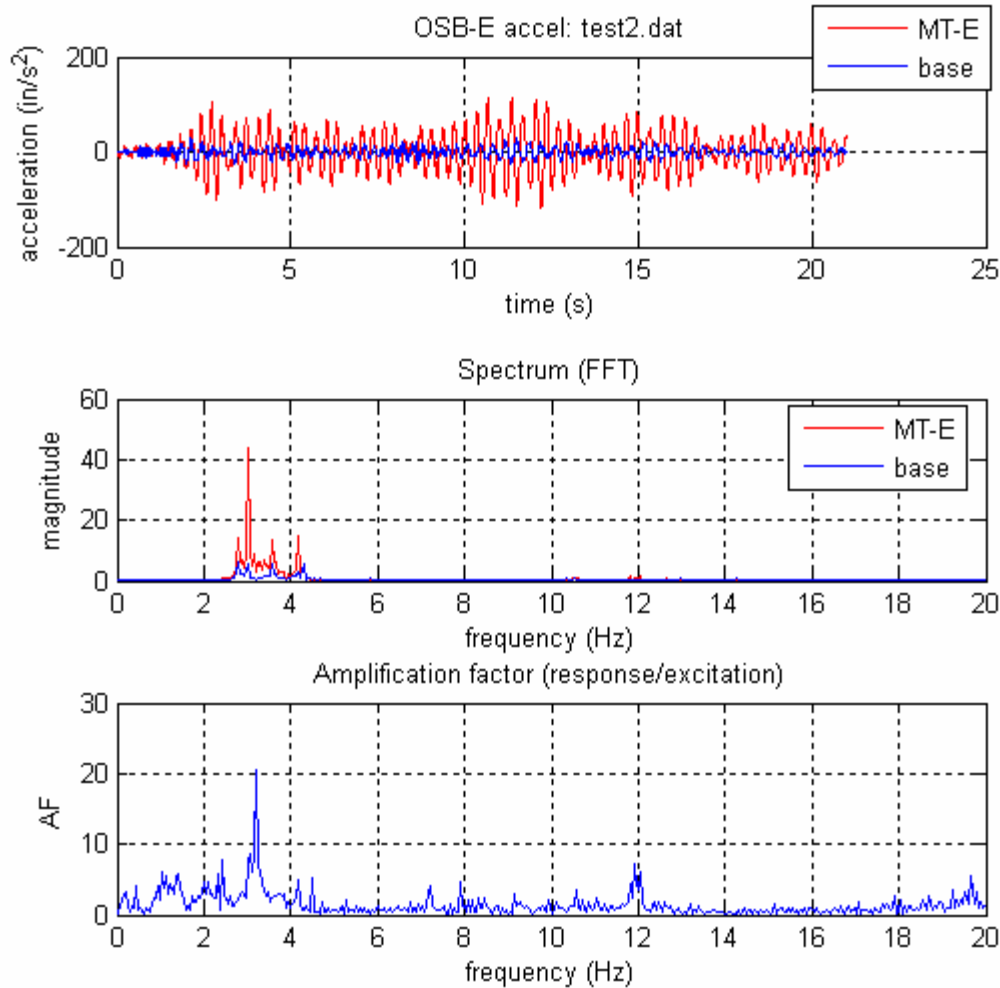
Figure 2.10 Horizontal Response of OSB-E to Vertical Bridge Vibration

The amplification plots for OSB-E for the midspan horizontal and vertical accelerations are plotted in Figure 2.10 and Figure 2.11 respectively. The 4.2 Hz natural vertical frequency of the OSB-E is clearly shown in Figure 2.11 along with a peak near 3 Hz and some higher frequency components that appear negligible in the spectrum (they could be harmonics). The peak at 3 Hz is also evident in the horizontal response shown in Figure 2.10 but the peak at 4.2 Hz is missing. The 4.2 Hz response is a torsional response of the OSB which produces a horizontal as well as a vertical displacement of the top chord of the OSB.

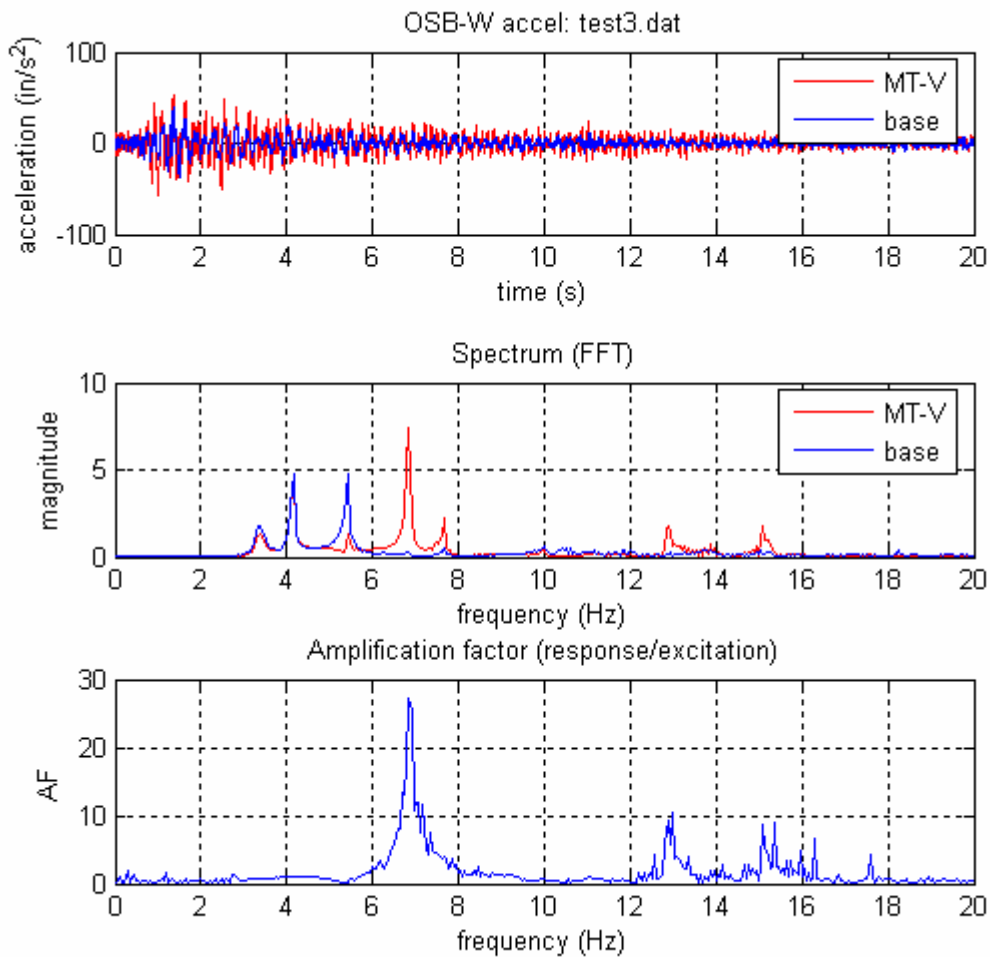
Figure 2.12 Vertical Response of OSB-W to Vertical Bridge Vibration

The AF plot for the OSB-W vertical midspan acceleration in Figure 2.12 shows a very distinct AF peak at the 6.8 Hz OSB resonance. The spectral peaks in the 4 to 6 Hz range of the highway bridge (base) do not produce a significant response from the OSB. They do not produce a significant AF plot, showing that the response of the OSB is simply the forced response of the OSB to the bridge without significant amplification. Even though the OSB and highway bridge frequencies do not coincide in the west bridge, significant

movement of the sign bridge occurred. The accelerations measured at midspan of the sign bridge were significantly larger than those measured at the base of the sign.

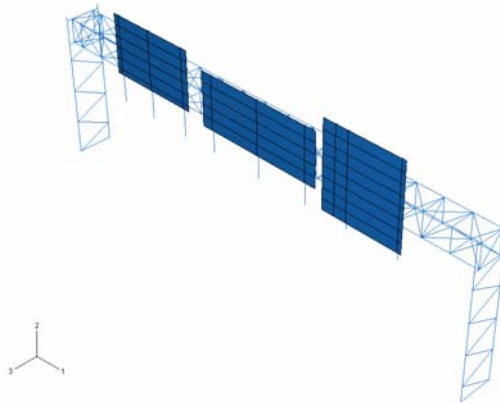
Figure 3.13 Revised Sign Bridge Model without Horizontal Arms, Lights and Walkway

A time series analysis using the same measured bridge acceleration records were performed with horizontal arms of the sign frame removed along with the attached lights and walkway. This was done since in the future the lights will no longer be required due to an improvement the sign reflectivity and it was suspected that removal of this mass would reduce the response of the OSB. The revised sign bridge model is shown in Figure 3.13. The predicted responses are shown in Figure 3.14 and Figure 3.15. The response of the modified structure to the original structure is compared in Table 3.4.

1. Remove the horizontal cantilever portion of the wide flange L brackets. This will reduce the vibrations in the OSB and eliminate the fatigue prone weld detail at the connection of the vertical and horizontal legs of the bracket.
2. Tighten all bolts on the sign bridge using the turn of the nut method. Loose bolts have been found in an inspection prior to this study. The movement of the sign bridge will loosen bolts unless they are properly tightened.
3. Mount the sign as close as possible the bridge pier to reduce the movement of the highway bridge at location of the OSB.

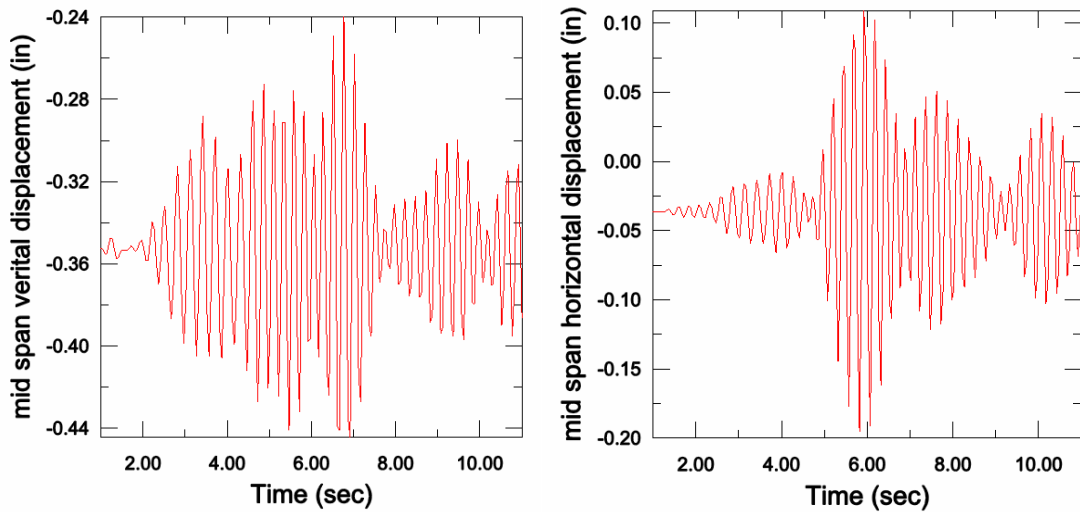
Figure 3.18 Predicted Truss Mid-Span Displacement in Vertical and Traffic Direction OSB-W

Time series acceleration data recorded by the accelerometers attached to the highway bridge were used to excite the overhead sign bridge model. The acceleration inputs are shown in Figure 3.17 and the predicted response of the sign bridge at mid span is shown in Figure 3.18. The displacements from this analysis were used as a base line to compare the influence of changes to the sign structure upon its dynamic response.

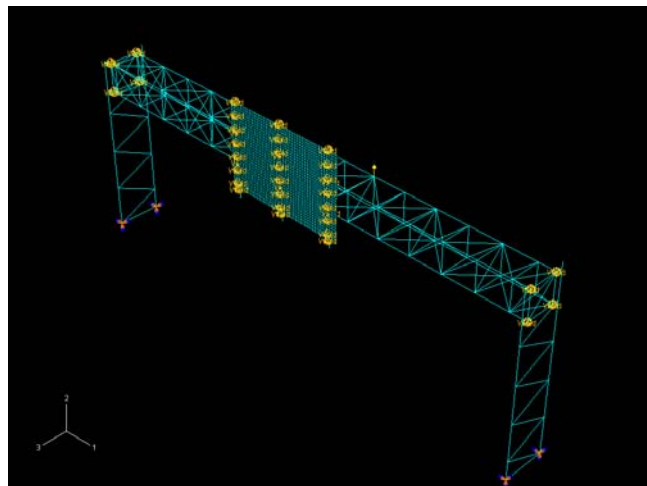
Figure 3.19 Revised OSB-W Model without Horizontal Arms, Lights and Walkway

The response of the modified sign bridge shown in Figure 3.19 is plotted in Figure 3.20 and can be compared the results in Figure 3.14 of the OSB with the horizontal arms. The maximum vertical displacements in the two models are comparable but the displacements damp out quickly in the OSB without the support. The horizontal displacement of the structure without the walkway and lights is negligible. Clearly, removal of these items from the structure will reduce the dynamic oscillation of the OSB.
