SEISMIC STRENGTHENING OF A REINFORCED CONCRETE FRAME
USING REINFORCED CONCRETE PIERS

Report on a Research Project

Phil M. Ferguson Structural Engineering Laboratory
Department of Civil Engineering
BUREAU OF ENGINEERING RESEARCH
THE UNIVERSITY OF TEXAS AT AUSTIN

May 1986

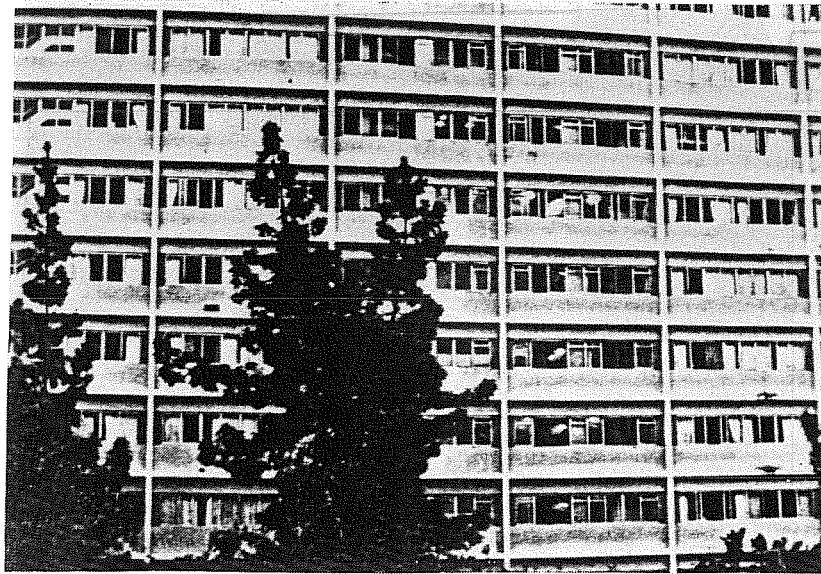
Fig. 1.1 Example building with deep beam-short column exterior frame

The structural system investigated was a reinforced concrete exterior frame system with deep, stiff spandrel beams framing into flexible columns having low shear strength. This form of construction for exterior frames of reinforced concrete buildings was a popular design in California in the 1950s and 1960s [9] because there was no need for exterior architectural walls. The deep spandrel beams formed the exterior wall with clear space at the correct height for windows. The deep beams also shortened the clear span of the flexible columns. An example building with a deep beam - short column exterior frame is pictured in Fig. 1.1. Studies of earthquake failures have indicated that the weak link in these framing systems is usually the column shear capacity. Column shear failures are potentially very hazardous non-ductile failures. Fig. 1.2 is a picture of a typical short column shear failure due to earthquake loading. A shear failure can drastically reduce the load carrying capacity of the column endangering the gravity system and stability of the building. An example of an earthquake failure in a building of this type in which the building suffered severe damage is pictured in Fig. 1.3.

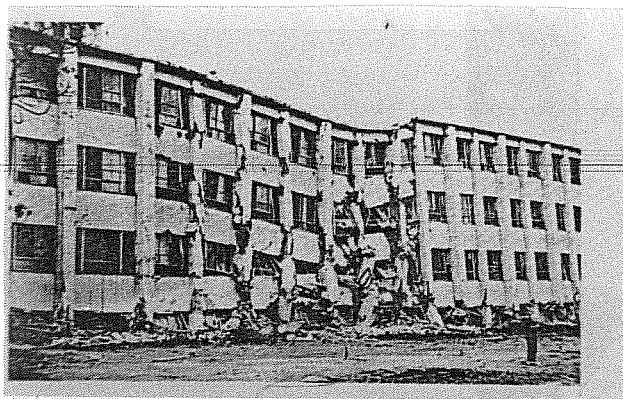
Fig. 1.3 Severe damage due to short column
shear failure. Hokodate College,
Tokachi-oki 1968 [10]

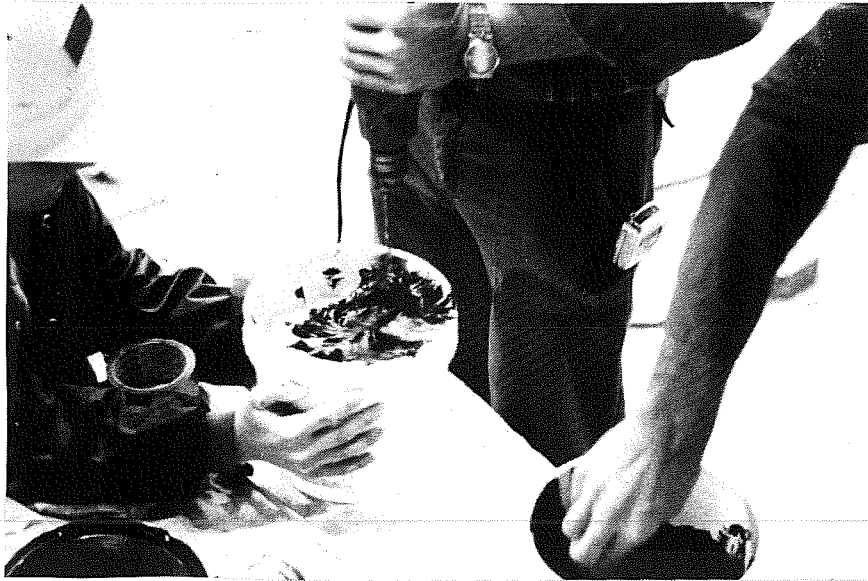
Fig. 2.25 Mixing epoxy ingredients

The dowels were epoxy-grouted into the frame using Adhesive Engineering Concrete 1411, a medium viscosity, non-sag epoxy. After thoroughly mixing the two ingredients of the epoxy (Fig 2.25), the epoxy was placed in the hole using a caulking gun. As the hole filled, the gun was slowly retracted (Fig. 2.26). The dowels were inserted while turning them 180 degrees. One hundred thirty-five dowels were epoxy-grouted into the frame using one gallon of the Concrete 1411. The potlife time of the epoxy, 2-1/2 hours, was not exceeded. The epoxy cured for two days before the reinforcing cage was placed.

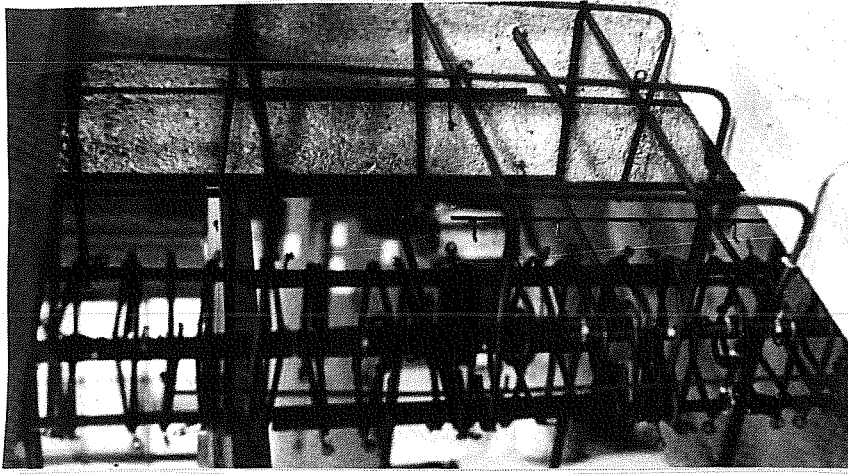
Fig. 2.31 Hooked #3 longitudinal bars in window area

hoops, the boundary element cage had to be rotated out of position. The rest of the longitudinal bars in the piers were then threaded down through the transverse steel and tied in place (Fig. 2.30). Finally, the inside #3 hooked bars (within the window segments) were tied as seen in Fig. 2.31. Because the bars were spliced at the window segment, it was necessary to tie two stages of reinforcement prior to placing concrete for the first stage.

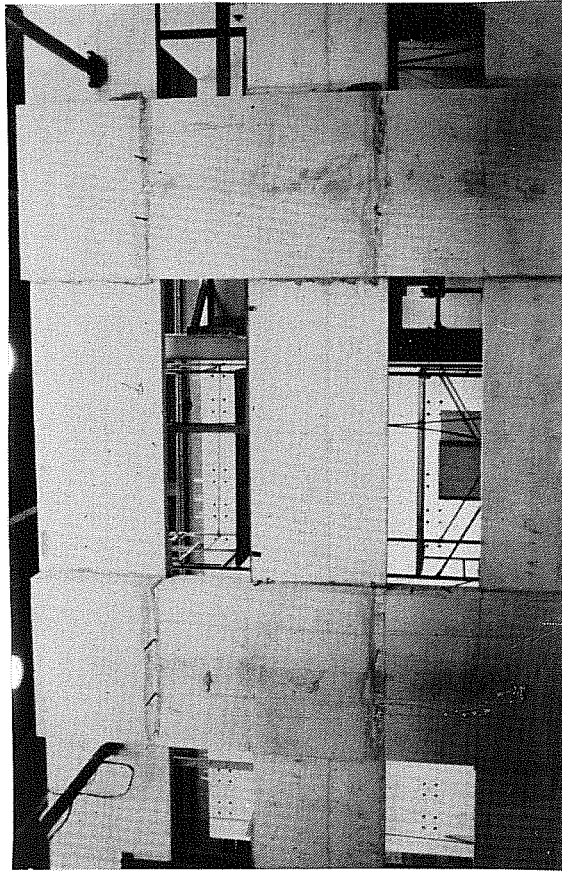
Fig. 2.35 The completed R/C pier strengthening scheme

Casting one story at each stage was convenient for alignment and logistic purposes. However, placing concrete seven feet through very narrow cages was likely to cause segregation of the aggregate and paste, as well as making compaction difficult. For this reason, the forms were built so that the concrete could be placed at two different heights. The forms were constructed so that the exterior three sides of the formwork were in place for the entire cast. The interior piece which would form the inside of the strengthened column in the space between beams was a separate piece. For the first part of the cast the exterior formwork was in place and the interior formwork was left off. The concrete was placed from the backside (interior) of the frame into a chute which emptied into the formwork over the top of the beam (Fig. 2.32). In this manner, the first 4 ft of casts 1 and 2 was placed and vibrated from the interior of the frame. After casting the first 4 ft, the inside formwork was bolted into place (Fig. 2.33). The remaining 2 ft 8 in. was placed from the top of the exterior formwork. In field construction, the formwork would have been broken and the entire pier cast from the exterior of the building. After each cast the concrete was covered with polyethylene for moist curing. The forms were stripped after two to three days and were used in the next casting stage. Figure 2.34 is a picture of the exterior of the construction sequence and Fig. 2.35 is a picture of the completed piers.

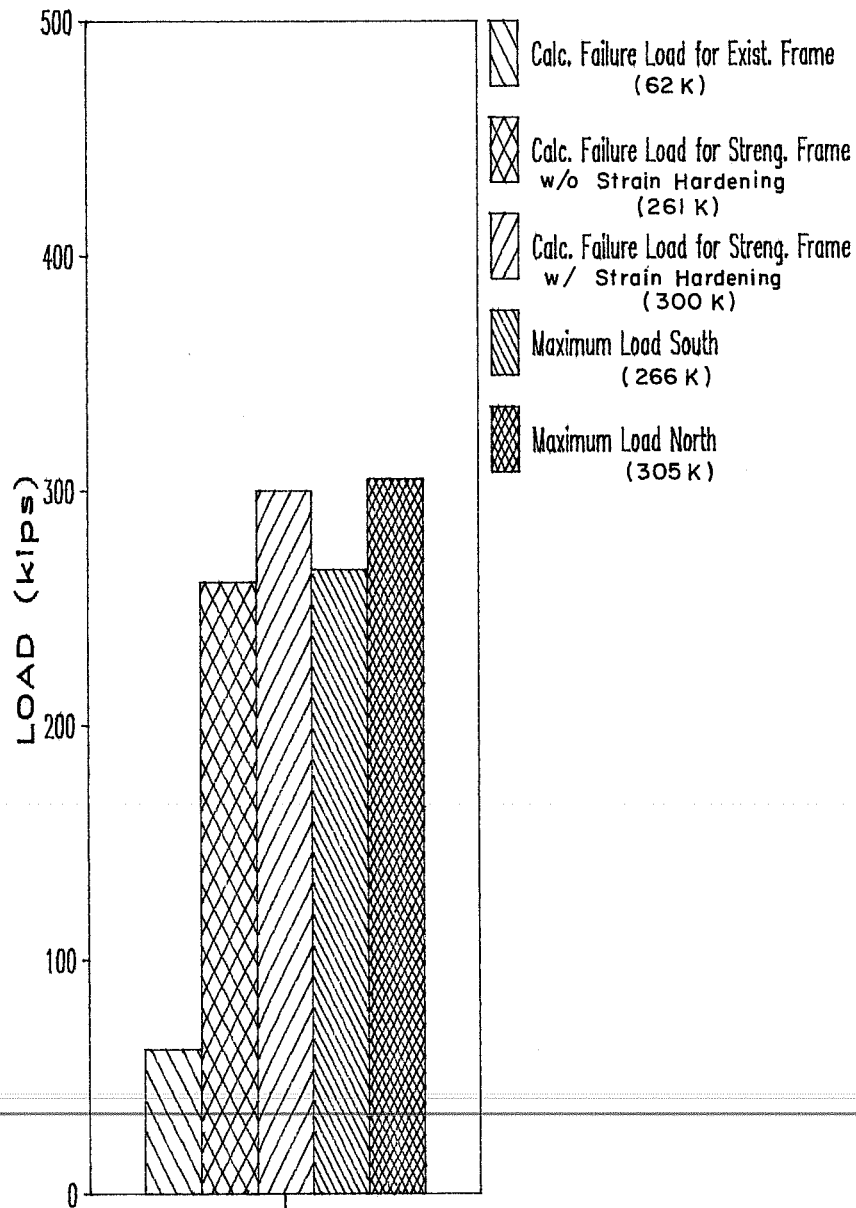
Fig. 5.3 Comparison of model with the calculated failure load of the existing frame model, the predicted failure load of the strengthened frame and the maximum loads on the frame

Figure 5.3 is a bar graph comparing the calculated capacity of the existing frame model, 62 k; the calculated failure load of the strengthened frame without strain hardening, P = 261 k; the calculated failure load of the strengthened frame with strain hardening, 300 k; and the two maximum loads applied to the frame, 305 k north and 266 k south. The maximum applied loads corresponded well with the calculated failure load from the failure mechanism analysis. The pier strengthening increased the lateral strength of the frame to over five times the calculated lateral strength, 62 k, of the existing frame model. The test results did not lead to conclusions of the available ductility because of the necessity of stopping the test before excessive damage of the frame occurred.

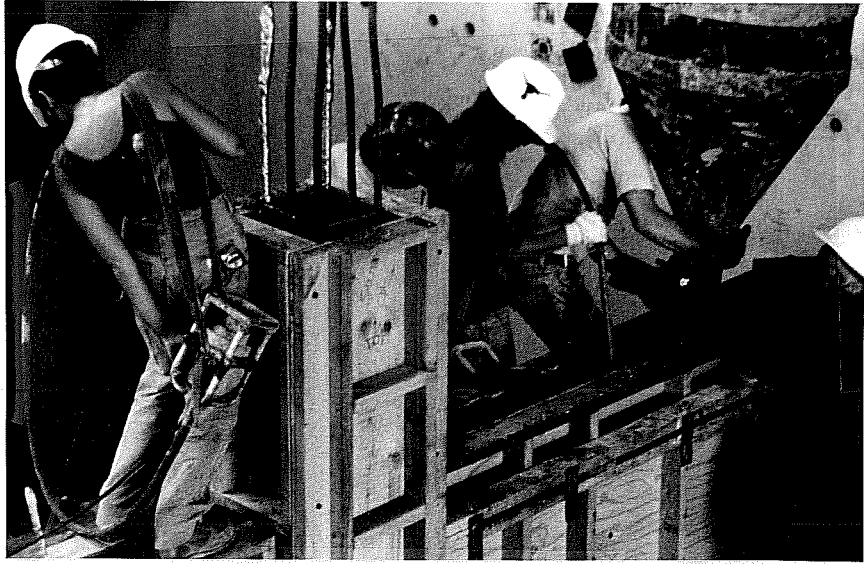
Fig. 2.18 Placing concrete in upper portion of beam form.

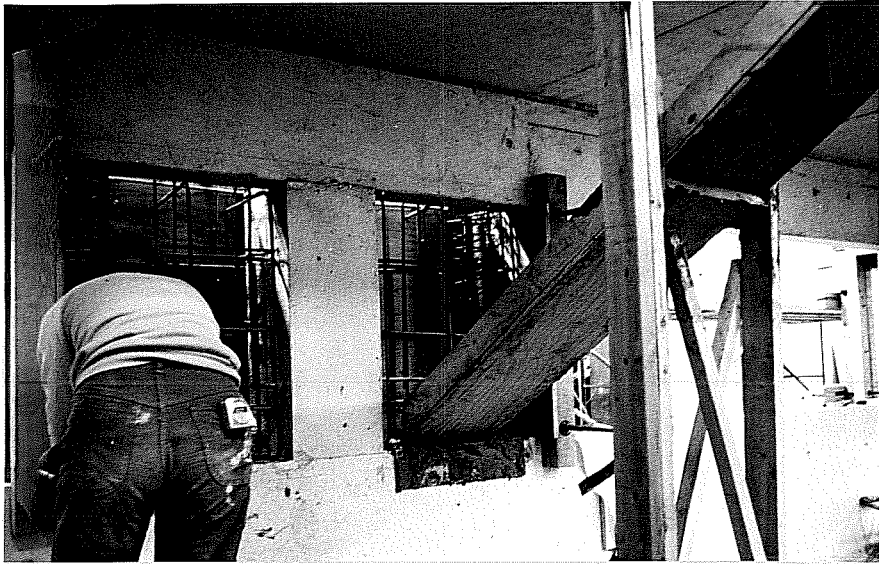
Fig. 2.32 Concrete was placed from the interior of the frame using a chute which emptied into the formwork.

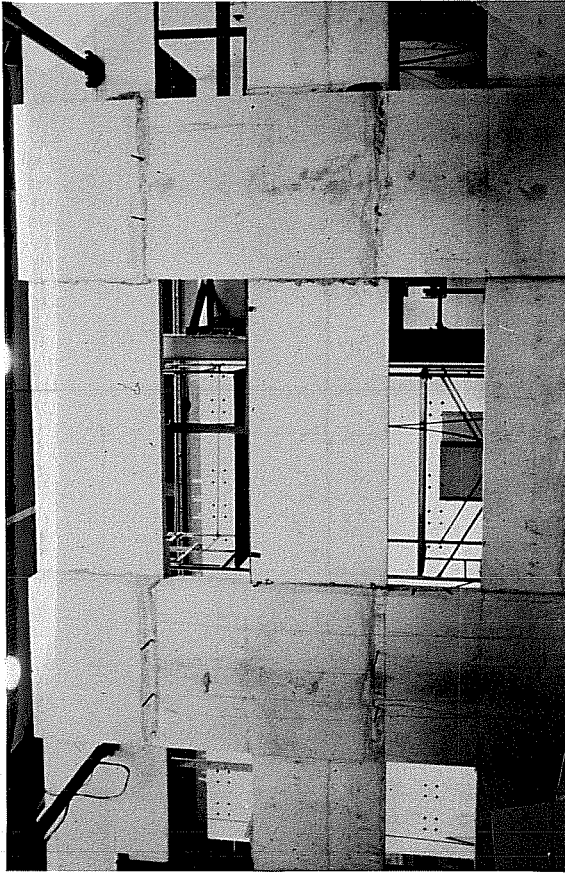
Fig. 2.35 The completed R/C pier strengthening scheme.

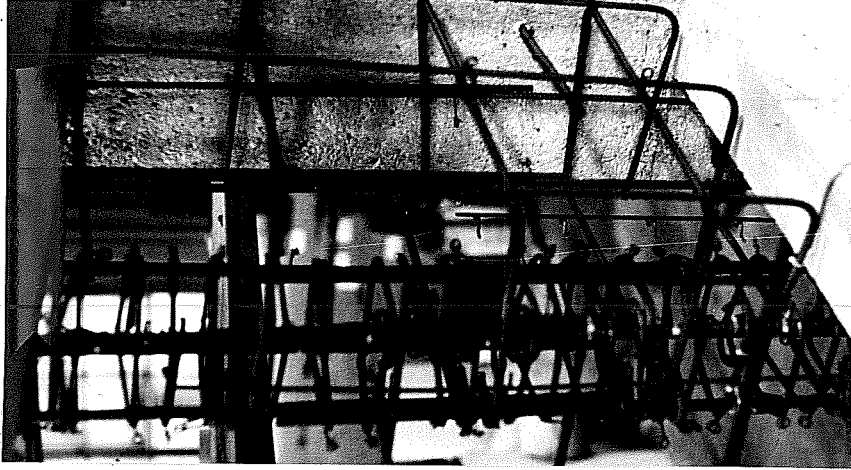
Fig. 2.31 Hooked #3 longitudinal bars in window area.

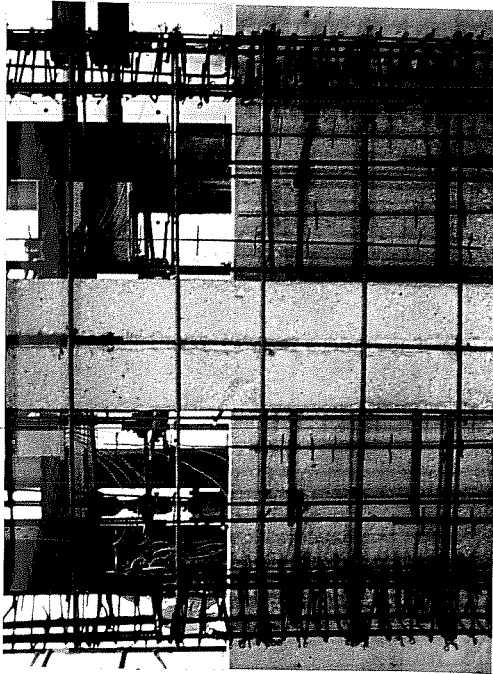
Fig. 2.30 Transverse and longitudinal steel in place.

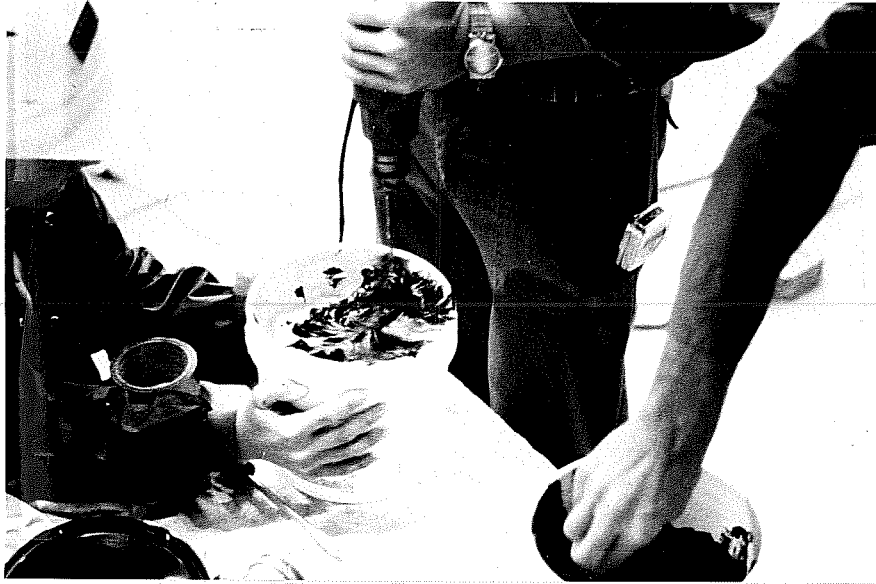
Fig. 2.25 Mixing epoxy ingredients.

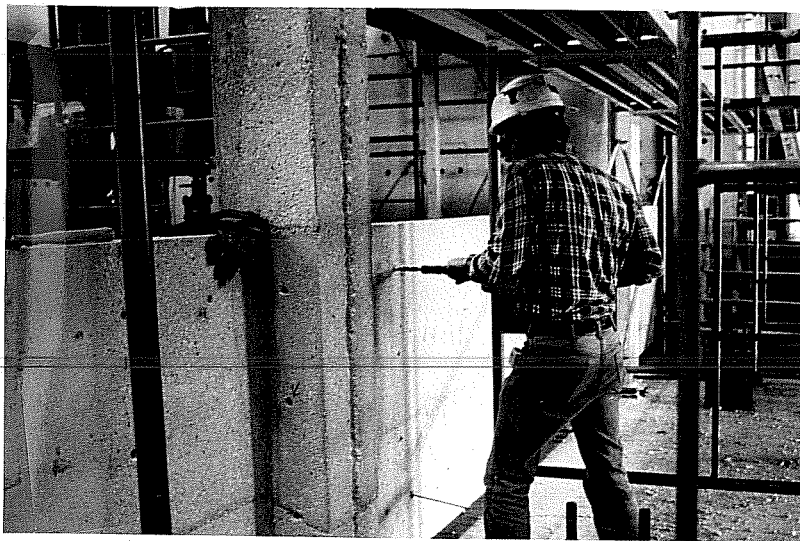
Fig. 2.24 Drilling holes for dowels.

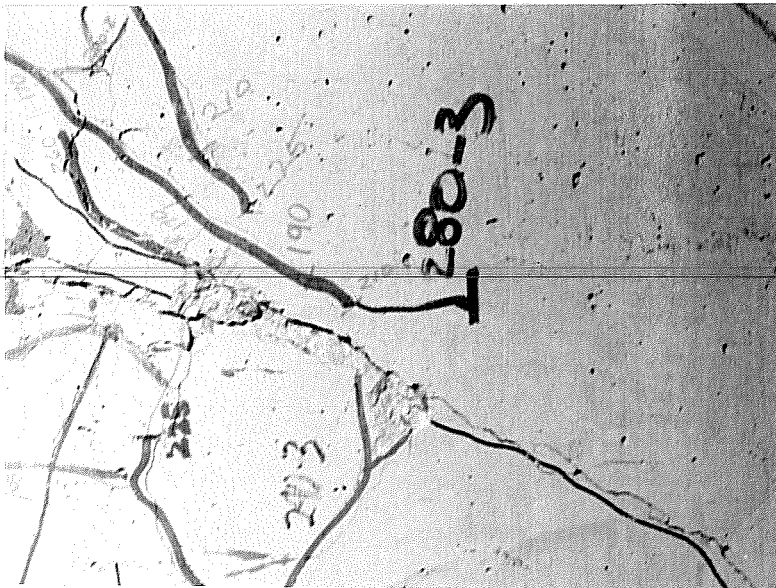
Fig. 3.13 Crack pattern on exterior face of north end, first level beam, 0.5% drift.

Fig. 3.13 Crack pattern on exterior face of north end, first level beam, 0.5% drift

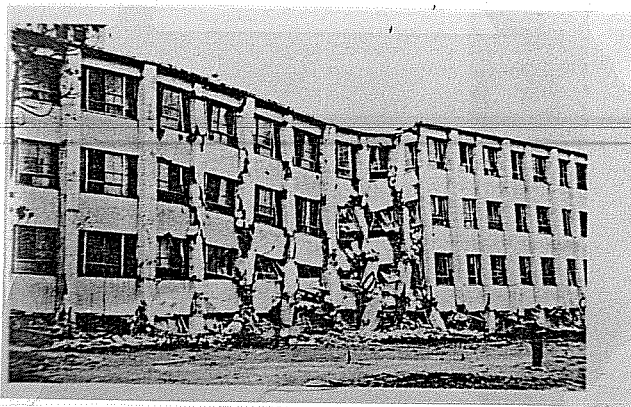
Fig. 1.2 Typical short column shear failure. Olive View Hospital, San Fernando 1971.

Fig. 1.2 Typical short column shear failure
Olive View Hospital, San Fernando
1971
