Testing of Precast Bridge Bent Cap Connection Details

Thesis

Master of Science in Engineering

December 1999

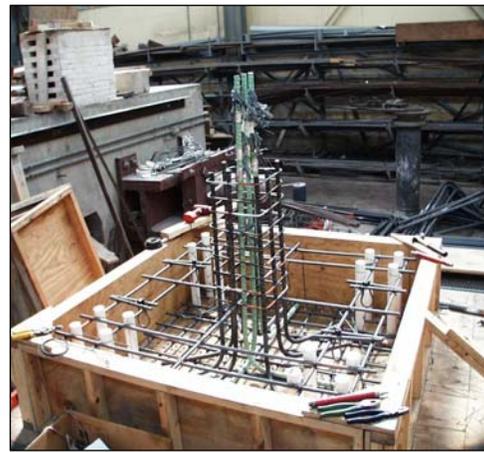
Figure 2.3 Pile and footing reinforcement

The pile segment used to support the precast cap segment had a 16 in. square cross section and 2 ft. height. The pile was cast together with an 18 in. deep, 68 in. square footing. The footing was used to tie the test specimen securely to the strong floor of the laboratory. Figure 2.3 shows the reinforcement cage for the pile and footing combination.

The pile had 8 #8 longitudinal reinforcing bars. Bars had a 90-degree hook on one end and were anchored inside the footing. Number 3 closed ties were placed at every 4 in. along the pile height.

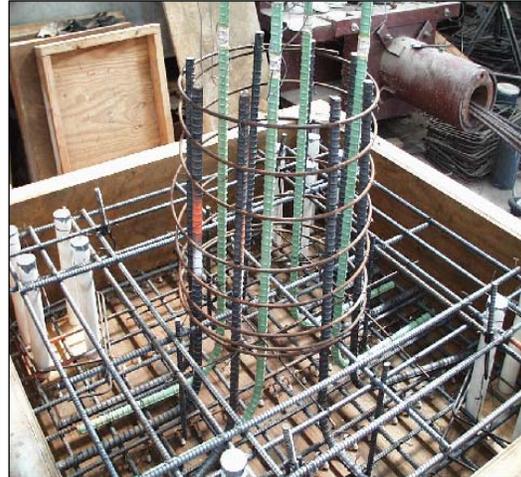
Figure 2.6 Reinforcement cage for C2-DL column and footing

The column segment for supporting the cap had a 30 in. circular cross section and was 2 ft. high. It was cast together with a footing similar to that described for the P2-SLE specimen. The column had 8 #9 longitudinal bars that were anchored inside the footing. The longitudinal rebars were confined with a 24 in. diameter spiral with 6-in. pitch. Figure 2.6 shows the reinforcement cage for the column-and-footing segment.

Four #9 epoxy-coated rebars were used to connect the column to the cap beam. These were also hooked at one end and anchored inside the footing. The straight bar anchorage length inside the bent-cap was 15 in.

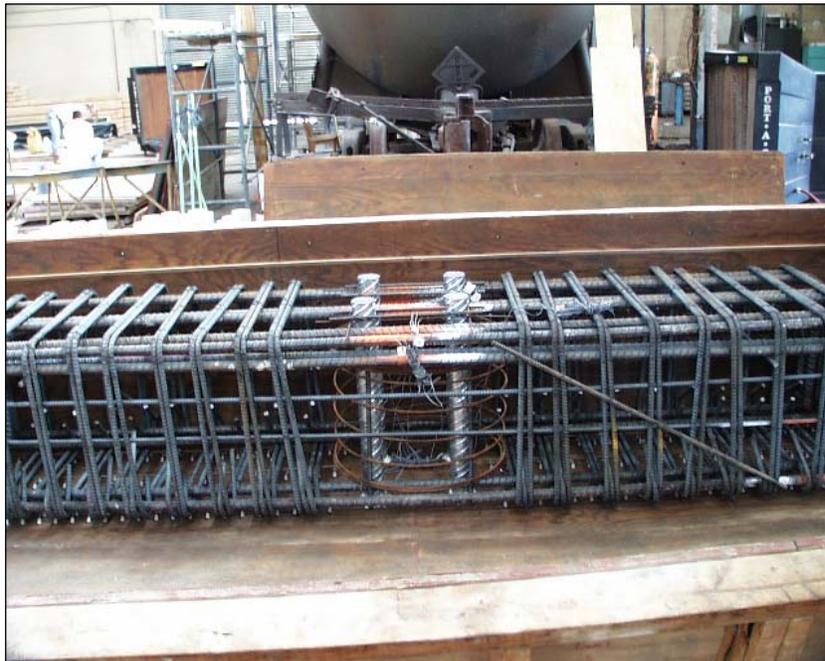
Figure 2.8 Reinforcement cage for C2-VD cap

Four 4 in. diameter metal ducts with 30 in. height were placed inside the cap before casting. The ducts were tied to adjacent rebars to maintain their position during casting. A 24 in. diameter spiral with 4 in. pitch confined the ducts. Figure 2.8 shows the reinforcement cage and ducts before casting.

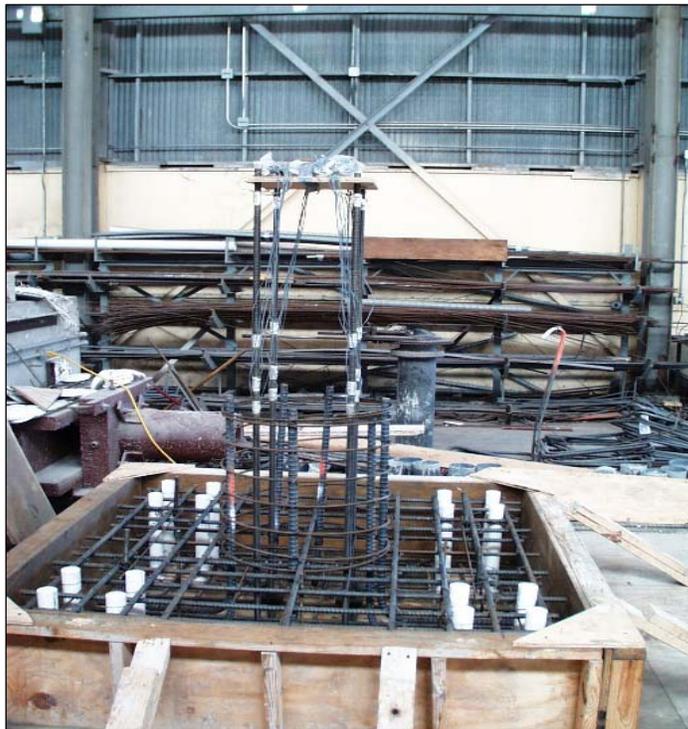
Figure 2.10 Reinforcement cage for C2-BC column and footing

For connecting the cap to the column, four 1 in. diameter threaded rods were placed inside the column core. The bars were anchored inside the footing by attached plates. The

bars were cut sufficiently long to ensure they would pass through the metal ducts inside the cap and still have the necessary length to accommodate bolts at the top. Figure 2.10 shows column-and-footing assembly before casting.

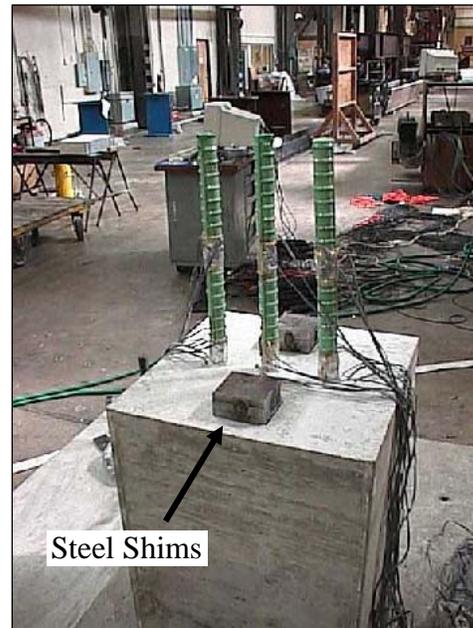
Figure 2.11 Shims and connectors

Cap placement and pre-grout set-up: The footing and 16 in. pile with a single line arrangement of the three epoxy-coated #9 connectors are shown in Figure 2.11. All Phase II specimens, except the bolted connection, had 15 in. embedment of the epoxy-coated bars into the cap. Two 3 in. x 3 in. x 1.5 in. steel shim stacks were used in setting the P2-SLE cap. The strain gage lead wires attached to strain gages on the bars are also visible in the photograph.

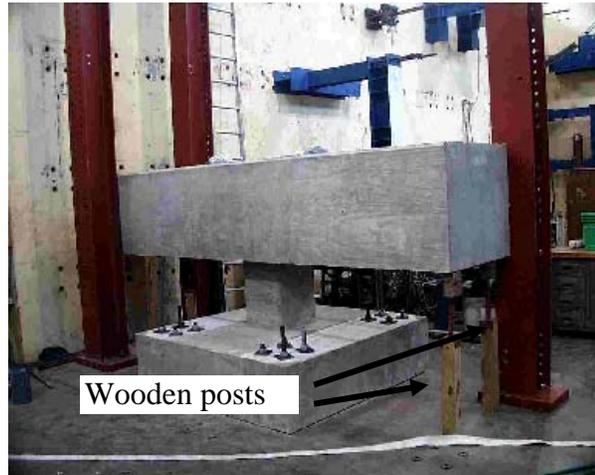
Figure 2.12 Cap in final position

After the cap was placed on the shims, three wooden posts were used to provide additional stability until the grout was placed. Figure 2.12 shows the cap in its final position. The block out for accepting the single-line connectors is shown in Figure 2.13 from the cap top. The strain gage lead wires were taped neatly on the cap top prior to the grouting procedure.

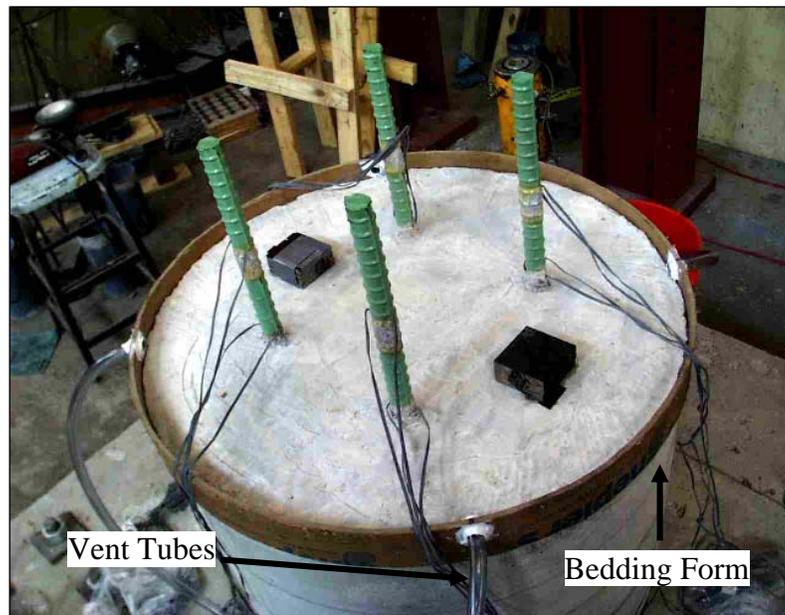
Figure 2.16 Column preparation for grouting

Cap placement and pre-grout set-up: The footing and 30 in. circular column with the double line arrangement of four epoxy-coated #9 connectors are shown in Figure 2.16. The figure also shows a small cardboard ring, 0.25 in. thick, used to form the bedding layer. Four vent tubes with 0.5 in. inside diameter provided the means to vent air during grouting. Strain gauge lead wires are also evident.

The footing and 30 in. column with four epoxy-coated #9 connectors for specimen C2-VD were quite similar to those for specimen C2-DL (Figure 2.16). Two 2.5 in. x 5 in. x 1.5 in. polyethylene shim stacks were used rather than steel shims. The same preliminary grouting steps, described for specimen C2-DL, were used for specimen C2-VD.

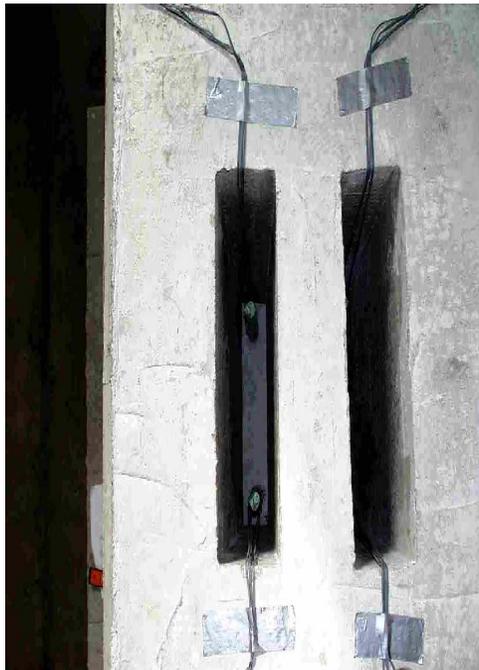
Figure 2.17 Block outs

Figure 2.17 shows the block outs for the double line connectors. The block outs (dimensions provided in Section 2.2.2) provided sufficient tolerance during placement of the cap. These V-shape block outs differed from the P2-SLE specimen's block out, which included a base void for embedment of the pile into the cap. The cap-to-column connections had bedding layers that were exposed. A 15 in. bar embedment was provided as the length of bar contained within the block out.

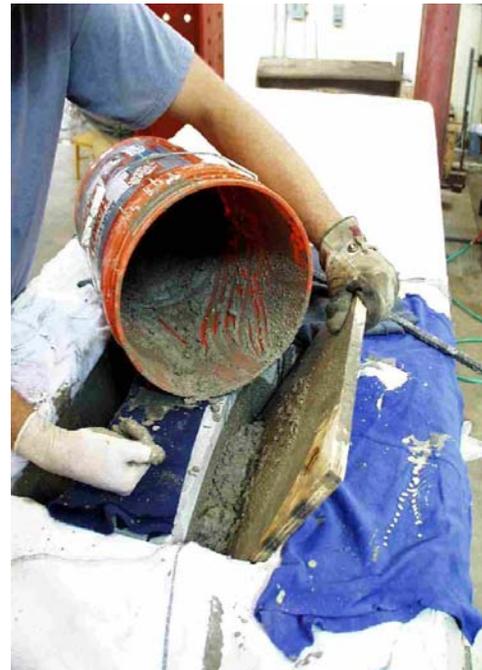
Figure 2.18 Placement of grout

Grout was poured against a piece of plywood to limit the introduction of air into the pockets (as shown in Figure 2.18). Grout was placed in the pockets in

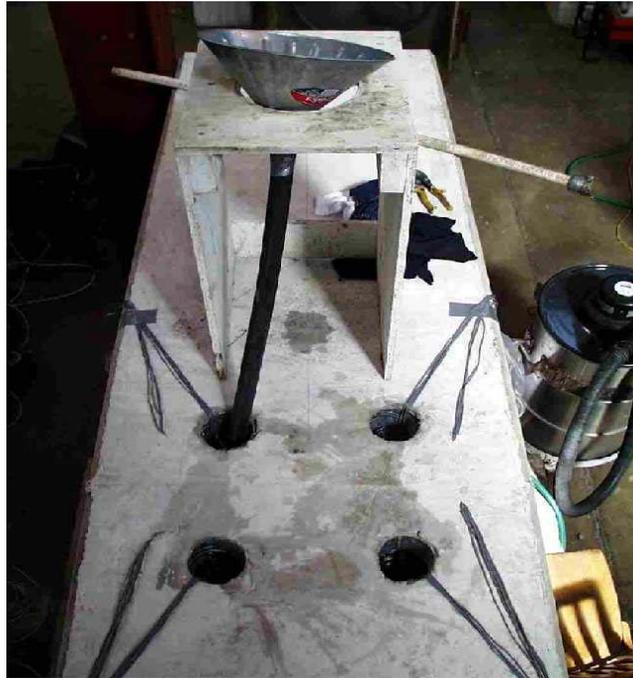
Figure 2.19 Funnel and hose used for grouting

Grout was poured in a duct through a funnel with a 1 in. inside diameter hose as shown in Figure 2.19. The end of the hose was placed very close to the bedding layer and the funnel was kept full while continuously placing grout to limit the air introduced inside the duct and bedding layer. Four 5 gallon buckets of grout were used to fill the bedding layer and four ducts. The grout surface at the top of the cap was covered with curing compound for two days. After three days, the bedding layer form and vent tubes were removed. Grout on the outer surface of the bedding layer appeared to be quite competent.

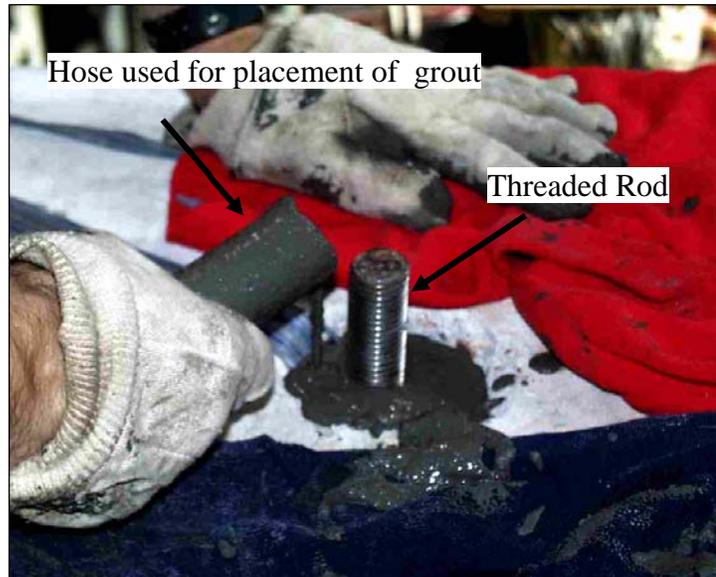
Figure 2.20 Threaded rod and grout

The same funnel and hose used for placing grout in the C2-VD connection were used for this connection. A continuous flow of grout through the funnel filled the bedding layer and ducts. Care was taken not to get grout on the protruding portions of the threaded rods. Figure 2.20 shows the end of the grouting procedure.

The top surface was sprayed with a curing compound for three days. After three days of curing, nuts were installed on the threaded rods and were tightened with a torque wrench to 200 lb-ft.

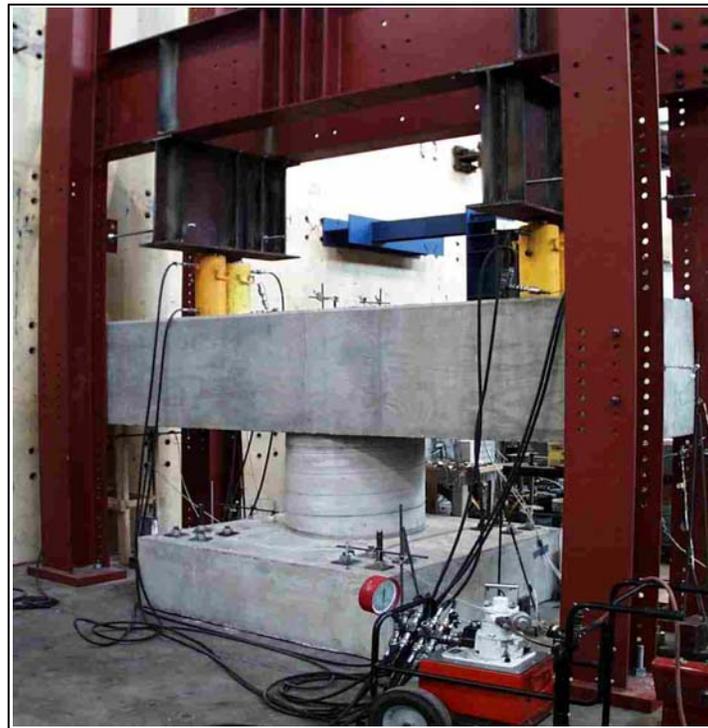
Figure 4.1 Test setup

Based on typical conditions for column bents, a maximum combined factored dead and live load of 290 kips was applied on each side of the connection, totaling 580 kips at the column top. These loads were typically applied with eccentricities in the 4 to 7 in. range. As shown in the photograph of the test setup of specimen C2-DL(Figure 4.1), vertical loads were applied to the cap using a total of four 100-ton rams, two on each side of the connection. In the load combinations shown below, the first three tests (1-3b) were considered to be proof loads for the connection. A very large transverse eccentricity of 55.5 in. in Test 4 was used to initiate yielding of connectors.

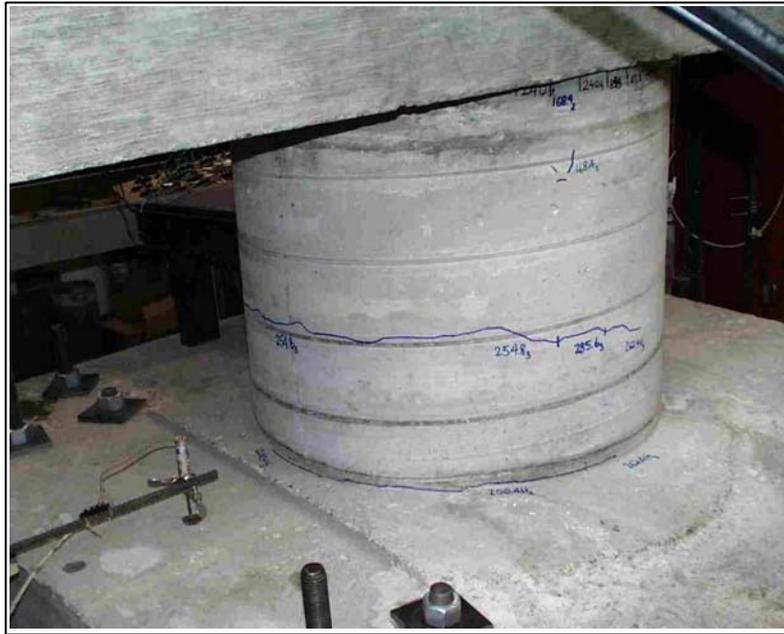
Figure 4.9 Column cracks during Test 3

At a load of 255 kips, a horizontal crack appeared on the northeast side of the column near mid-height, as shown in Figure 4.9. As load was increased to the factored load level, this crack extended in the column and new shear cracks appeared on the south face of the cap beam. Upon application of the horizontal load, vertical cracks appeared on the west column face, and the horizontal column crack and beam shear cracks extended. Maximum crack width at the pocket top was slightly larger than during Test 2. Grout-concrete relative displacements were still negligible as shown in the displacement response.

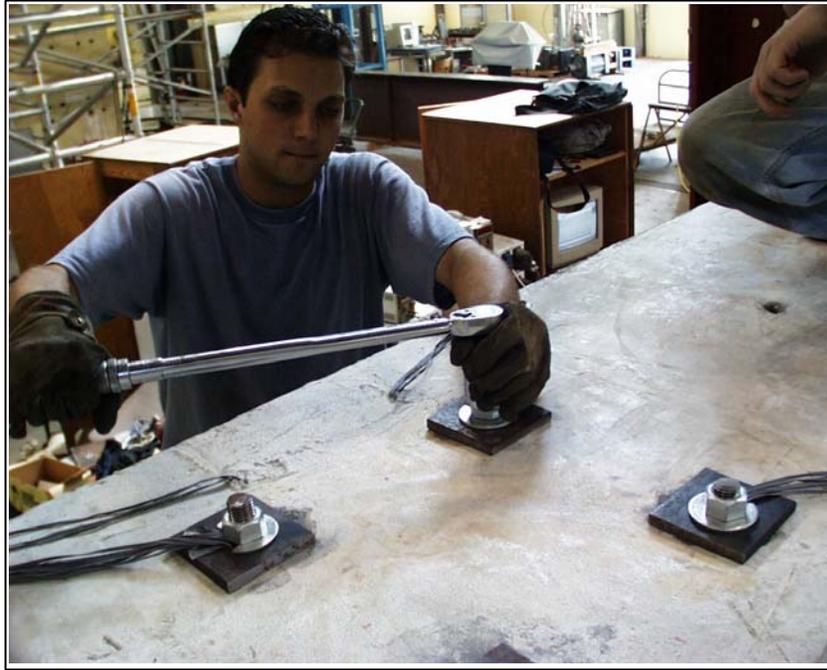
Figure 6.1 Tightening nuts on top of cap

Before testing began, bolts were tightened to 200 lb-ft with a torque wrench as shown in Figure 6.1. A portion of each circular washer was cut away so that the strain gage lead wires exiting the top of the grouted ducts were not crushed while tightening the nuts. During the usual examination of the specimen before testing, some cracks were observed in the footing.
