**THE EFFECT OF OPENINGS ON A PRECAST INFILL WALL
SEISMIC STRENGTHENING SYSTEM**

Thesis

Presented to the Faculty of The Graduate School
of The University of Texas at Austin
in Partial Fulfillment
of the Requirements
for the Degree of

August 1996

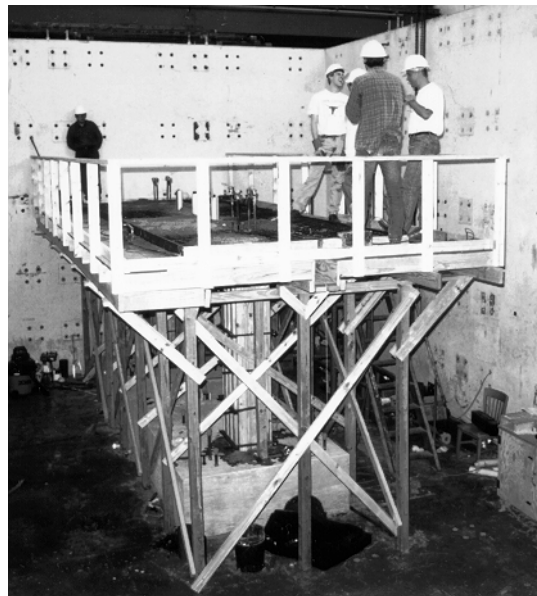
Figure 2.5: First Story Construction

During construction, the formwork for the floors and beams was shored to the ground using wooden two-by-fours and four-by-fours. The two columns below a floor level were cast simultaneously with that floor. Figures 2.5 through 2.8 show various stages in the construction of the model frame from the first story to the completed structure.

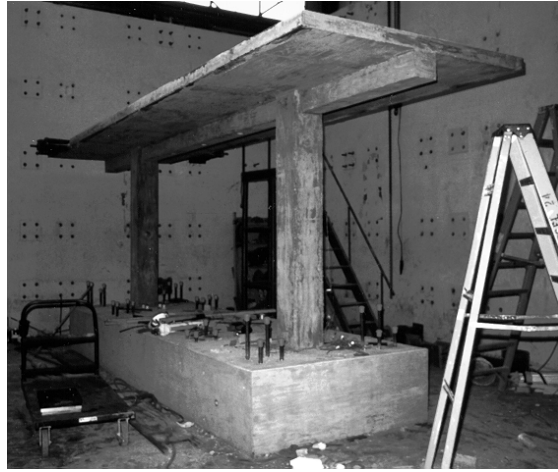
Figure 2.6: Completed First Story

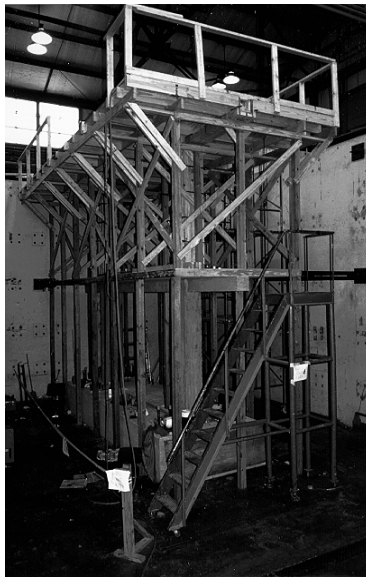
Figure 2.7: Second Story Construction

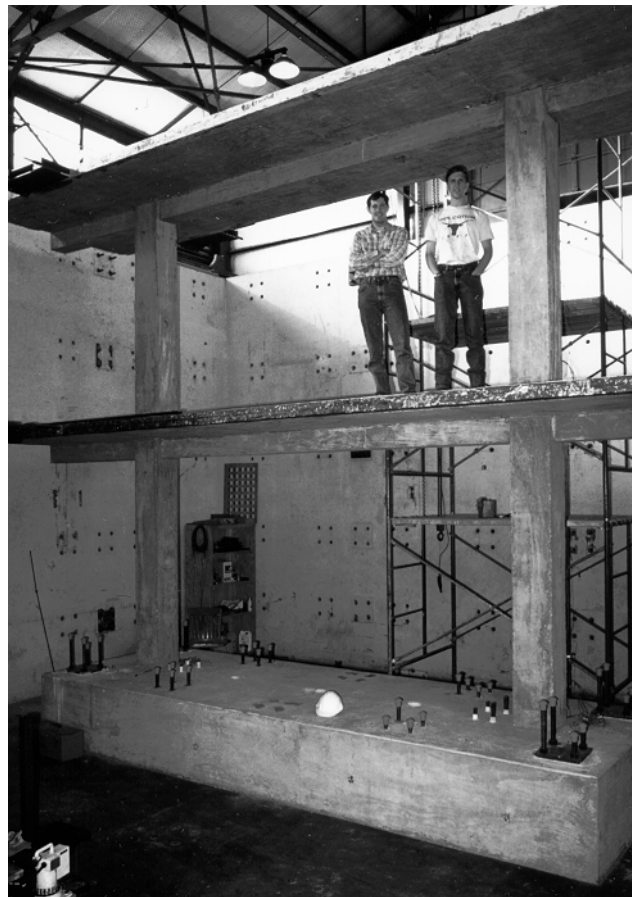
Figure 2.8: Completed Existing Frame

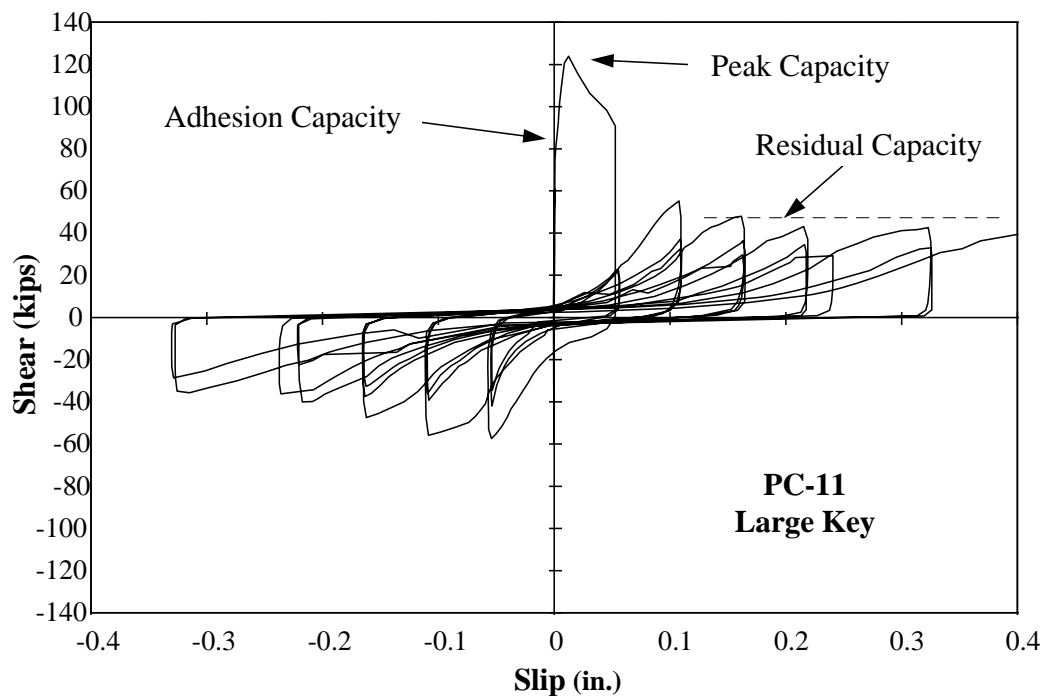
A typical load-displacement response curve from these panel connection tests is presented in Figure 2.12. As can be observed in this plot, the progression of strength development for these specimens was:

- *Adhesion capacity.* Initially, the specimen is very stiff, until adhesion is broken along the interface between the panel shear keys and the grout.

Figure 2.12: Typical Panel Connection Test Results^[6]

- *Peak capacity.* After loss of adhesion, some stiffness is lost, but the load continues to increase until the peak capacity is reached when a failure plane develops along the shear keys.
- *Residual capacity.* After the shear keys fail, the vertical reinforcement in the closure strip is mobilized in shear friction and yields, creating a ductile failure mechanism with a residual strength typically between 30% and 40% of the peak strength.

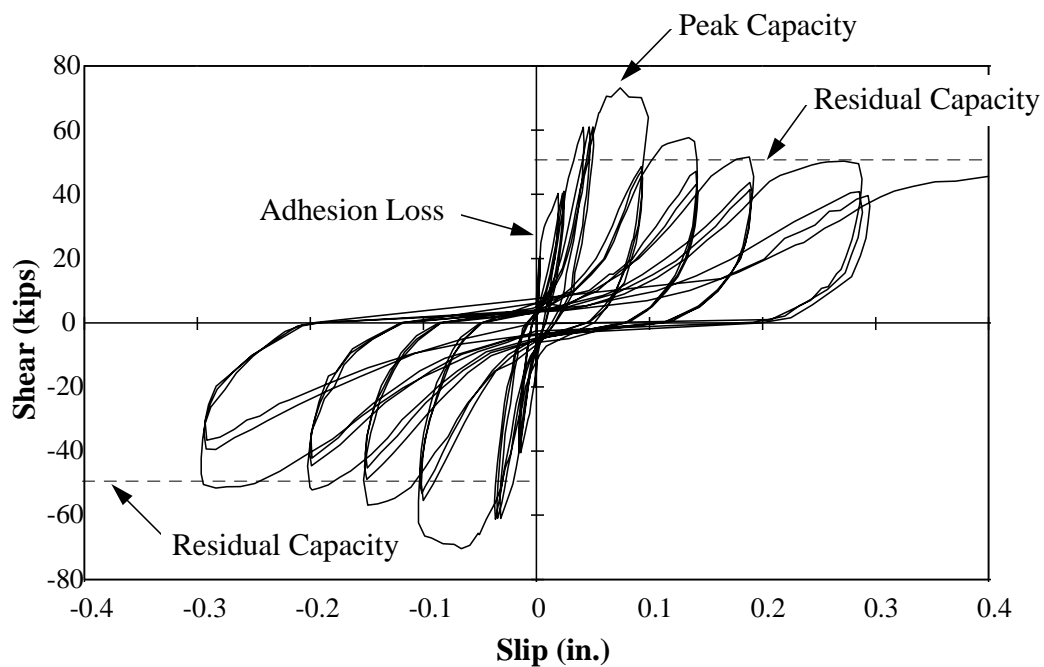
The specimens behaved similarly to the panel connection specimens, as can be seen in Figure 2.15. After adhesion loss, capacity increased at a reduced stiffness until the shear keys failed, after which residual capacity was developed by shear friction. From these tests, it was determined that the connection is adequate to mobilize the strength of the panels. The steel pipe should have enough embedment length to develop residual strength (i.e., it should extend through the grout strip into the space between the panels), or else the connection should be designed based on satisfactory vertical reinforcing steel, as in the panel connection tests.

Figure 2.15: Typical Frame Connection Test Results^[6]

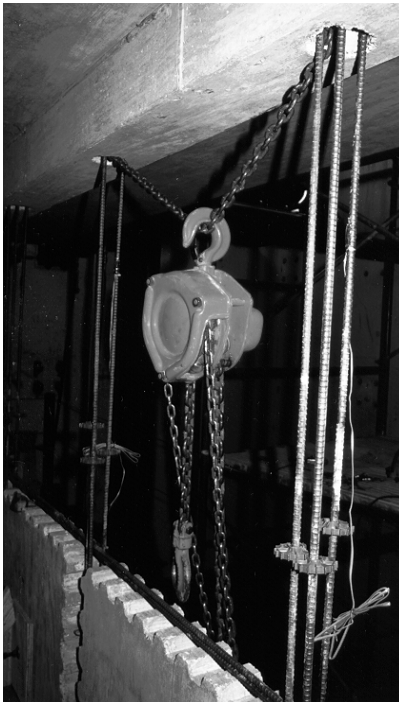
Figure 2.19: Crane Used for Panel Placement

The panels were placed in four stages, as shown in Figure 2.18. The panels were brought to the structure and lifted to the proper floor using a light forklift. Due to space restrictions at the floor levels, the forklift could not be used to place the panels. Instead, a 2-ton crane, supported from the story above, was used to place the panels using clevis plates bolted to the lifting inserts at the top or sides of the panels (Figure 2.19). In the inserts not occupied by clevis plates, bolts were inserted to help space the panels 4 inches apart. Once in place and aligned with the aid of the bolts, plywood panels were bolted to the lifting inserts at the front and back centers of the panels, and two-by-fours were nailed to the plywood to brace the panels to the floor (Figure 2.20). Afterwards, the vertical and horizontal strip steel could be placed, along with the steel pipes (Figure 2.21). Four #4 bars were used in the 6 in. wall, while three #4 bars were placed in the 4 in. wall. The amounts of steel were chosen so that the connections would be stronger than the strength of the shear lugs. For the 6 in. wall, a 2-1/2" diameter XS pipe was used, while a 2" diameter XS pipe was used in the 4 in. wall. These

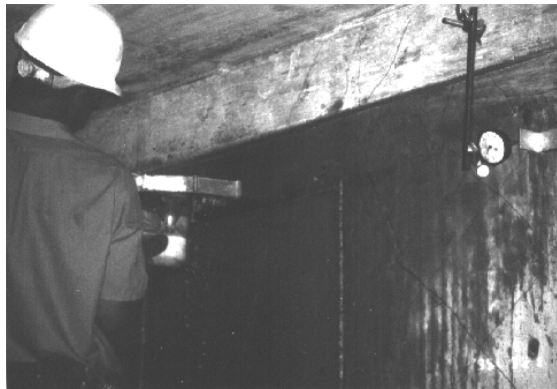
The single panel from the lower level was cut along the grout strip using a large gas-powered circular concrete saw with a water wash coolant. Figure 2.24

illustrates the sawing operation. The cuts were made just inside the boundary of the shear keys of the panel so that the panel keys remained in the wall. Cuts were made from both sides of the wall to cut as much of the perimeter as possible without over-cutting into the remaining portion of the wall. This process left small portions of the panel attached to the wall at the corners, so the panel had to be knocked out of the wall using a sledge hammer. Figure 2.25 shows the wall with the panel removed.

Figure 2.24: Panel Sawing Operation

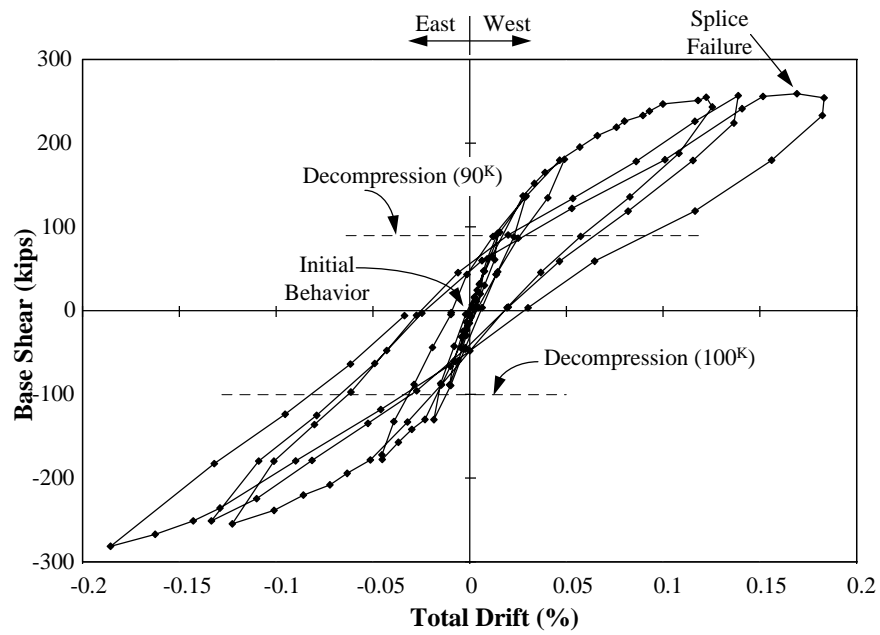
Figure 3.1: Behavior of Full Infill Prior to Splice Failure During Flexure Test^[6]

Initially, the structure was very stiff, until the initial compression induced by the post-tensioning bars was overcome. At this point, termed the "decompression load," the stiffness gradually decreased. In the west direction (forces applied to the west), a splice failure was achieved in the east column, and the stiffness of the structure decreased further. Figure 3.1 illustrates the behavior of the specimen prior to splice failure, and Figure 3.2 shows the load-displacement history for the entire test. Subsequent cycles in the west direction revealed an initially higher stiffness due to compression in the post-tensioning bars, followed by a reduction in stiffness upon exceeding the decompression load. It was observed that the initial forces in the post-tensioning bars helped pull the structure back to near its original position upon release of the loads. At large drift levels, yielding occurred in one of the two 1 in. bars. Loads were not applied to fail the splice in the east direction, because the base shear was approaching the design shear capacity.

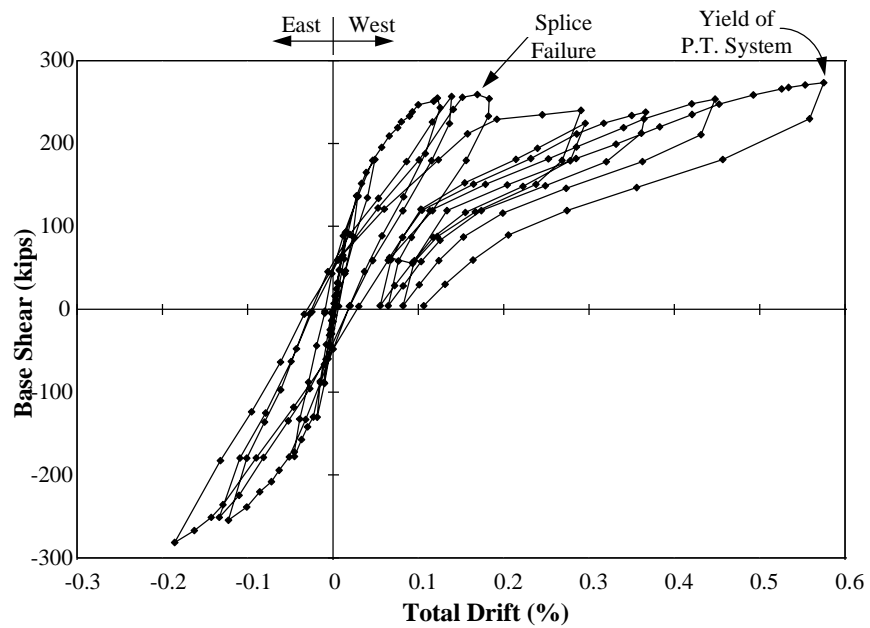
Figure 3.2: Behavior of Full Infill Wall During Flexure Test^[6]

previous section, the splices in the east column failed, causing a reduction in the stiffness of the structure. After splice failure occurred in the east column and uplift forces were taken primarily by the post-tensioning bars, the wall began to rotate as a rigid body at the base of the wall. This rotation occurred about the corner of the wall at the end opposite of the tension bars. The rotation of the wall produced a large gap, measuring up to $3/4$ of an inch, between the base of the wall and the top of the footing at the east end. With unloading, the gap closed completely. Because the post-tensioning bars were unbonded, the only flexural crack that formed in the wall was at the base.

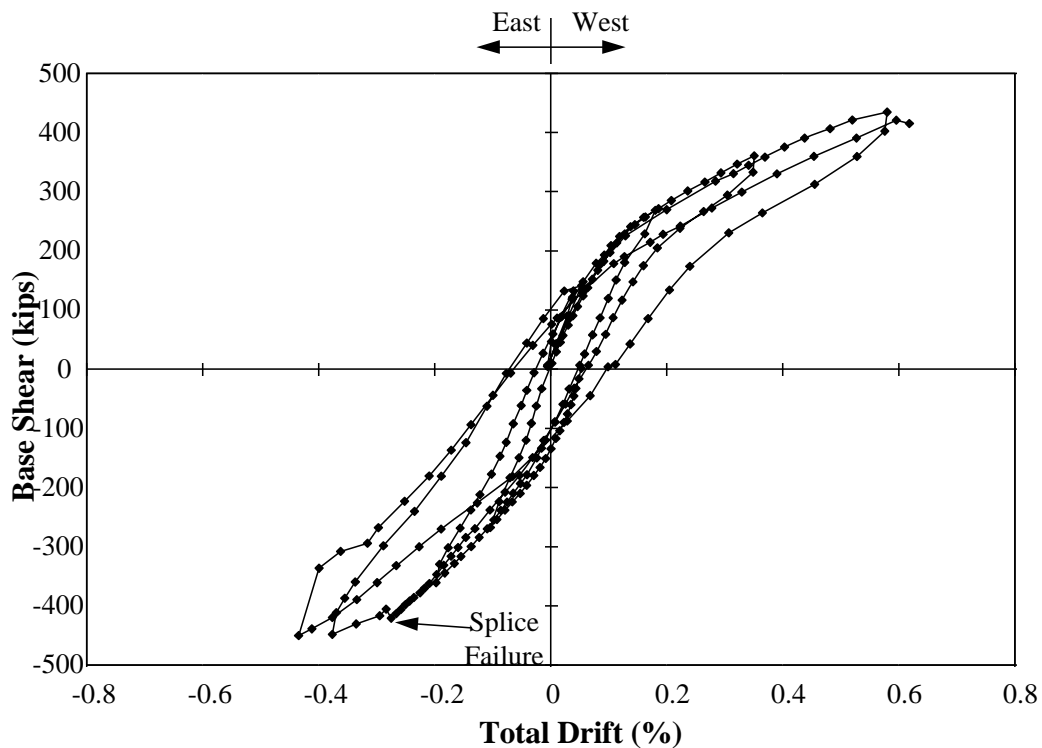
Figure 3.5: Behavior of Full Infill During First Shear Test^[6]

Initially, the loads on the structure were cycled back and forth at base shears of approximately 270 and 360 kips. Because the splices in only the east column (corresponding to loading in the west direction) had failed in the flexure test, the structure was stiffer in the east direction. The next loading in the east direction produced a splice failure in the west column at 421 kips. After splice failure, the load was increased to 450 kips, with a slight change in stiffness. Two full cycles to 450 kips of base shear were performed, until a failure in the loading system occurred in the west direction. The details of the loading system failure and the repairs required for the window and door tests will be discussed in Section 3.5. At this point, the test with initial tension in the rods was stopped. The load-drift record for this test is shown in Figure 3.5.

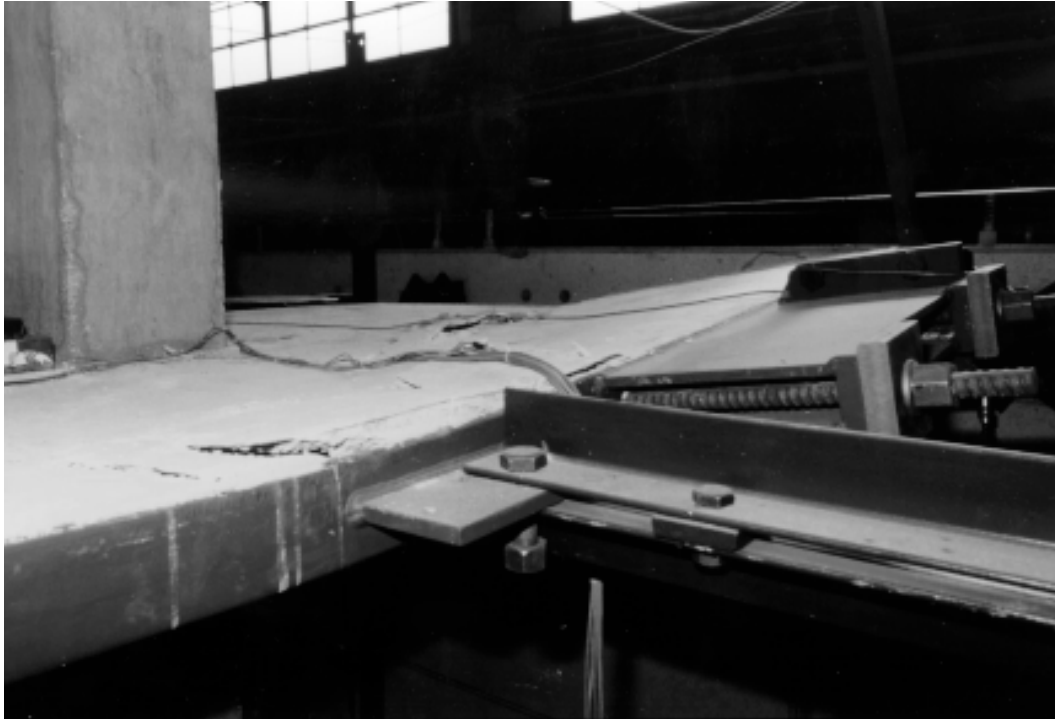
Figure 3.7: Failed Loading System at Third Floor, Viewed From the Southwest

The last loading in the west direction during the shear tests created a failure in the loading system. The damage, shown in Figure 3.7, was the result of uplift on the slab at the third floor. Because the wall was rotating as a rigid body about the toe of the wall at the west column, large vertical displacements occurred on the east side of the structure. Uplift of the specimen caused the rams to tilt upward, creating a vertical force component which increased with increased loading. In turn, this vertical force component produced uplift on the floor slabs, which cantilever out from the wall in the north and south directions. These uplift forces became great enough to produce a flexural failure in the slab at the southeast corner. The failure line extended in an arc from the west end of the loading head to the eastern edge of the slab along the cantilevered beam. The brittle tensile failure (fracture) of the welded wire fabric which reinforced the slab allowed a brittle failure of the slab. Yielding of the steel angle occurred on the

west side of the loading head, on the line of the failure arc. This yielding helped slow the failure of the slab, although the slab still failed with little warning.

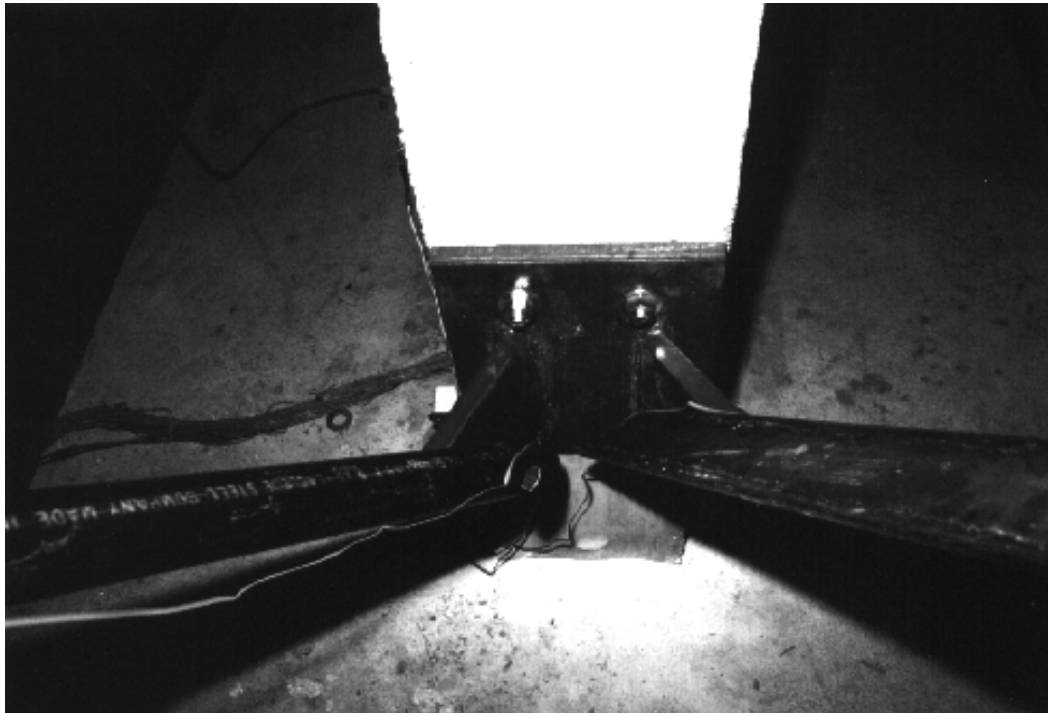
Figure 3.8: Connection of Bracing System to Column

The retrofit was performed with available materials at the lab. The installed brace (a 2" diameter XS pipe) spanned from the southeast corner of the slab to the east face of the east column, about 24 in. above the second floor. Holes were cored in the corner of the slab, and two 1 in. thick steel plates were bolted together through the holes in the slab. A gusset plate was welded to the plate which hung underneath the slab, and the brace was attached to the gusset plate with a single bolt. The other end of the brace was attached to a gusset plate which was welded to another steel plate. The steel plate was attached to the

column with four expansion anchor bolts. The connection of the bracing system to the column is pictured in Figure 3.8.

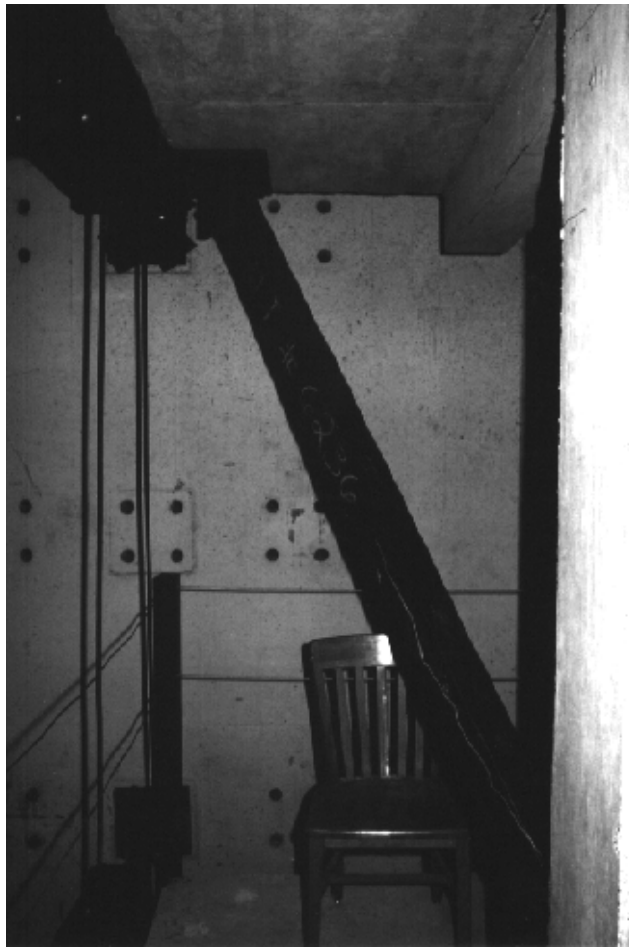
Figure 3.9: Brace for the Loading System

To prevent a similar collapse from occurring in the third floor loading system on the other (north) edge of the slab, another brace was similarly installed, connecting the northeast corner of the slab to the column. A steel angle was used for this brace, shown in Figure 3.9.

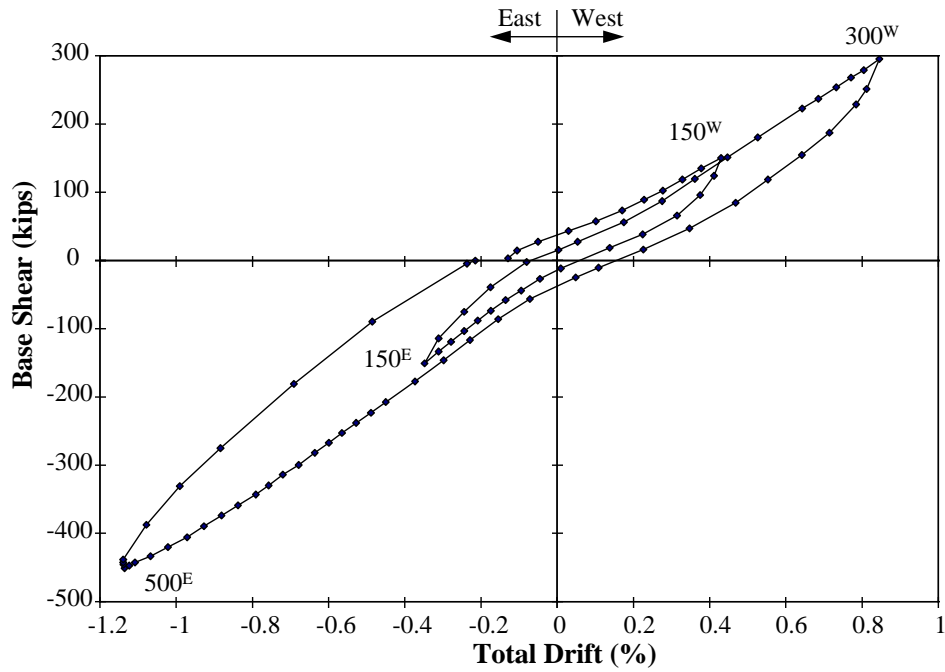
Figure 4.3: Window Test: Load vs. Drift Response

Two full cycles of load were applied to the specimen during the window test. The loading history is shown in Figure 4.2, and the load-drift response is presented in Figure 4.3. The first cycle reached a base shear of 150 kips, and

Although new cracking occurred during this test, the stiffness of the structure remained relatively constant throughout the test, indicating that the strength of the wall was being mobilized without significant new damage to the structure.

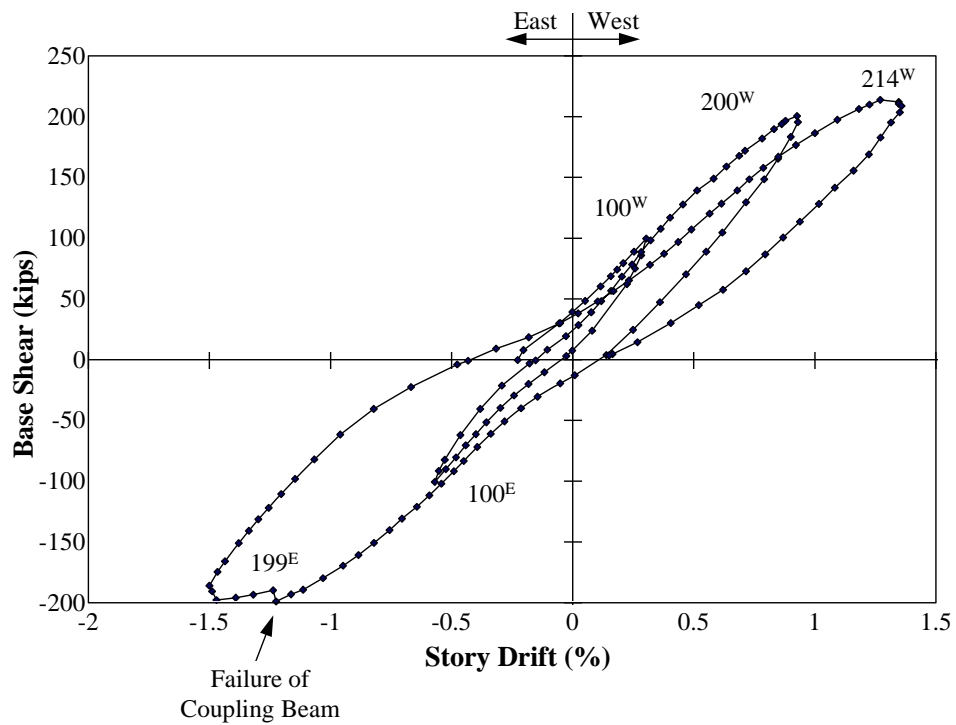
Figure 4.9: Door Test: Load vs. Drift Response

Two-and-one-half load cycles were applied to the specimen during the door test. Figure 4.8 presents the loading history of this test, and Figure 4.9 shows the load-displacement response of the structure. Testing began in the west direction with a full cycle to 100 kips base shear (where “base” now refers to the base of the second story wall). The next west half-cycle went to 200 kips. Finally, the ultimate load was reached in half-cycles to 199 kips and 214 kips in the east and west directions, respectively.

In the final cycle in the west direction, the structure responded at a slightly reduced stiffness (approximately 80% of its stiffness in the previous west cycle). This is probably due to the advanced failure of the coupling beam in the preceding

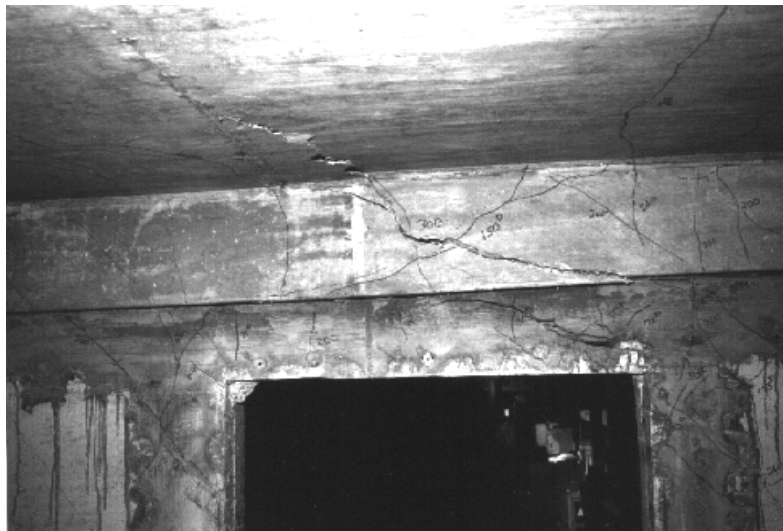
**Figure 4.10: Failed Coupling Beam During West
Direction Loading**

east cycle (to be described in the next section). At a load just over 200 kips, the shear crack which had begun to form in the beam over the door opening during the previous cycle grew and opened rapidly. The crack propagated into the third floor slab until loading was stopped. Failure of the coupling beam in this manner signified that the peak capacity of the wall system had been reached. The failed coupling beam is shown in Figure 4.10. It can be seen in this photo that the two components of the coupling beam, the existing frame beam and the horizontal grout strip, failed separately. When the coupling beam failed, the bars in the closure strip immediately to the right of the door yielded. The yielded bars buckled during subsequent unloading of the structure because the steel in the strip had no confining reinforcement. The buckled bars are shown in Figure 4.11. A base crack (shown in Figure 4.12) was observed to open during the higher load cycles at the base of the wall section to the right of the door. This portion of the wall section rotated about the toe of the wall.

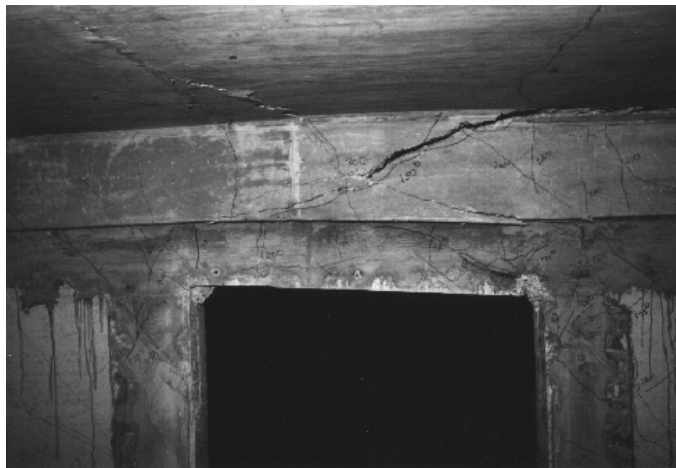
Figure 4.13: Failed Coupling Beam During East Direction Loading

Between 190 kips and 200 kips, the coupling beam over the door failed in shear. The failed coupling beam is shown in Figure 4.13. Significant uplift occurred at the base of the wall to the left of the opening, and the vertical grout strip reinforcement yielded. Distress is apparent in this picture in the grout strip area around the pipe. On the other side of the door, the compression zone in the right wall section began to crush simultaneously. As for the west direction, the yielded bars buckled upon unloading because the steel in the strip had no confining reinforcement.

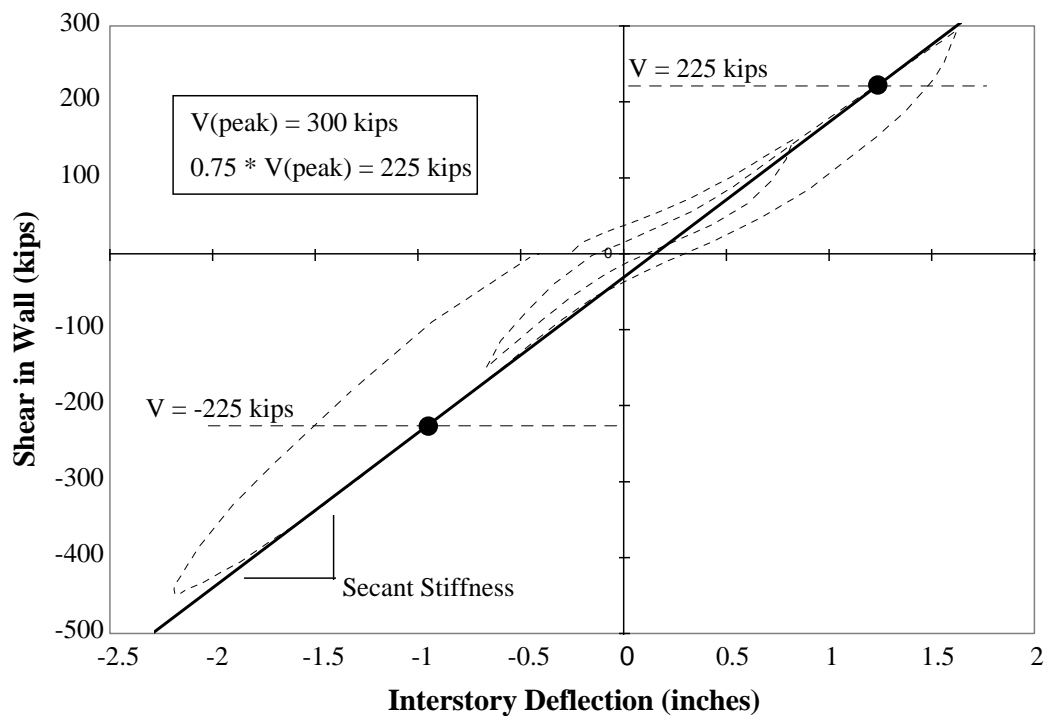
Figure 5.5: Secant Stiffness Determination (Window Test Shown)

The secant stiffnesses were compared at approximately 75% of the lowest peak load reached in the ultimate cycles of the two tests. Thus, the window was compared at 75% of 300 kips base shear, or 225 kips, and the door stiffness was compared at 75% of 199 kips base shear, or 150 kips. This method was chosen to eliminate the effects of damage that occur at higher load levels. Figure 5.5 illustrates this method for the window test.
