| 4. Title and Subtitle<br><b>Use of Carbon Fiber Reinforced Polymer Composites to Increase the Flexural Capacity of Reinforced Concrete Beams</b> | | | | 5. Report Date<br><i>April 2001</i> | |
| 7. Author(s)<br><b>Sergio F. Breña, Regan M. Bramblett, Michaël A. Benouaich, Sharon L. Wood, and Michael E. Kreger</b> | | | | 8. Performing Organization Report No.<br>Research Report 1776-1 | |

**USE OF CARBON FIBER REINFORCED POLYMER  
COMPOSITES TO INCREASE THE FLEXURAL CAPACITY OF  
REINFORCED CONCRETE BEAMS**

**Research Report 1776-1**

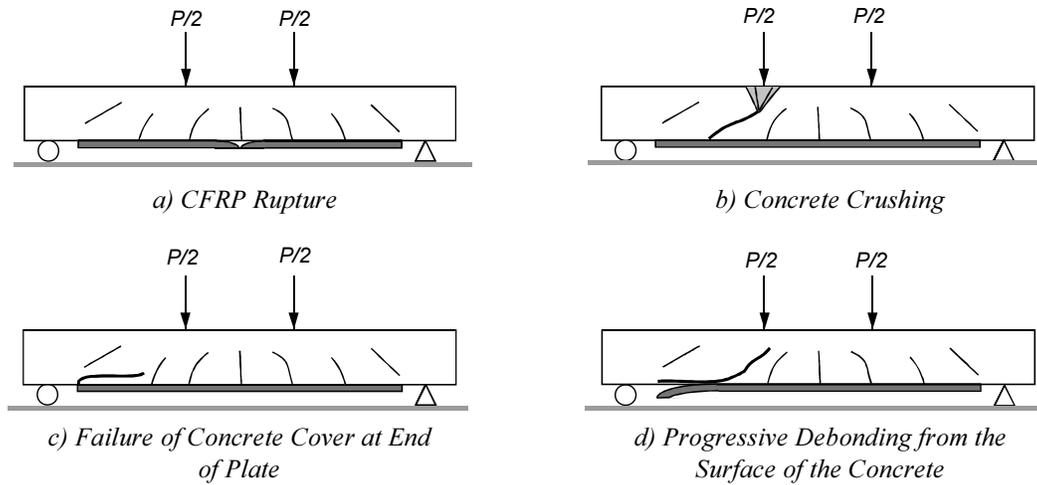
- Tensile rupture of the CFRP composites (sheets).
- Failure by crushing of the concrete in compression.

- Diagonal tension failure at end of CFRP composites (plates).
- Debonding (peeling) of the CFRP composites.

**Figure 2.1 Observed Failure Modes of Strengthened Members Using CFRP Composites**

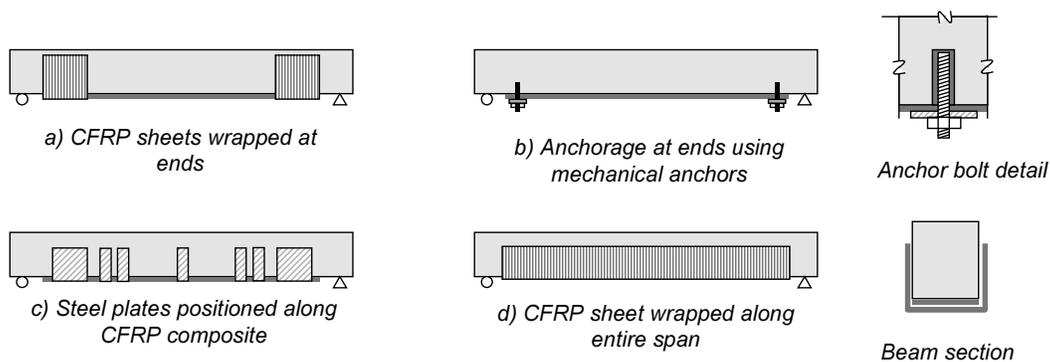
**Figure 2.2 Techniques used by Previous Researchers to Anchor Longitudinal CFRP Composites**

A common observation in these research programs was that failure of the beams was often controlled by CFRP debonding from the surface of the concrete (Table 2.5). Therefore, several researchers investigated the use of different techniques to delay or eliminate debonding as a failure mode. Some of the techniques that were investigated are illustrated in Figure 2.2.

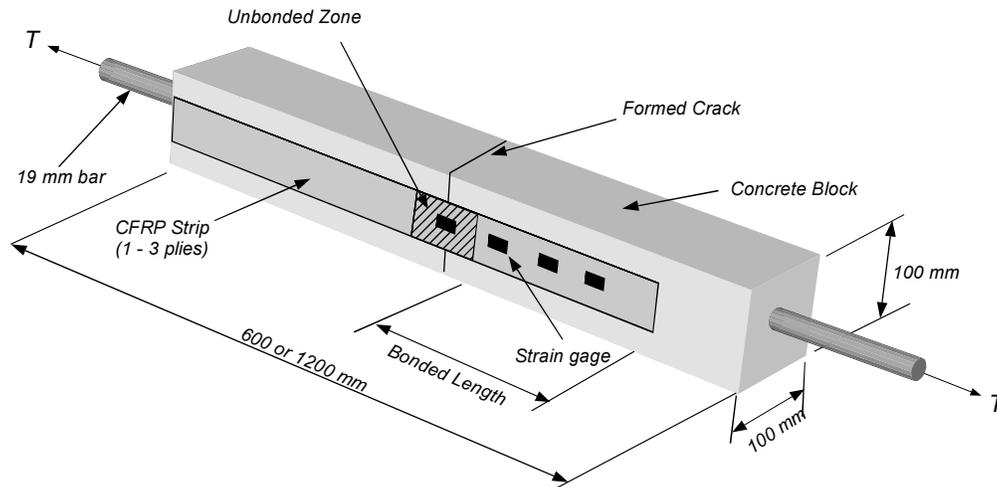
**Figure 2.5 Bar-Pullout Bond Test Apparatus [Iketani and Jinno, 1997]**

Other researchers have investigated the effect of cracking in the distribution of bond stresses along the composite-concrete interface. Iketani and Jinno [1997] used the test specimen illustrated in Figure 2.5 to study the transfer of shear stresses between the surface of the concrete and CFRP composite sheets. This figure illustrates a pair of concrete blocks that are held together through the use of CFRP sheets bonded on both sides. Tension loads were applied through a steel bar that was cast in each concrete block. The CFRP sheets were instrumented using strain gages to quantify the distribution of strain with distance from the concrete discontinuity. The variables investigated included the influence of concrete strength and number of plies on the maximum load that could be applied to the bar pullout specimens.

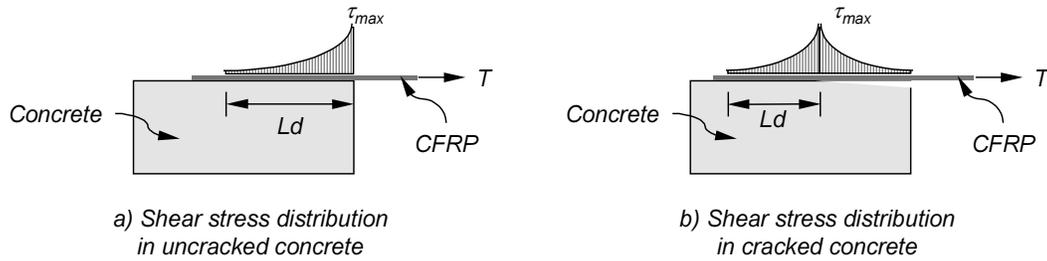
**Figure 2.6 Variation of Interface Shear Stress with Distance**  
**[Brosens and VanGemert, 1997]**

From these tests, the variation of shear stress at the interface between the composite and the surface of the concrete with distance from the free edge has been identified. The distribution of shear stresses along the composite-concrete interface is illustrated schematically in Figure 2.6. The distance where the interface shear stresses can be considered negligible varied in the different investigations, but it typically ranged between 100 and 275 mm.

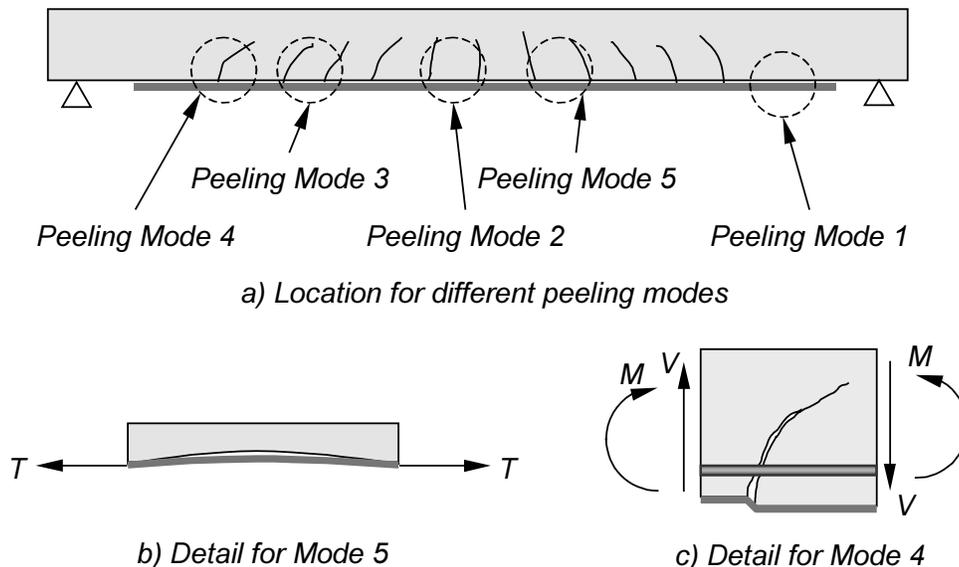
- FRP peeling-off at the outermost flexural crack in the uncracked anchorage zone (Mode 1).
- FRP peeling-off at flexural cracks in the area of maximum moment (Mode 2).
- FRP peeling-off at flexural cracks between the outermost crack and the area of maximum moment (Mode 3).
- FRP peeling-off caused by shear cracks (Mode 4).
- FRP peeling-off caused by unevenness of the concrete surface (Mode 5).

**Figure 2.7 Regions in Strengthened Beam where Different Peeling Modes Initiate**  
**[Blaschko et al., 1998]**

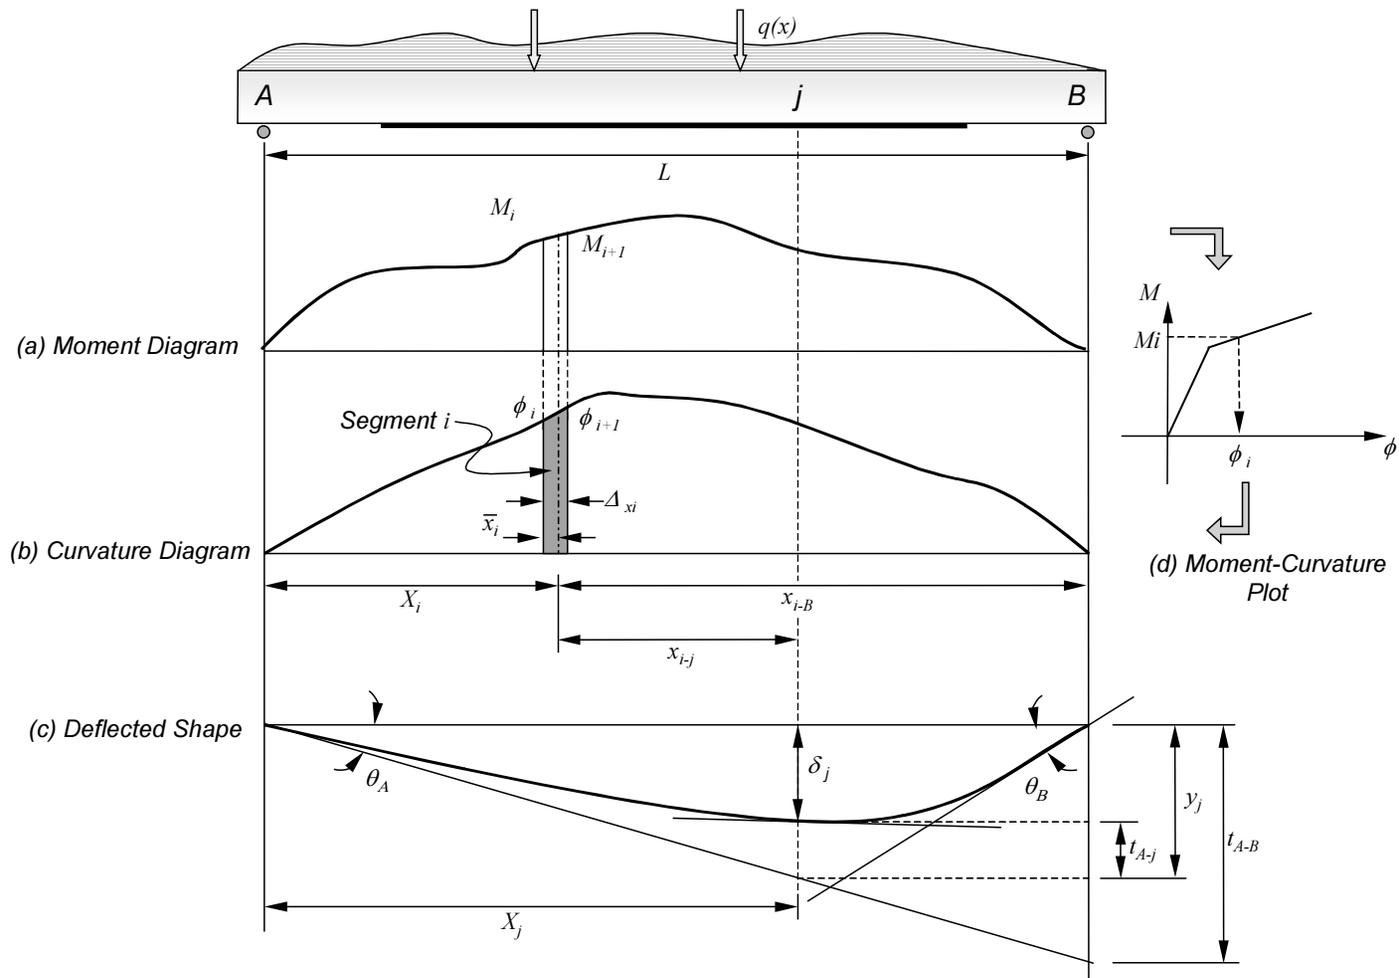
**Figure 3.5 Procedure to Calculate Deflections of an Element with a Nonlinear Moment-Curvature Relationship**

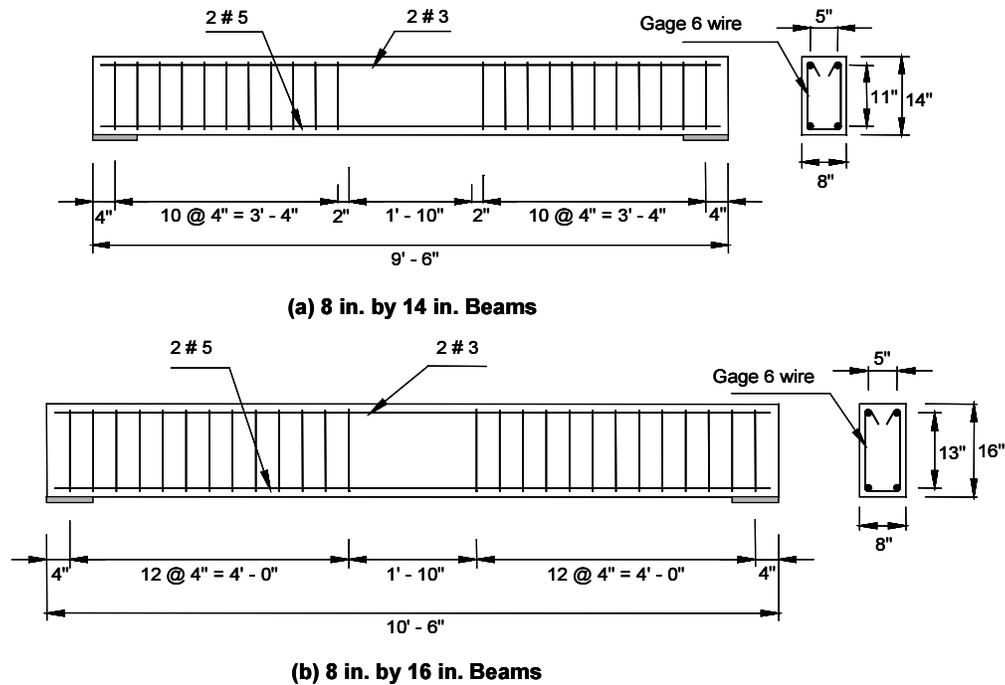
**Figure 4.2 Geometry and Reinforcement of Laboratory Specimens**

All beams were designed using a nominal 28-day compressive strength of concrete,  $f'_c$ , equal to 4,500 psi. The concrete strength was selected based on the estimated strength of the existing concrete in the prototype bridges. Reinforcing bars had a minimum specified yield stress,  $f_y$ , equal to 60 ksi. The minimum specified yield stress of the smooth wire was 75 ksi.

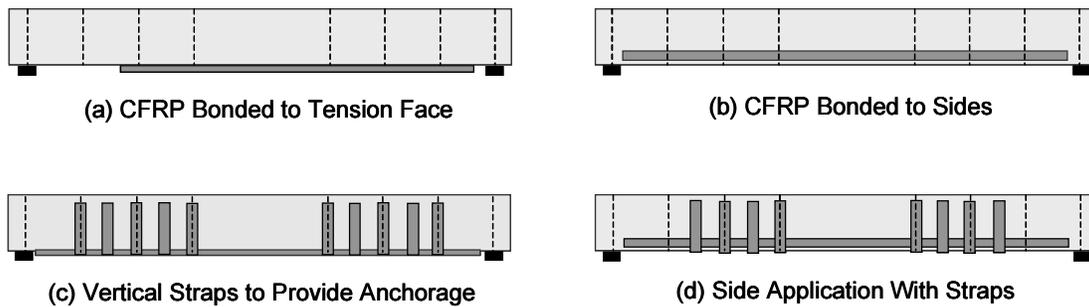
**Figure 4.7 Composite Strengthening Schemes Used in Rectangular Beam Specimens**

The first series of tests were conducted with the CFRP composites attached to the tension face of the beams. The results obtained from these tests indicated that failure by debonding from the surface of the concrete was not eliminated by simply extending the composite from the section of maximum moment. Therefore, other configurations of the composite systems were used to attempt to eliminate the failure mode by debonding. Other configurations included attaching the composites to the sides of the beams and the use of vertical composite straps to control the propagation of debonding. Figure 4.7 illustrates the composite strengthening schemes that were used in different specimens. A description of each of the strengthening schemes is presented in the following sections.

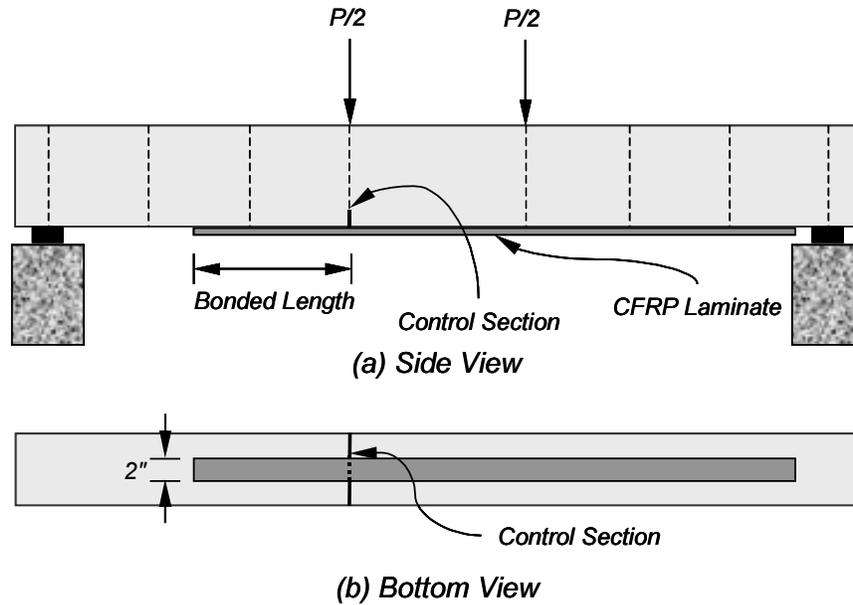
**Figure 4.8 Schematic of Specimen with CFRP Bonded to Tension Face**

The composites were bonded asymmetrically to the tension face of the specimens to force failure by debonding from the surface of the concrete on the short side. The average shear stresses developed along the concrete-composite interface could then be calculated dividing the force developed in the composite system during the test by the width and length of the composite from the critical section. All of the composite systems had a 2 in. width to eliminate variations in behavior introduced by different widths of covered concrete surface. Figure 4.8 illustrates a specimen with a CFRP system attached to the tension face.

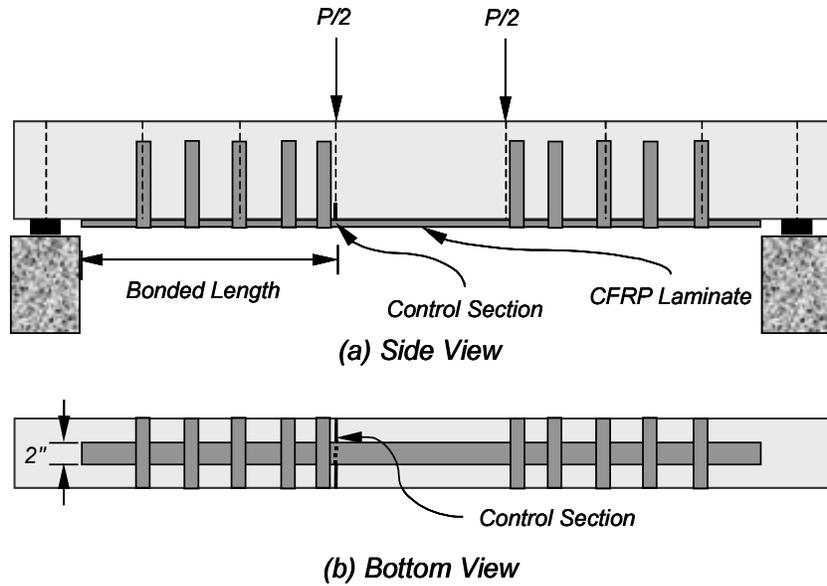
**Figure 4.9 Schematic of Specimen with Transverse Straps to Control Debonding**

Transverse composite straps positioned within the shear span were chosen to control the propagation of debonding from the surface of the specimens (Figure 4.9). The straps were similar to those tested previously to enhance shear strength [Triantafillou, 1998]. The composite straps had a 2-in. width and were placed at discrete locations over the longitudinal composite. They extended on both side faces of the beams and were stopped 3 in. from the top surface of the beam. The center-to-center spacing between straps was equal to half the beam depth to be able to intercept potential diagonal cracks with at least one strap. The straps were intended to allow some debonding between straps but to control the propagation of debonding to the composite ends. Also, their purpose was to restrain shear cracks in order to prevent vertical offsets from occurring along the bottom face of beams.

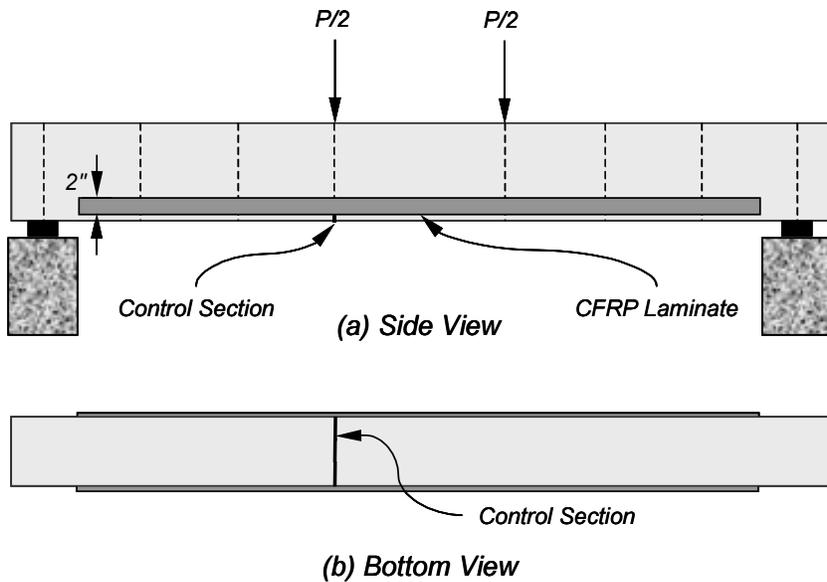
**Figure 4.10 Schematic of Specimen with CFRP Bonded to Sides**

Results from the initial tests of the beams with the composite systems attached to the bottom face of the beams indicated that debonding initiated at flexural crack locations that exhibited vertical offsets. The bond between the composite and the surface of the concrete appeared to be weaker in the direction perpendicular to the surface of the concrete where the composites were attached. Therefore, another approach to control debonding of the composites was selected by attaching the laminates to the sides of the beams and reduce the deformations induced by crack movement. This strengthening scheme is illustrated in Figure 4.10.

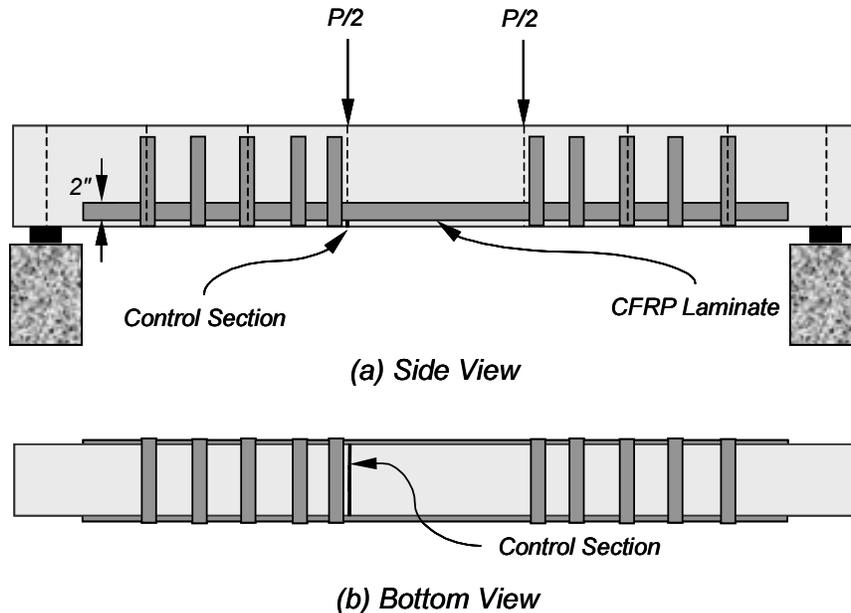
**Figure 4.11 Schematic of Specimen with CFRP Bonded to Sides and Anchorage Using Vertical Straps**

Beams with composite material applied to the side faces of the specimens generally failed because of debonding at the interface between the composites and the surface of the concrete. Some specimens failed by rupturing of the cover-concrete of the beams as the composite detached from the surface of the concrete. Transverse straps, similar to those used with the bottom application, were attached to provide additional anchorage for the composites placed longitudinally on the beams (Figure 4.11). In this case, the straps were intended to provide additional bonded area and reduce interface stresses. The composite straps were 2 in. wide and had a center-to-center spacing equal to half the depth of the beams.

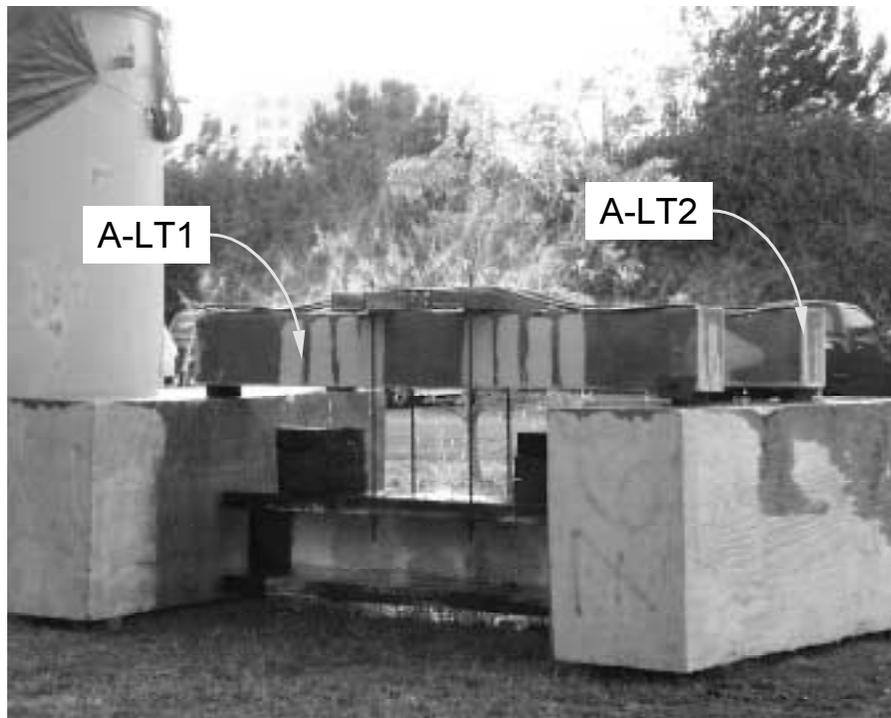
*Figure 5.1 Photograph Showing Specimens Subjected to Moisture*

degradation due to ultraviolet radiation [Master Builders, 1999]. The beams were loaded initially to cause cracking corresponding to service load conditions before strengthening. Only composite system A was used to strengthen the beams in these tests, using the bottom application with straps illustrated in Figure 4.9. One of the specimens (A-LT1) was subjected to a sustained load to force flexural cracks to open and facilitate ingress of moisture into the concrete. The sustained load applied to the beam was approximately equal to 20% of the yield load of the strengthened specimen. The other specimen (A-LT2) supported only its self-weight. Figure 5.1 shows a photograph of the two specimens during the eight-month period that they were subjected to periodic moisture cycles. The characteristics of all specimens for the static-load tests are listed in Table 5.1.

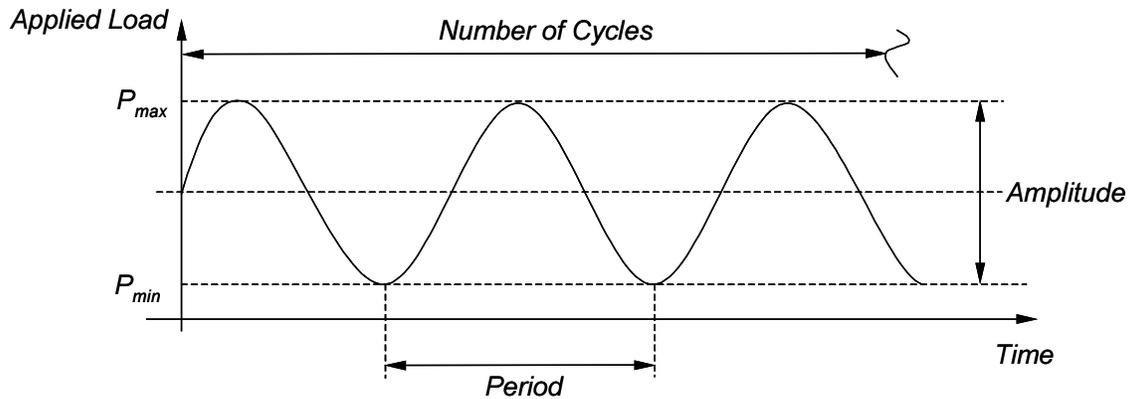
**Figure 5.3 Schematic of Loading Protocol for Fatigue Tests**

The minimum repeated load for all specimens was approximately 1 kip (Figure 5.3). The minimum load was selected to ensure that the bearing pads would remain in compression throughout the fatigue tests.

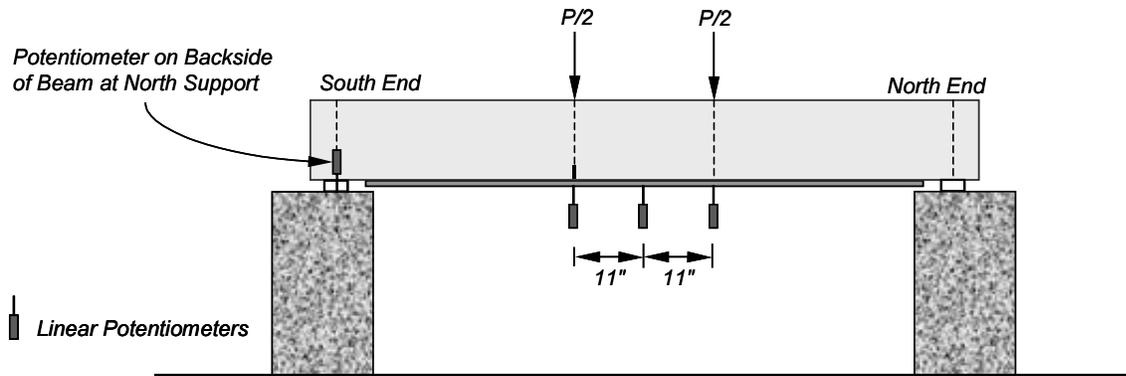
**Figure 5.5** Position of Linear Potentiometers on Laboratory Specimens

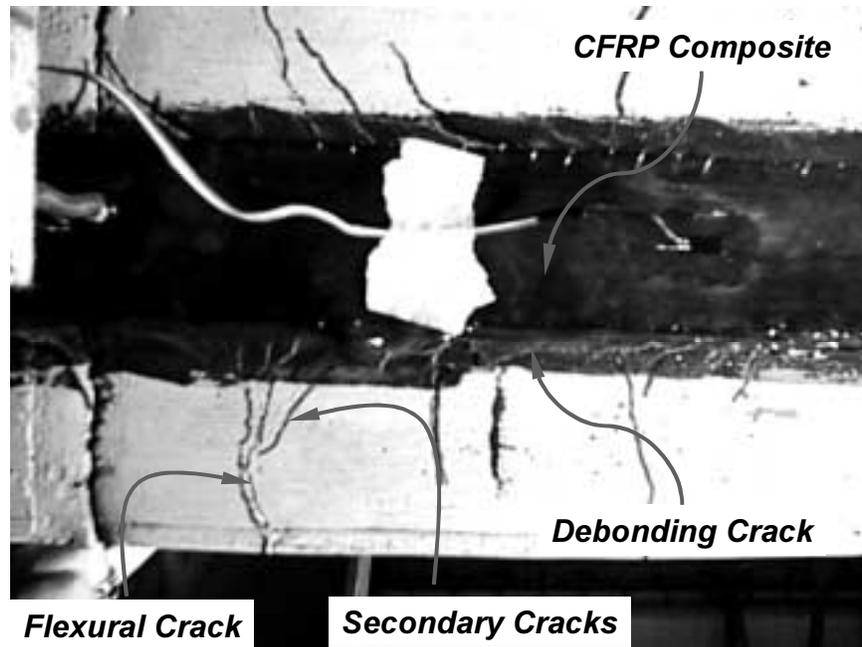
**Figure 6.1** *View of Bottom of Specimen A2 Showing the Formation of Secondary Cracks and Debonding Cracks Along Both Sides of the CFRP Composite*

The observed response of all the strengthened specimens was similar up to the yield load. No evidence of debonding of the CFRP composites was observed until after yielding of the reinforcement. The formation of secondary cracks adjacent to existing flexural cracks was an indication of initiation of debonding of the composite laminates. These cracks were followed by the formation of longitudinal debonding cracks along the sides of the CFRP composites (Figure 6.1). These cracks propagated toward the end of the composite laminates and caused total debonding of the composites from the surface of the concrete. The load required to cause propagation of the debonding cracks to the end of the CFRP composites varied depending on the strengthening configuration.

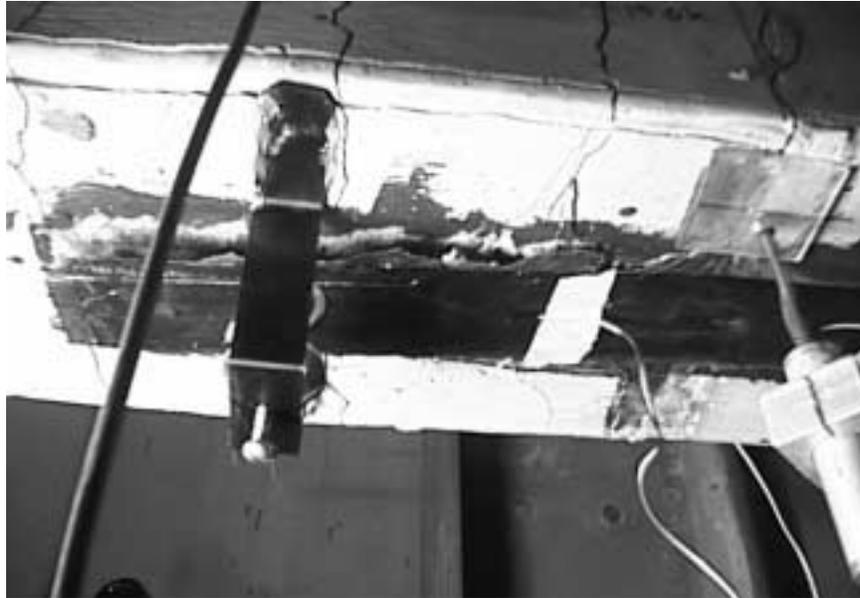
**Figure 6.2** *View of the Bottom Face of Specimen A1 after Debonding of the CFRP Composite*

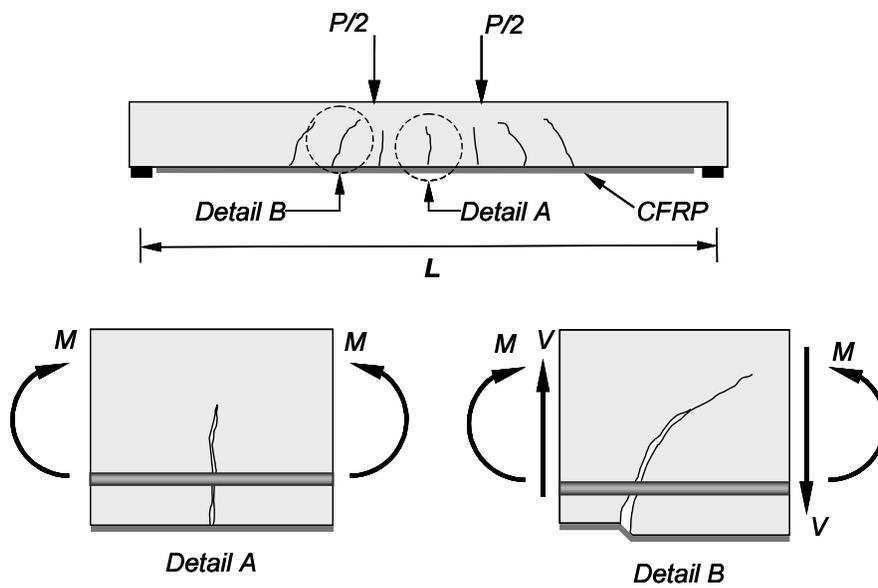
**Figure 6.3** *Schematic Representation of Cracking Mechanisms at Different Locations of a Strengthened Beam*

Because the length of the composites extended a distance greater than the depth of the specimens, several flexural cracks that formed within the shear span of the beams crossed the laminates at different locations. The width of the cracks that formed within the shear span increased as the magnitude of the applied moment increased, and the beams experienced a relative vertical displacement from one side of these cracks to the other due to the presence of shear. The vertical offset triggered debonding of the CFRP composites from the surface of the concrete in the vicinity of the flexural-shear crack. Debonding generally initiated at the location of the flexural-shear crack within the shear span that formed closest to the critical section. A comparison of the mechanisms involved in the opening of cracks that form within the constant moment region and within the shear span of a strengthened beam is presented in Figure 6.3. Initiation of CFRP debonding caused by relative displacement of a flexural-shear crack in specimen B1 is shown in Figure 6.4.

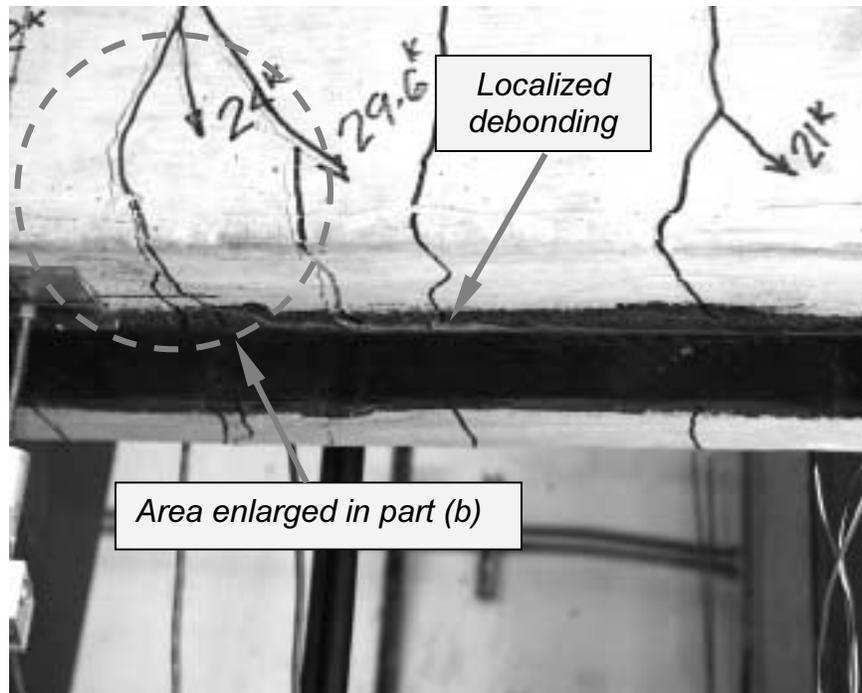
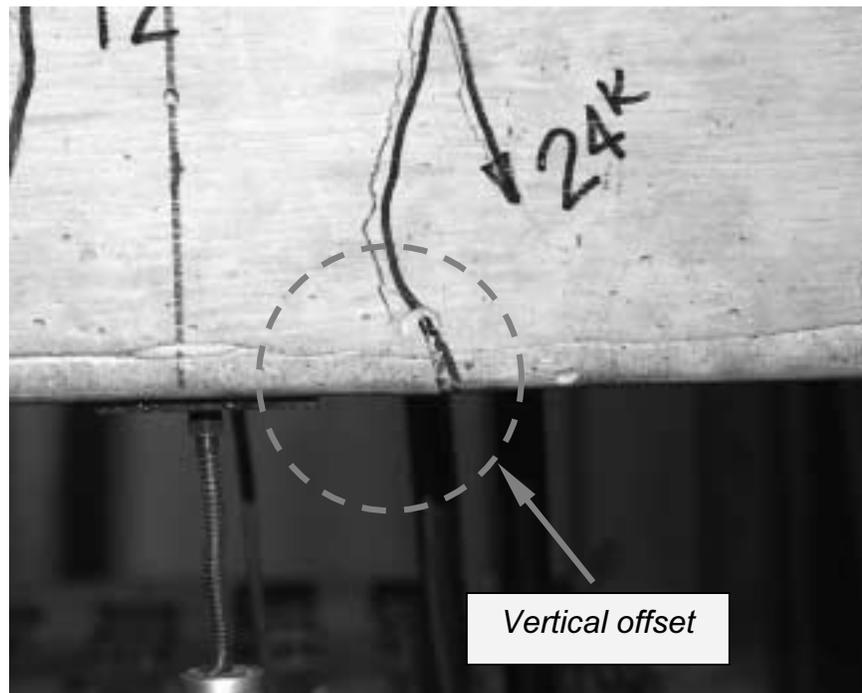
(a) Localized debonding in the vicinity of crack

(b) Vertical movement across critical crack within shear span

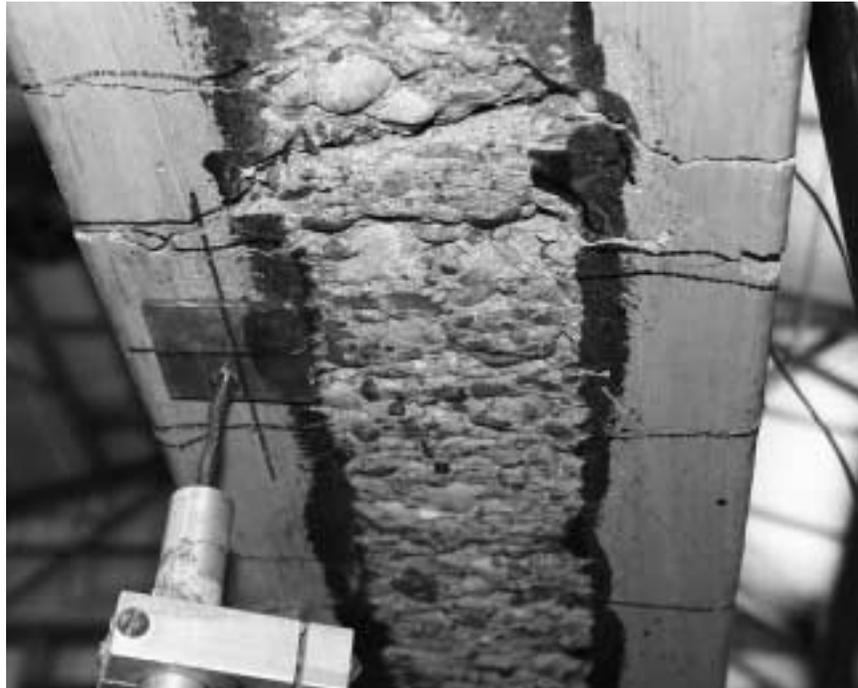
***Figure 6.5 Bottom View of Specimen B1 Showing the Surface of the Concrete in the Area where CFRP Debonding Initiated***

Concrete was pulled-off from the surface of the beam in the form of a wedge in the region where debonding of the composite laminate initiated. A detail of the surface of the concrete after debonding of the CFRP composite for specimen B1 is shown in Figure 6.5. The characteristics of the debonding sequence for specimens A3, C1, C2, D1, and D2 were similar to the ones described in this section. In these specimens the bonded length of the CFRP composites was larger than 2.5 times the depth of the beams.

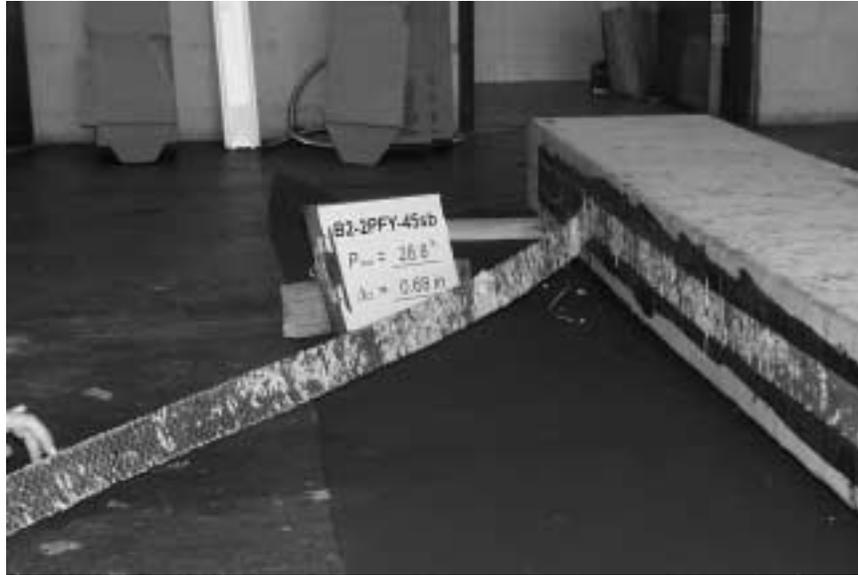
**Figure 6.6 Concrete Pulled-off from Surface of Specimen C2 after Debonding**

Additionally, the surface of the composites was examined after the laminates debonded from these specimens. The amount of concrete that remained attached to the composites after debonding varied depending on the type of surface preparation that was used. No significant difference in the amount of concrete that remained attached to the surface of the composite laminate for composite type C was observed after debonding. Figure 6.6 shows the surface of the concrete and CFRP composite of specimen C2 after failure. On the other hand, the surface of the composite plate for beams strengthened using composite type D showed more concrete after failure when the beam surface was prepared by sand blasting (Figure 6.7). Therefore, no clear trend could be established based on the limited number of tests that were conducted. Grinding was therefore used to prepare the surface of the concrete for all subsequent specimens.

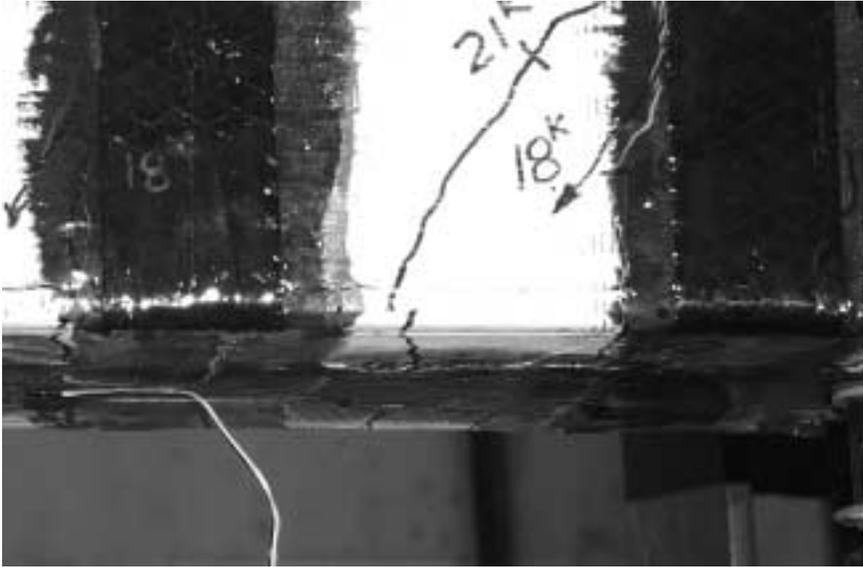
**Figure 6.8** Localized Debonding Arrested by Vertical Straps in Specimen B2

flexural cracks. Although localized debonding triggered the formation of debonding cracks along the composites, the straps were effective in arresting the crack propagation (Figure 6.8). Therefore, the specimens exhibited larger deflections and were able to sustain higher loads than similar specimens that were strengthened without using straps. In most cases, failure was reached when the composites ruptured at the control section although debonding had proceeded toward the ends of the beam (Figure 6.9).

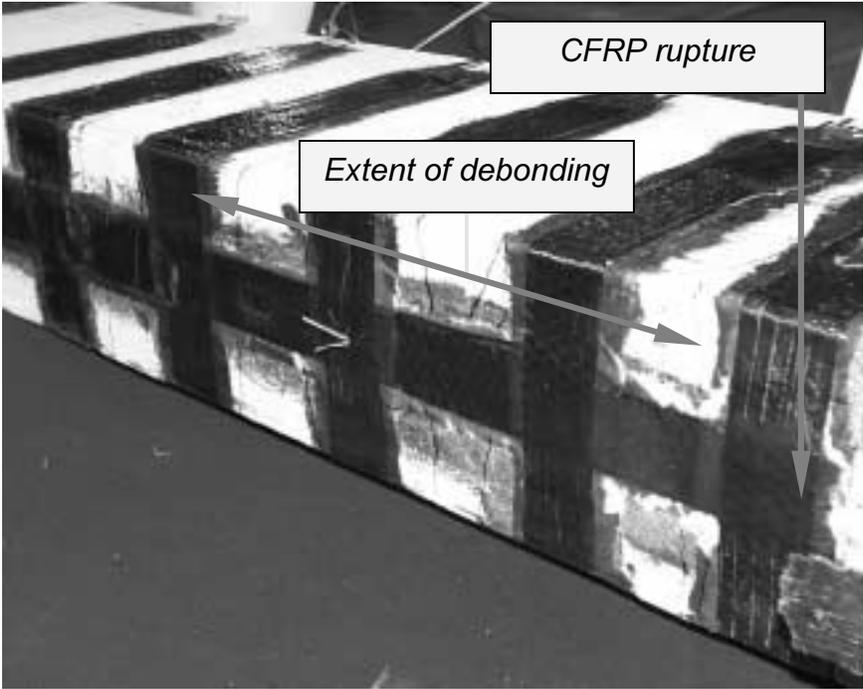
**Figure 6.9** Extent of Debonding and Rupture of CFRP Composite in Specimen B2

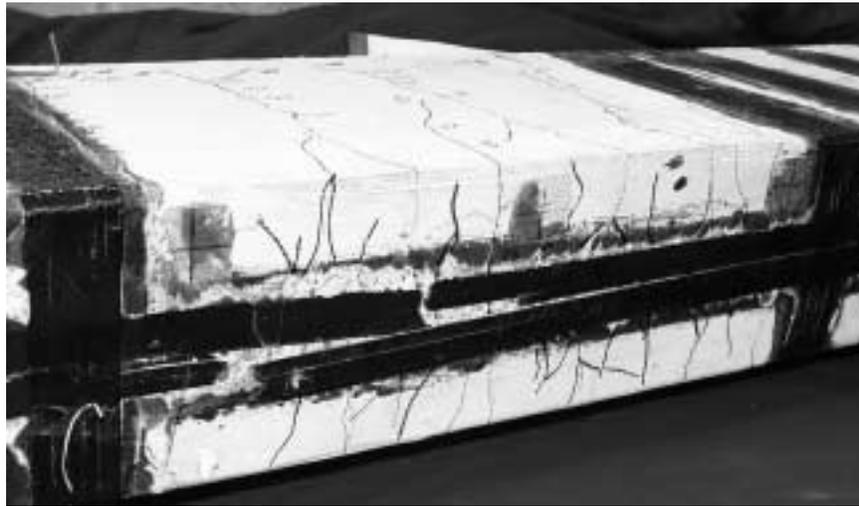
*Figure 6.10 Rupture of CFRP Composite in Specimen B4*

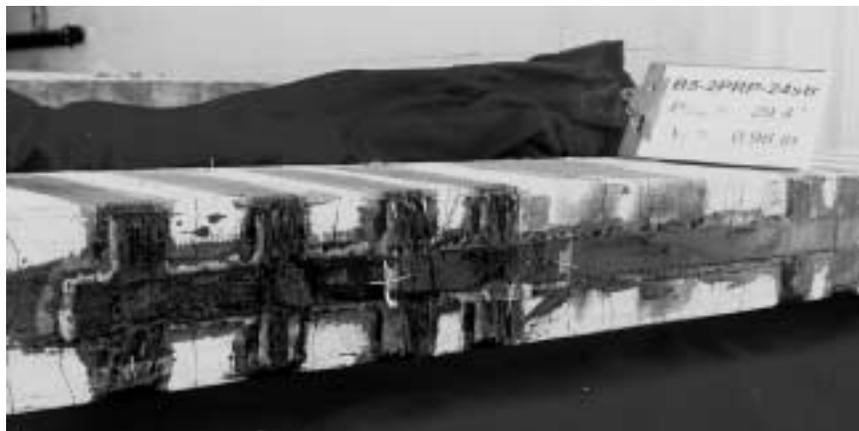
*Figure 6.11 Bottom View of Specimen B5 after Debonding*

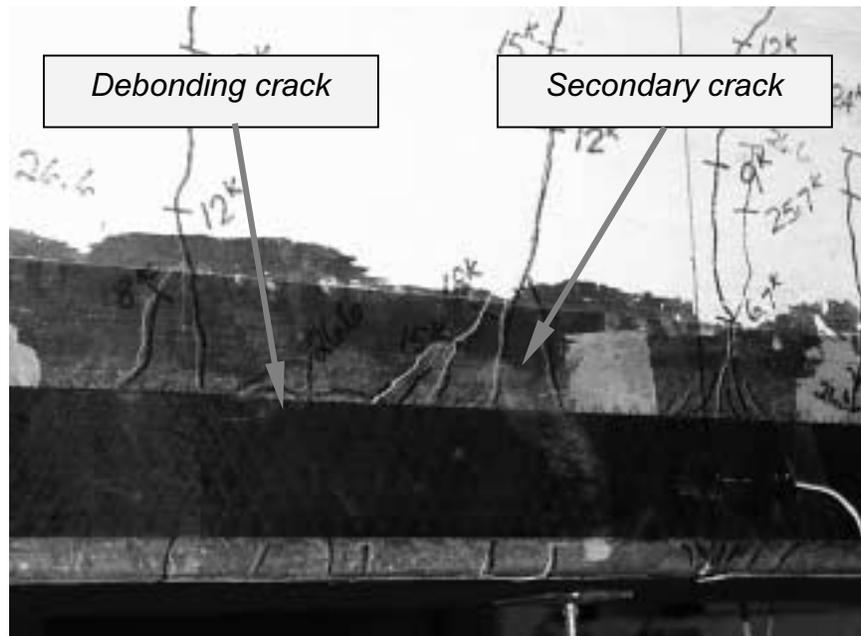
**Figure 6.12 Propagation of Secondary Cracks into a Debonding Crack in Specimen B3**

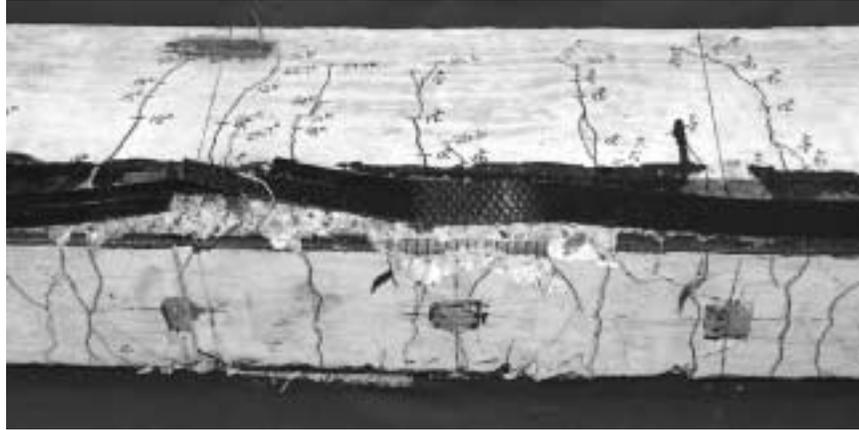
*Figure 6.13 Rupture of CFRP Composite in Specimen B3 after Failure*

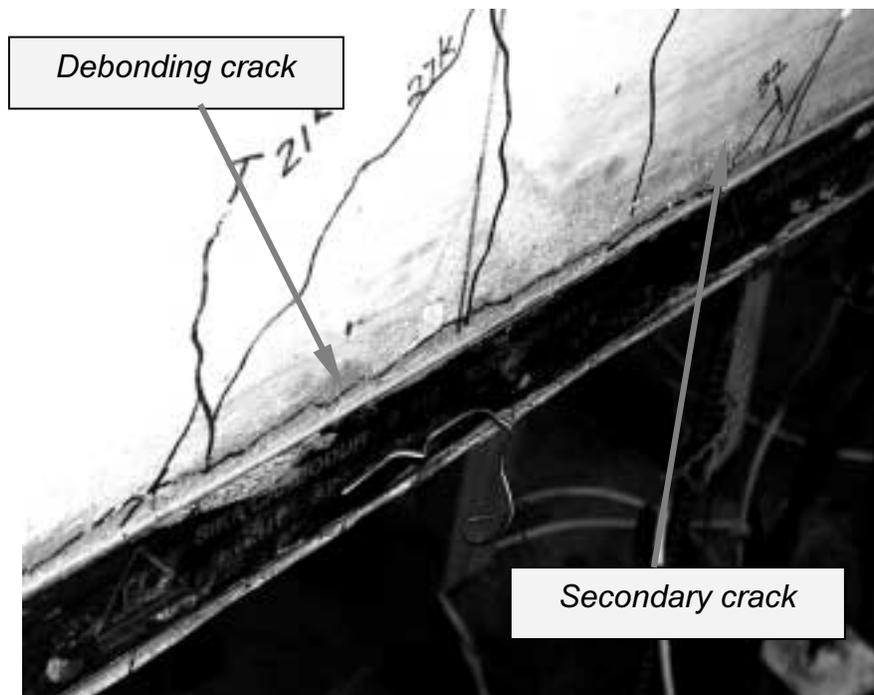
*Figure 6.14 Close-up of Debonding Crack that Originated from a Secondary Crack in Specimen D3*

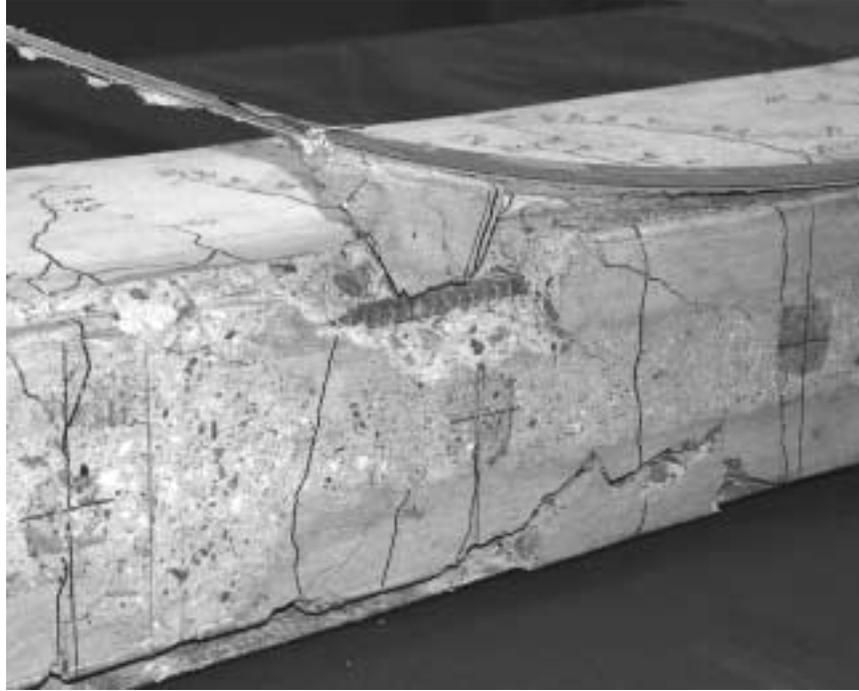
*Figure 6.15 Bottom View of Specimen D3 Showing Exposed Reinforcement after Debonding of CFRP Plates*

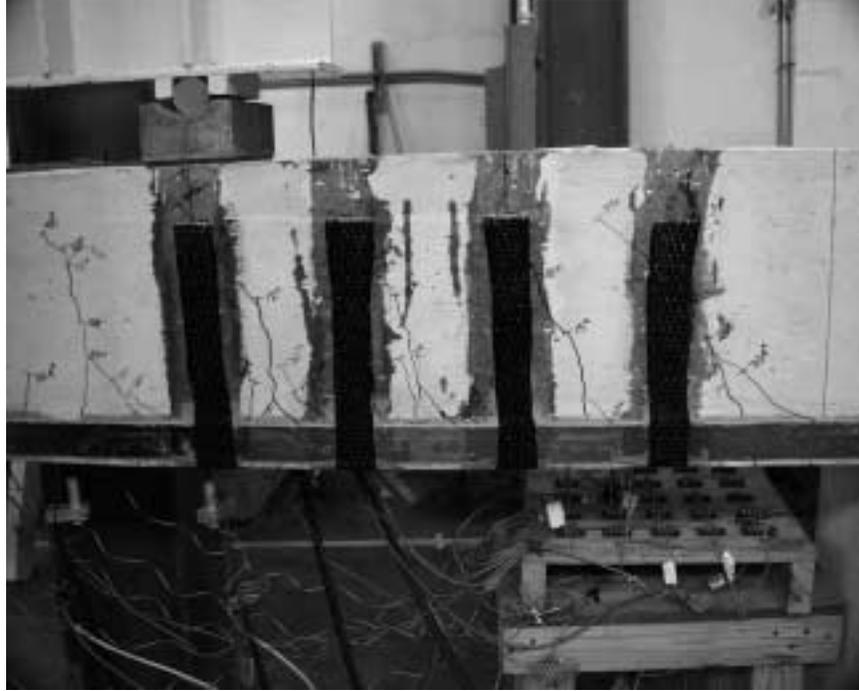
*Figure 6.16 Formation of Debonding Cracks in Specimen D4*

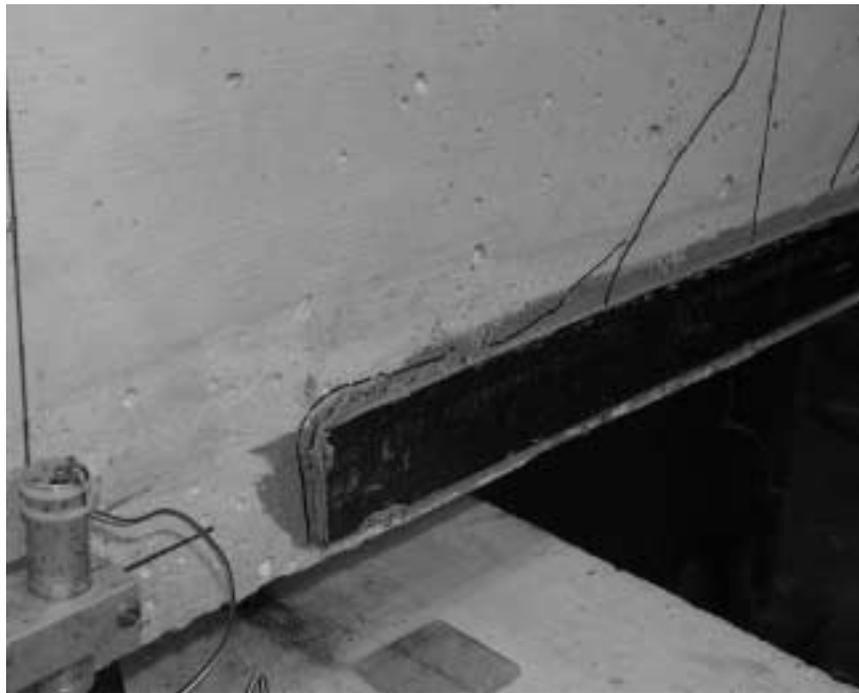
*Figure 6.17 Debonding at the End of the CFRP Composite Plate in Specimen D4*

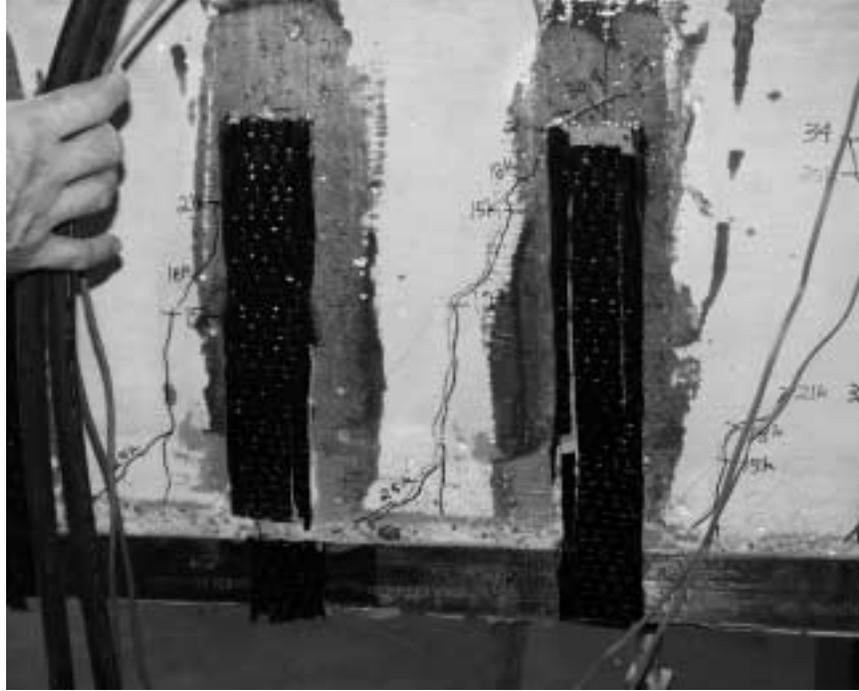
***Figure 6.18 Shearing of Transverse Composite Straps after Debonding of CFRP Composites in Specimen D4***

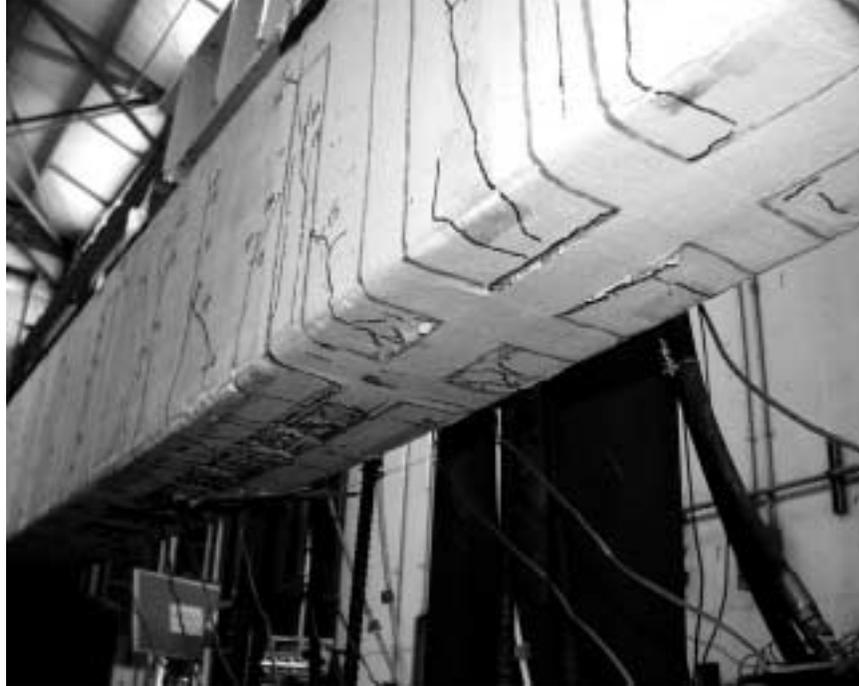
*Figure 6.19 Bottom View of Specimen A-LT1 after Rupture of the CFRP Composite*
