| 4. Title and Subtitle<br><b>Use of Carbon Fiber Reinforced Polymer Composites to Increase the Flexural Capacity of Reinforced Concrete Beams</b> | | | | 5. Report Date<br><i>April 2001</i> | |
| 7. Author(s)<br><b>Sergio F. Breña, Regan M. Bramblett, Michaël A. Benouaich, Sharon L. Wood, and Michael E. Kreger</b> | | | | 8. Performing Organization Report No.<br>Research Report 1776-1 | |

**USE OF CARBON FIBER REINFORCED POLYMER  
COMPOSITES TO INCREASE THE FLEXURAL CAPACITY OF  
REINFORCED CONCRETE BEAMS**

**Research Report 1776-1**

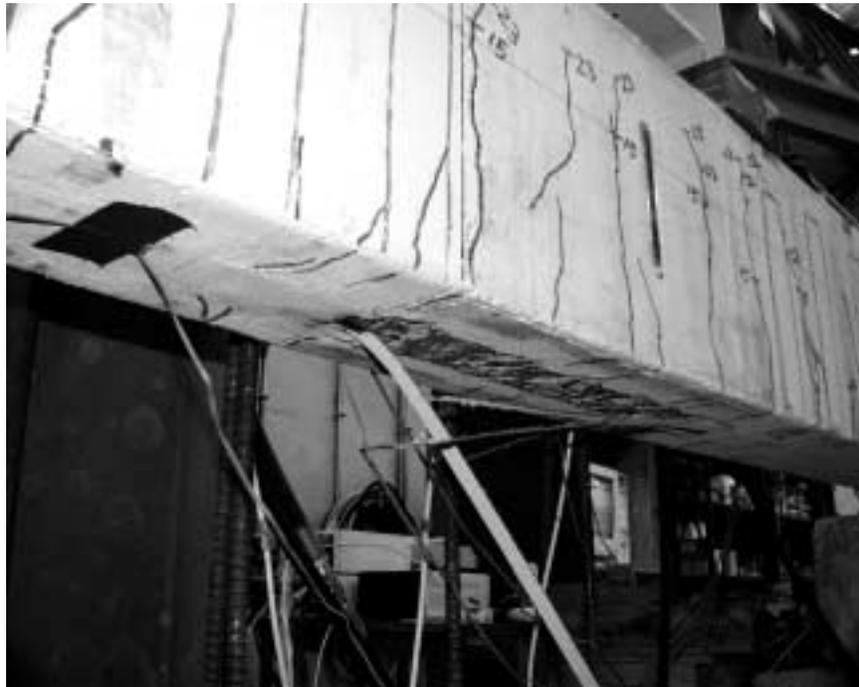
*Figure 6.20 Bottom View of Specimen A-LT2 after Rupture of the CFRP Composite*

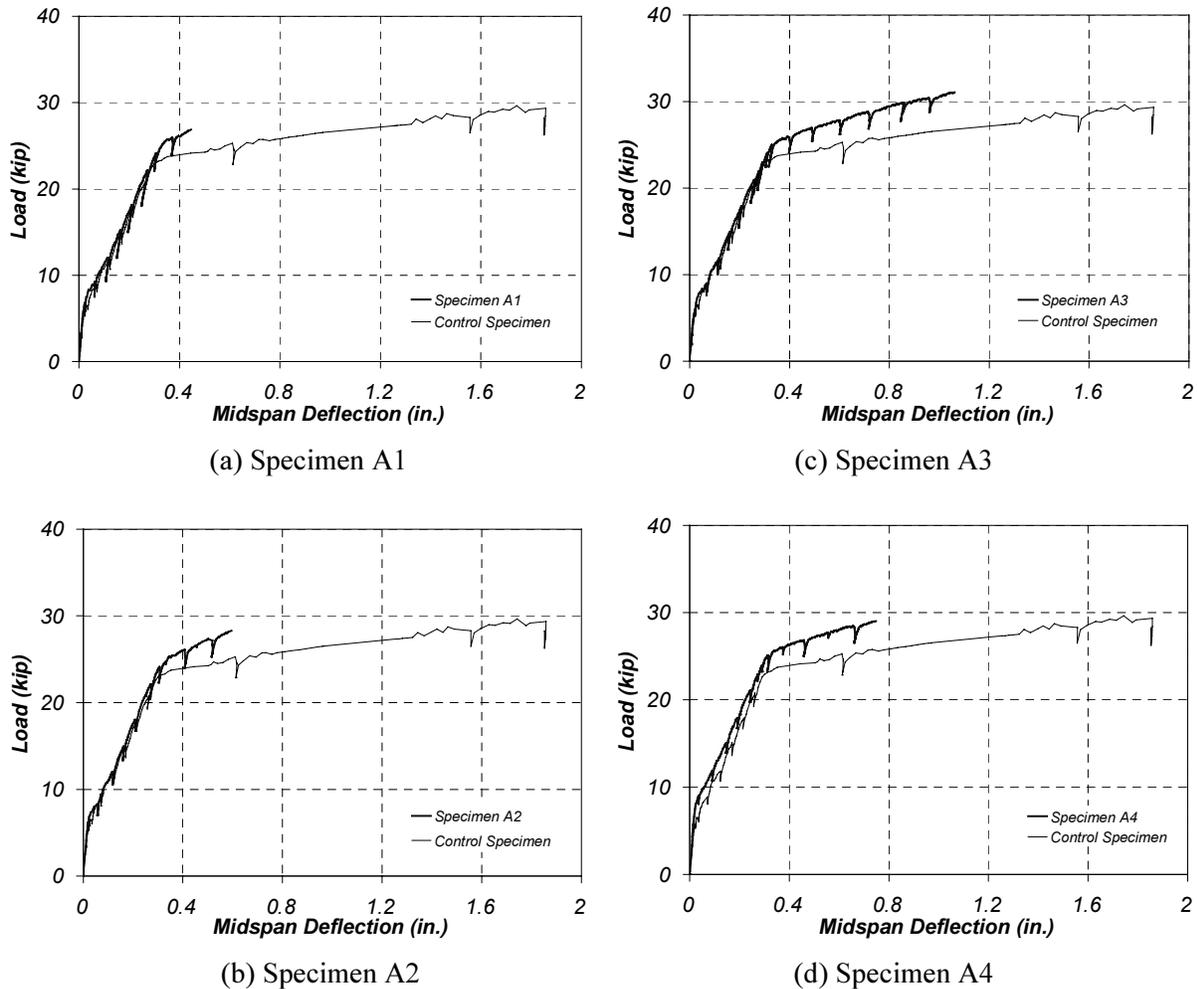
**Figure 6.22 Comparison of the Load-Deflection Response of Specimens Strengthened Using Composite System A**

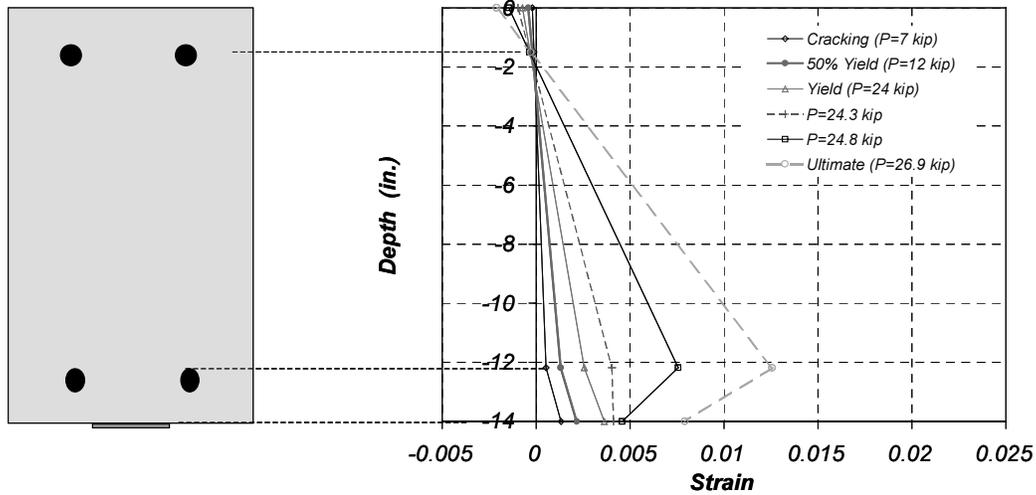
**Figure 7.1 Strain Profiles for Specimen A1 (Section 1)**

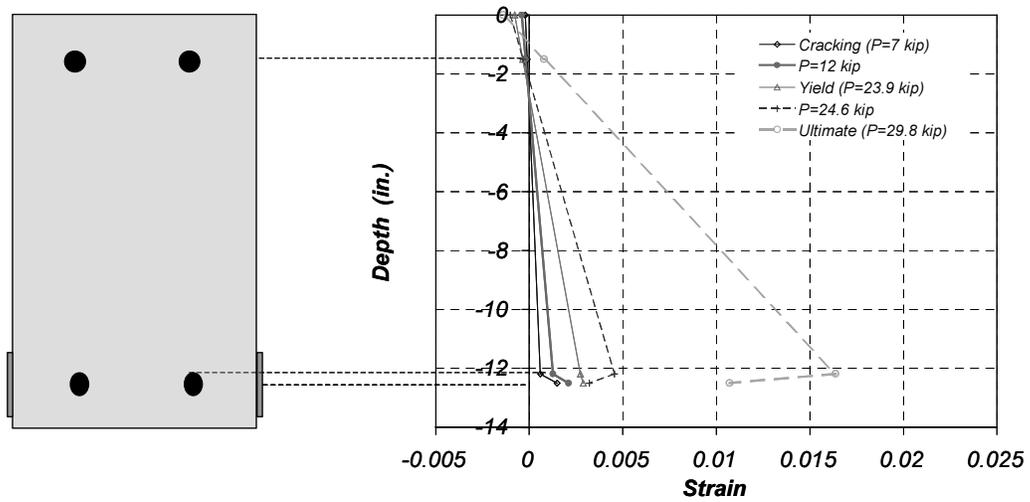
**Figure 7.2 Strain Profiles for Specimen B3 (Section 1)**

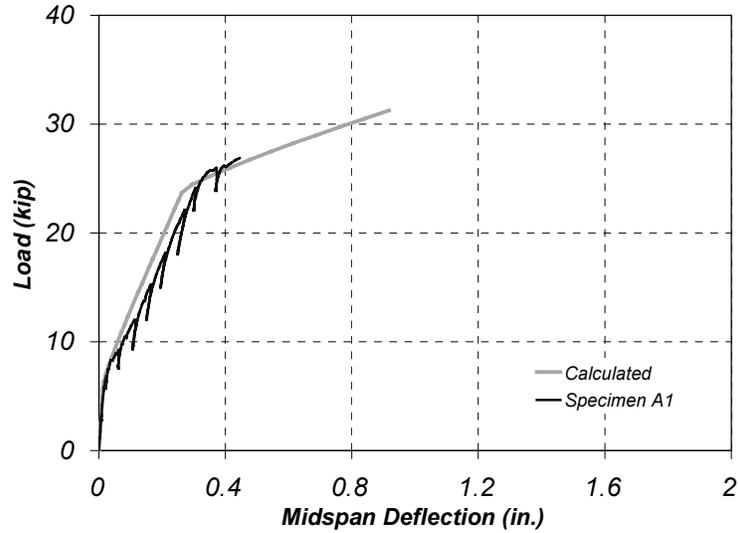
**Figure 7.12 Comparison of Measured and Calculated Load-Deflection Response of Specimen A1**

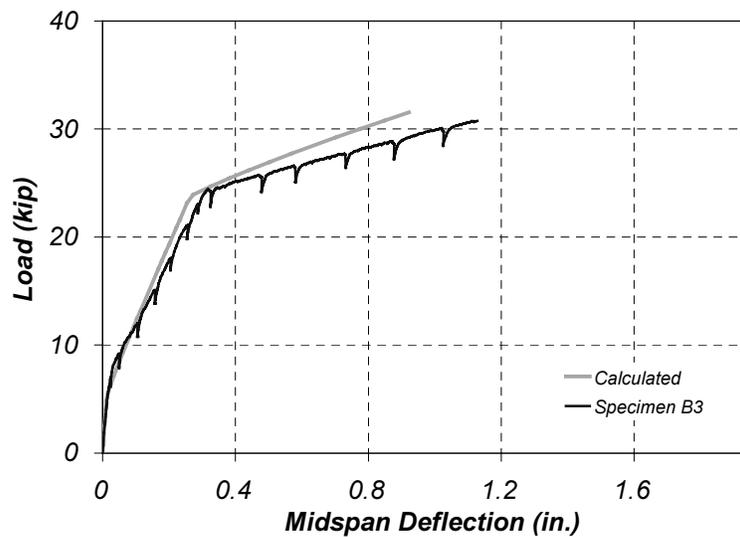
**Figure 7.13 Comparison of Measured and Calculated Load-Deflection Response of Specimen B3**

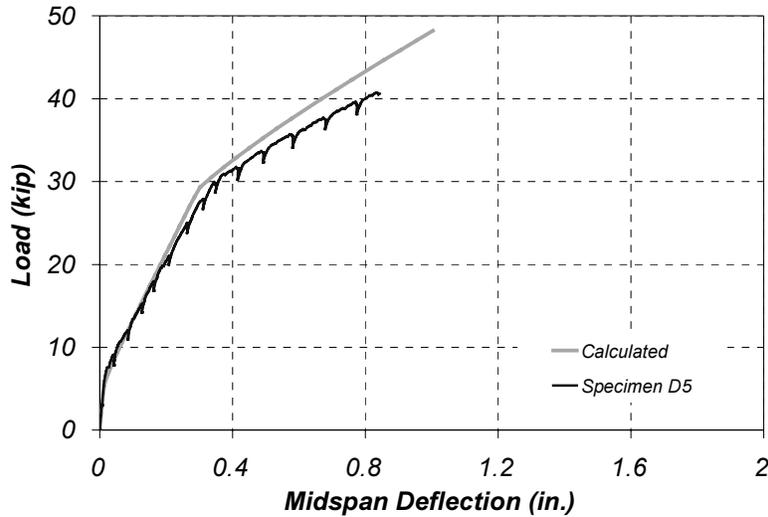
**Figure 7.16 Comparison of Measured and Calculated Load-Deflection Response of Specimen D5**

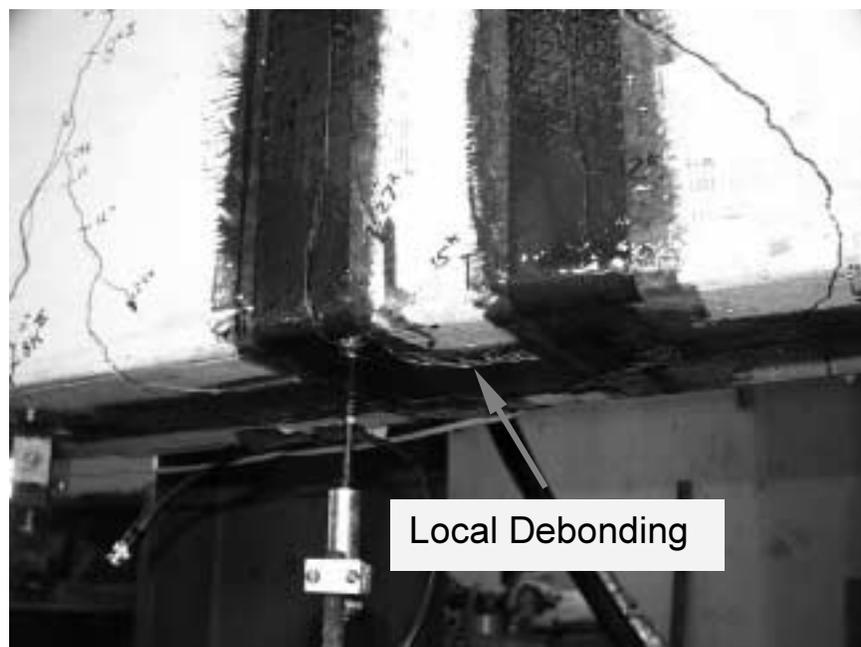
*Figure 8.1 Initiation of Debonding of Specimen A-F1*

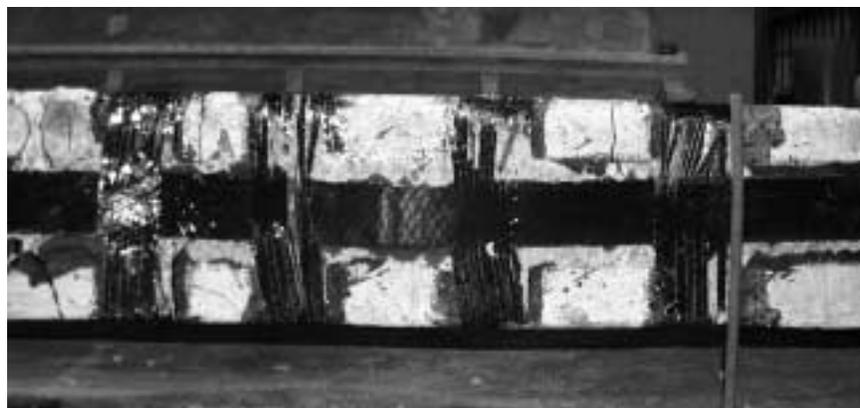
*Figure 8.2 View of Tension Face of Specimen A-F2 after Debonding*

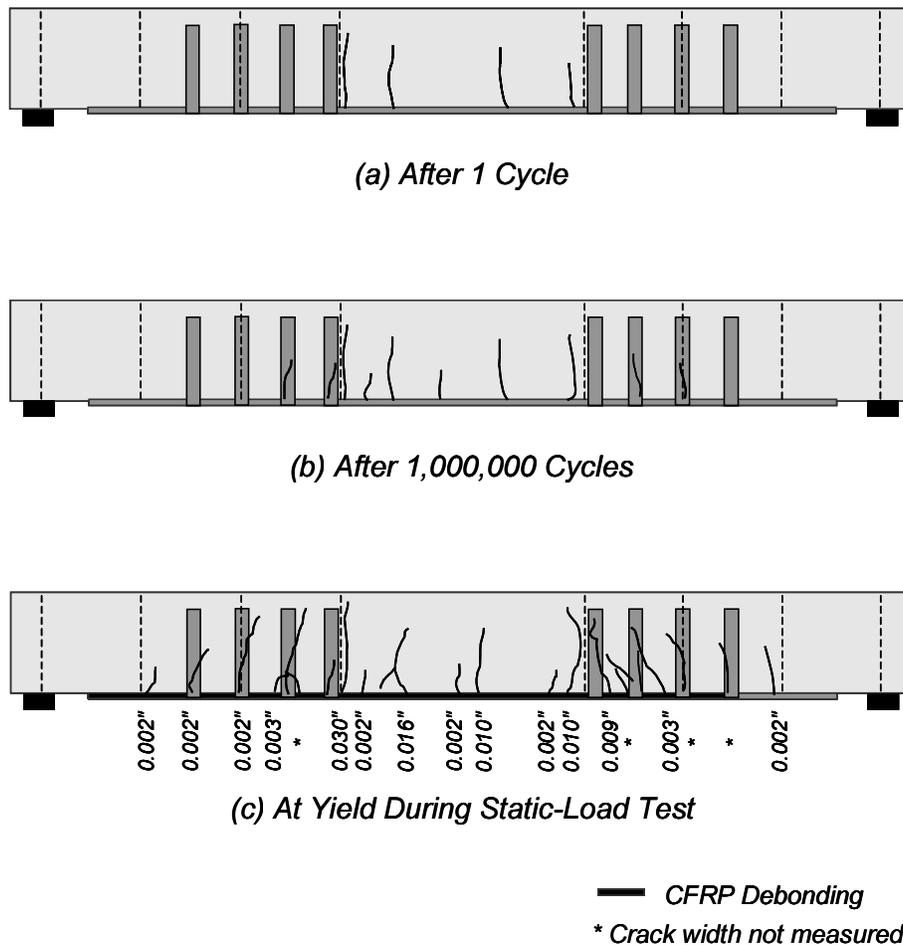
**Figure 8.3 Extension of Cracks during Cycling of Specimen A-F3**

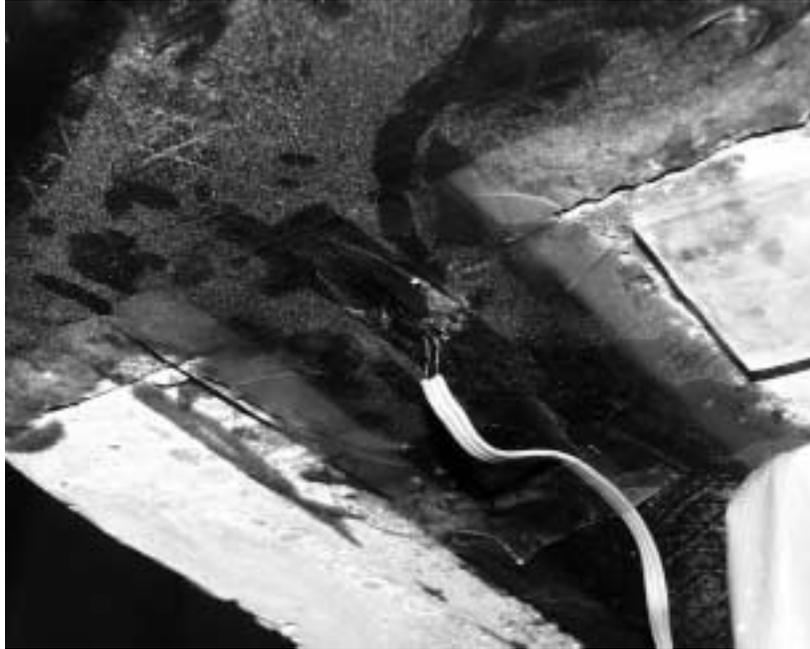
***Figure 8.4 Local Debonding of CFRP Composite after 100,000 Cycles of Loading in Specimen A-F3***

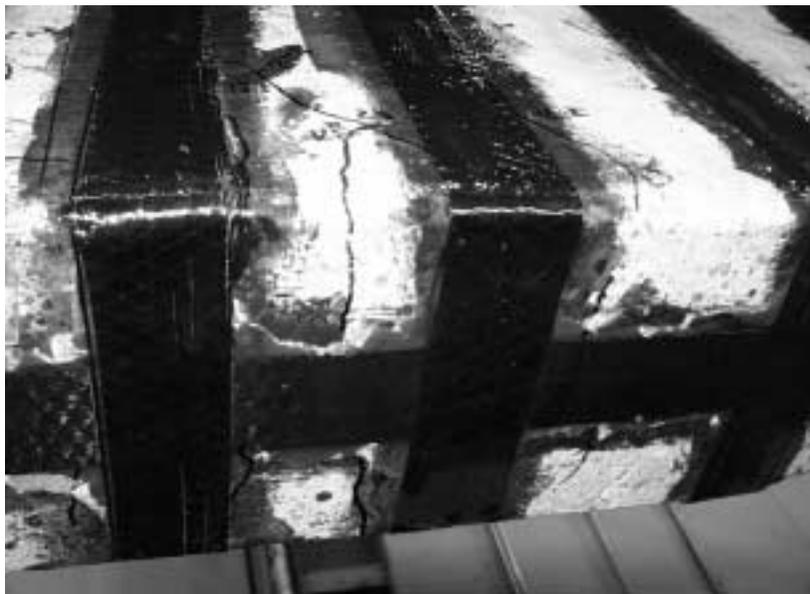
***Figure 8.5 Propagation of Debonding and Initiation of Strap Splitting after Failure of Specimen A-F3***

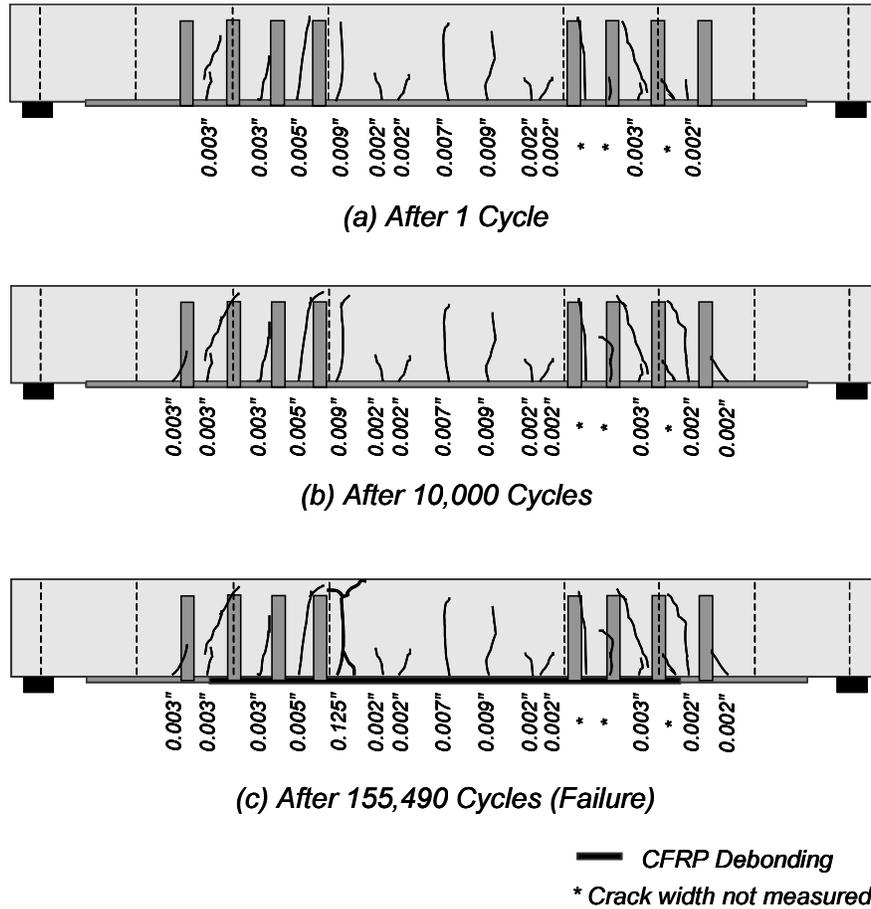
**Figure 8.6** Extension of Cracks during Cycling of Specimen A-F4

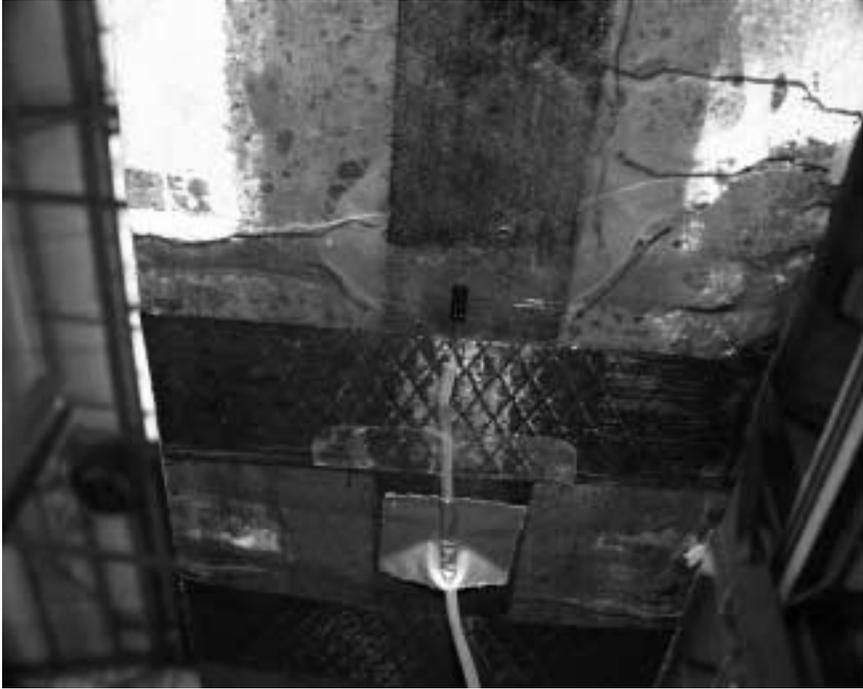
*Figure 8.7 Bottom View of Specimen A-F4 Showing the Formation of Secondary Cracks during Cycling in the Vicinity of the Crack Initiator*

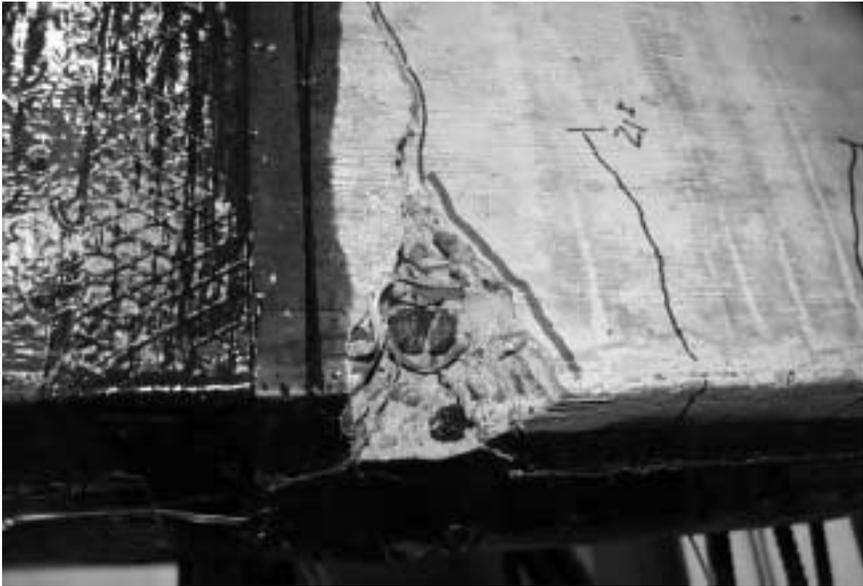
*Figure 8.8 Detail Showing Fatigue Fracture of Reinforcing Bar in Specimen A-F4*

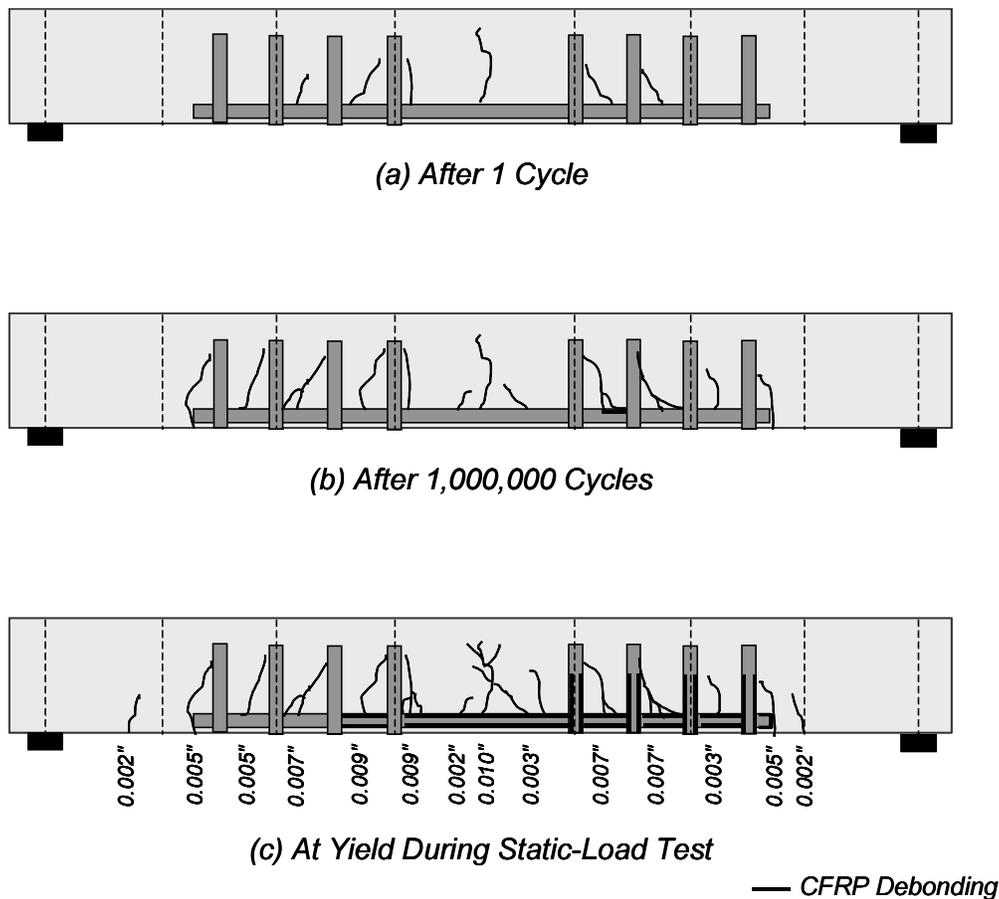
**Figure 8.9** Formation and Extension of Crack Lengths as a Function of Load Cycling in Specimen D-F2

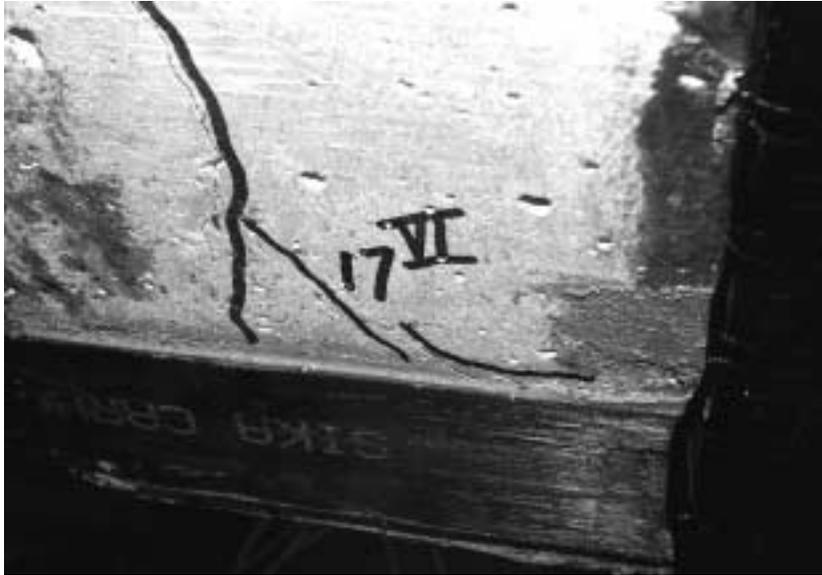
***Figure 8.10 Local Debonding of CFRP Plate on Specimen D-F2 during Fatigue Cycling***

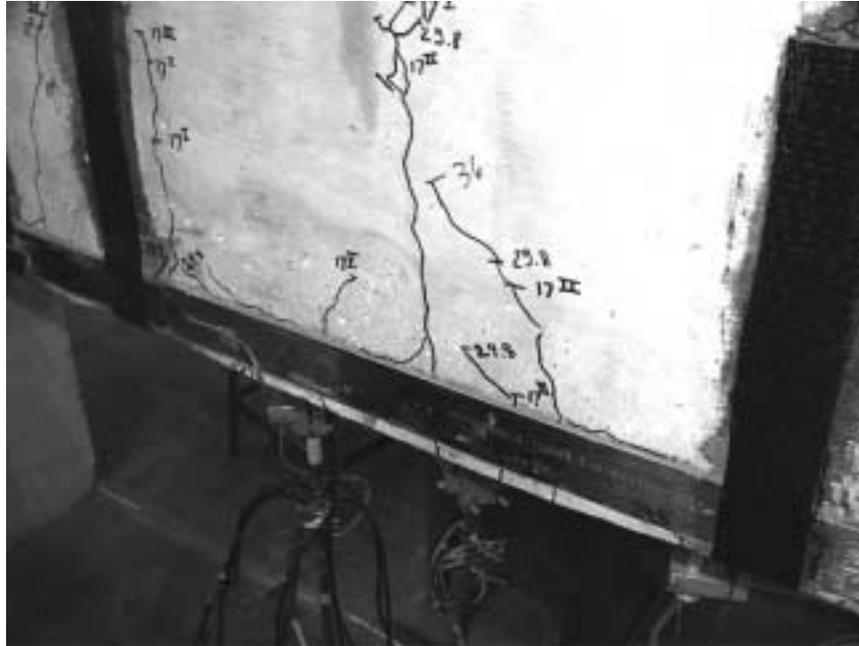
*Figure 8.11 Formation of Debonding Cracks in Specimen D-F2*

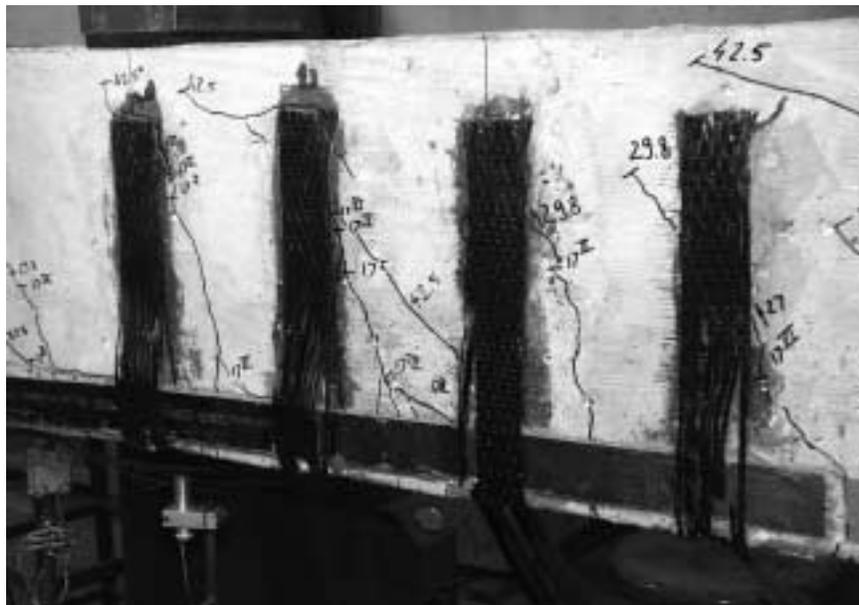
*Figure 8.12 Debonding at the End of the CFRP Composite Plate in Specimen D-F2*

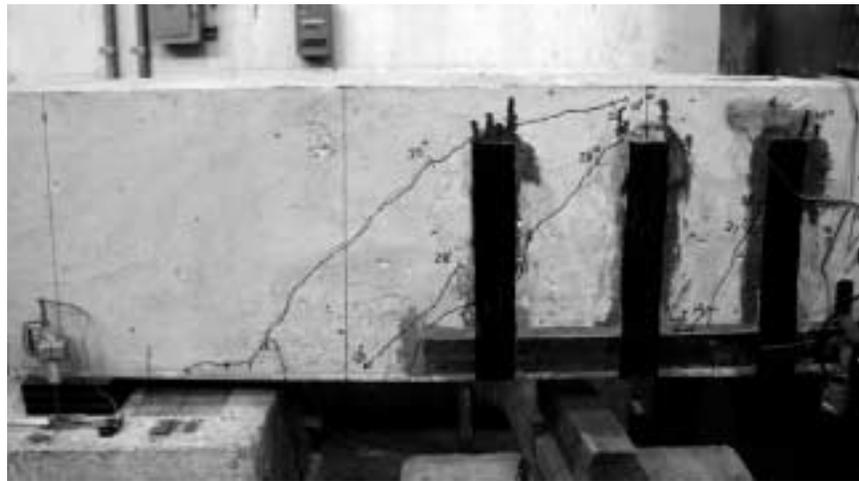
**Figure 8.14** Shear Crack that Formed During Cycling of Specimen D-F3

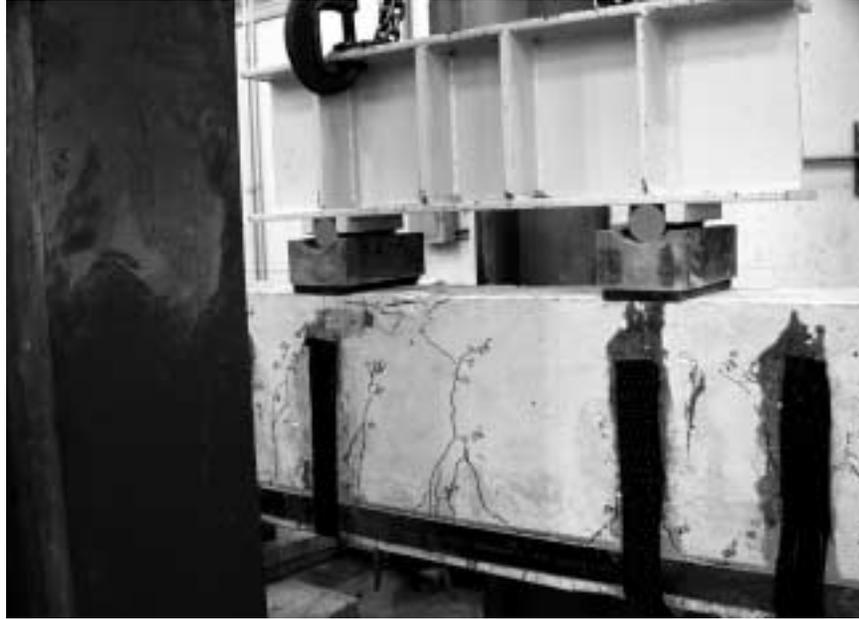
***Figure 8.15 Crushing of the Concrete in the Compression Zone after Debonding of the CFRP Plate on the Opposite Side of Specimen D-F3***

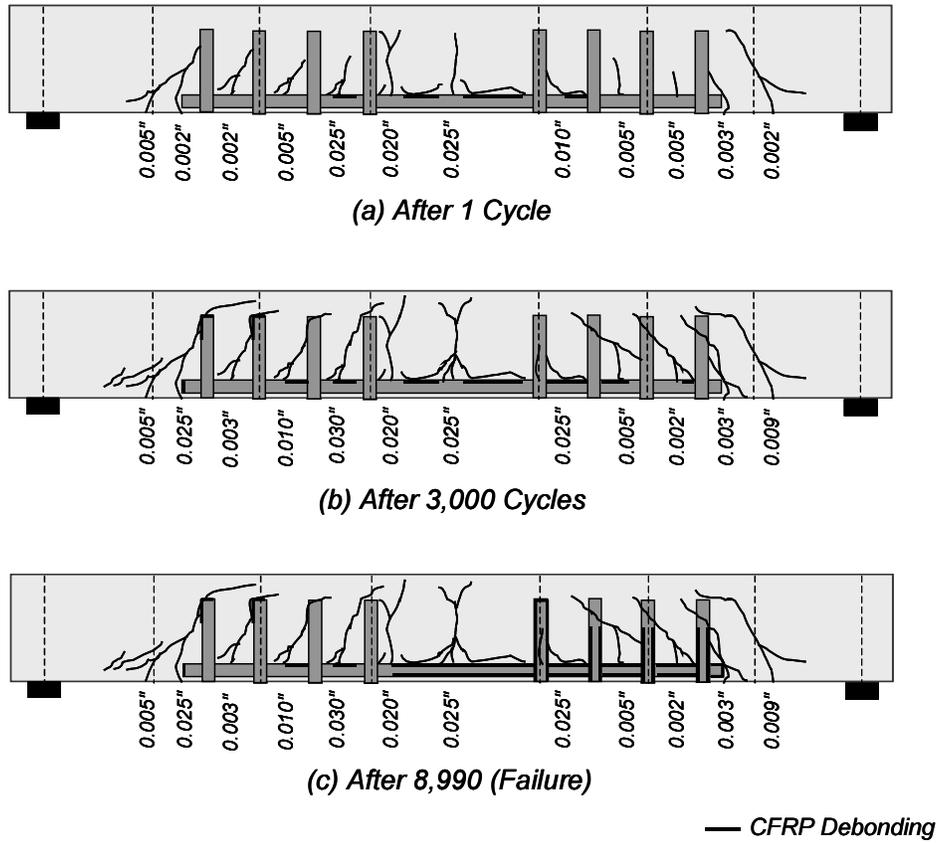
**Figure 8.16** Formation and Extension of Crack Lengths as a Function of Load Cycling in Specimen D-F4

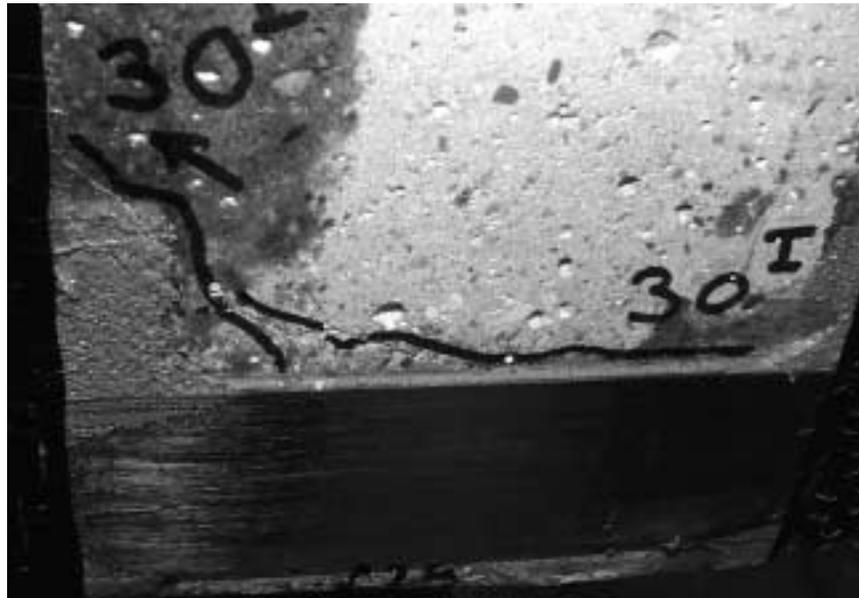
**Figure 8.17** Detail Showing Propagation of Debonding Along the Top Edge of the Composite Laminate in Specimen D-F4 during the First Cycle of Loading

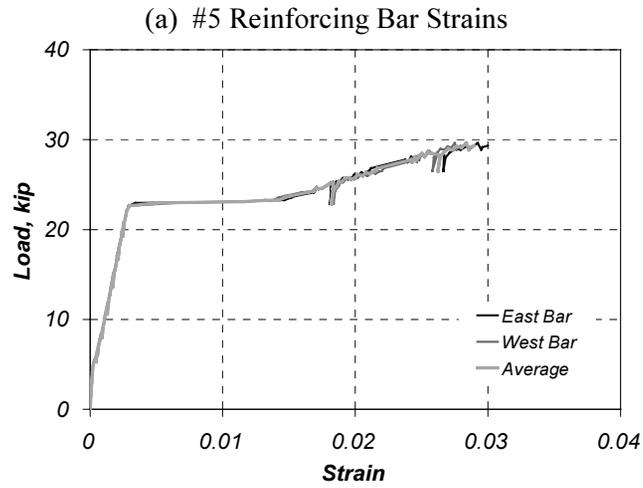
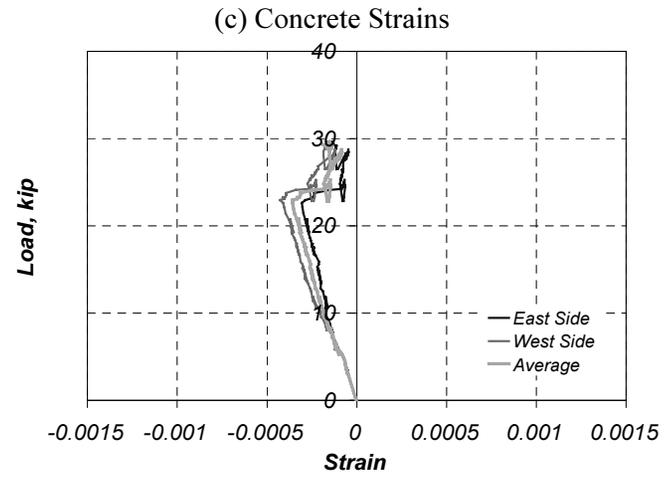
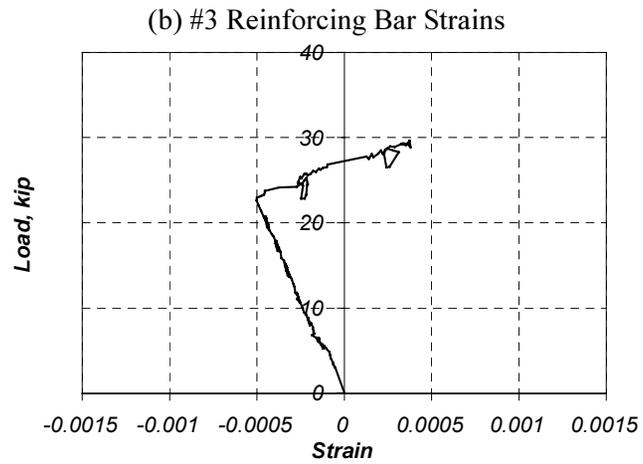
Figure D.3 Measured Strains in Control Specimen A & B (Section 1)
